## **Ash Impoundment Closure Report**

Independence Power & Light  
Blue Valley Power Station  
21500 East Truman Road  
Independence, Missouri 64056

**SCS ENGINEERS**  
7311 West 130th Street, Suite 100  
Overland Park, Kansas 66213  
(913) 681-0030

April 2018  
Revised June 2018  
File No. 27215142.00

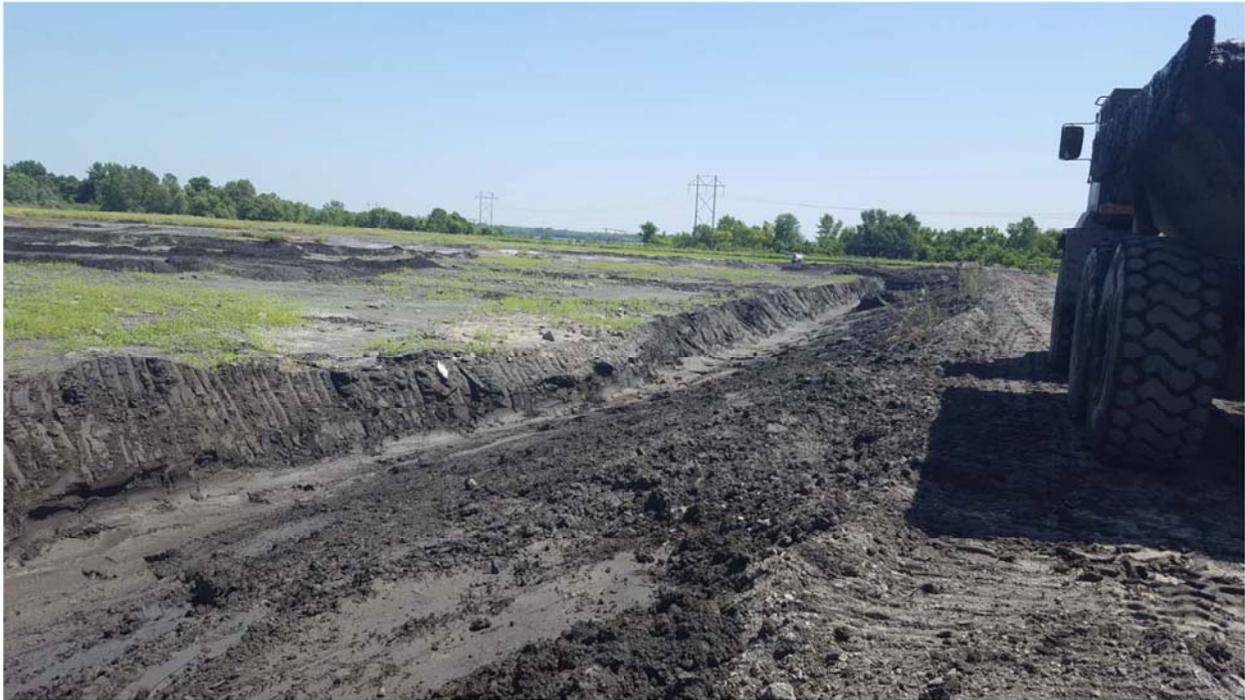
Figure 9: Excavating and relocating saturated fly ash from the south end of the north pond (facing northeast)

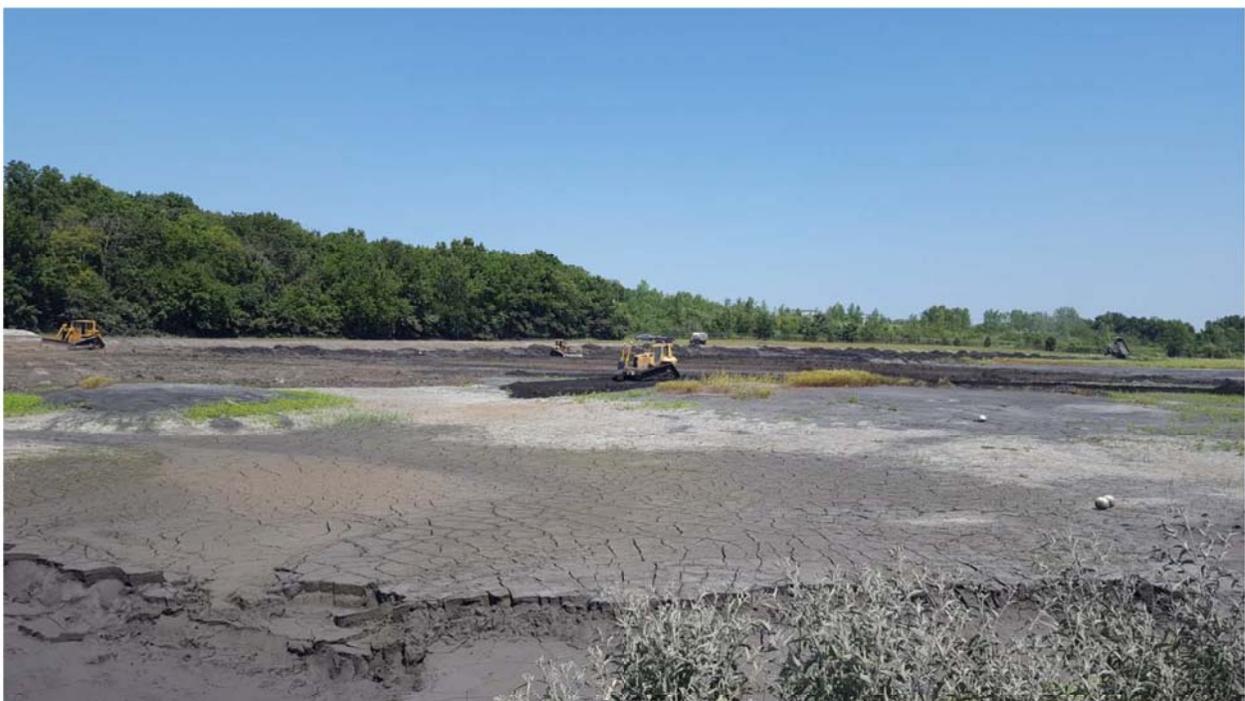
Figure 10: Dozers grading to dry out the fly ash in the north pond (facing north)

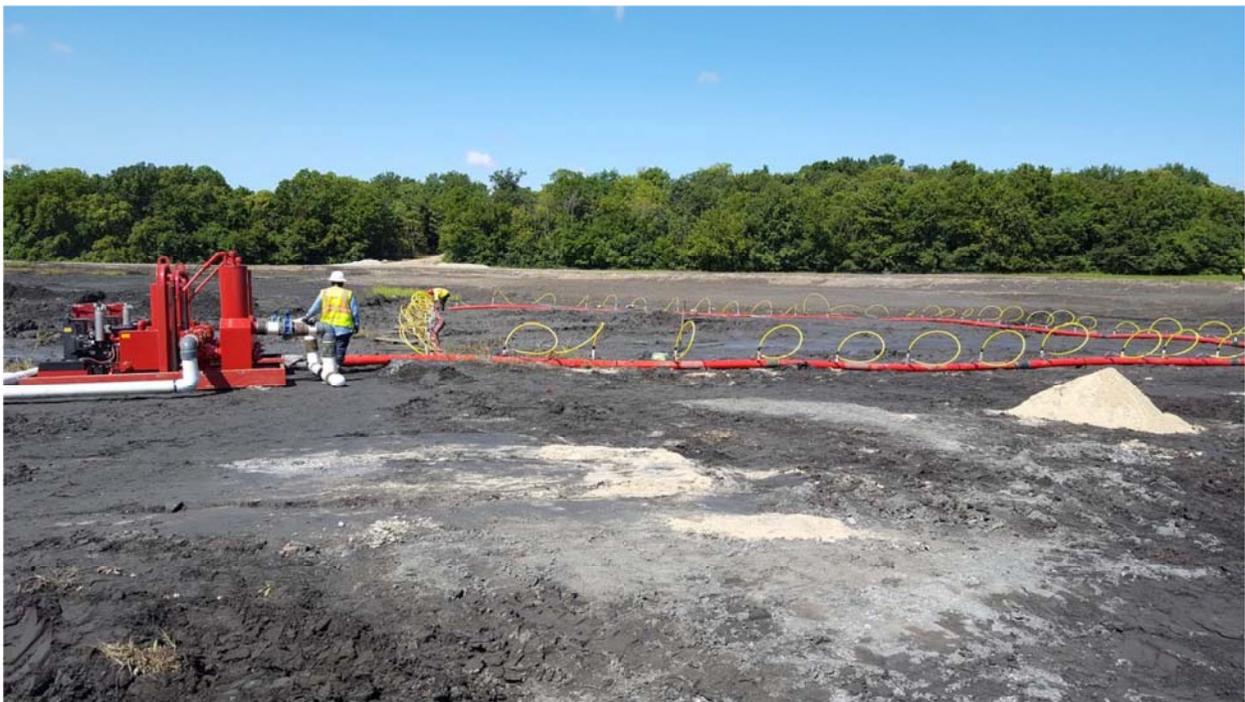
Figure 2: Well points and water extraction system installed in the north pond (facing west)

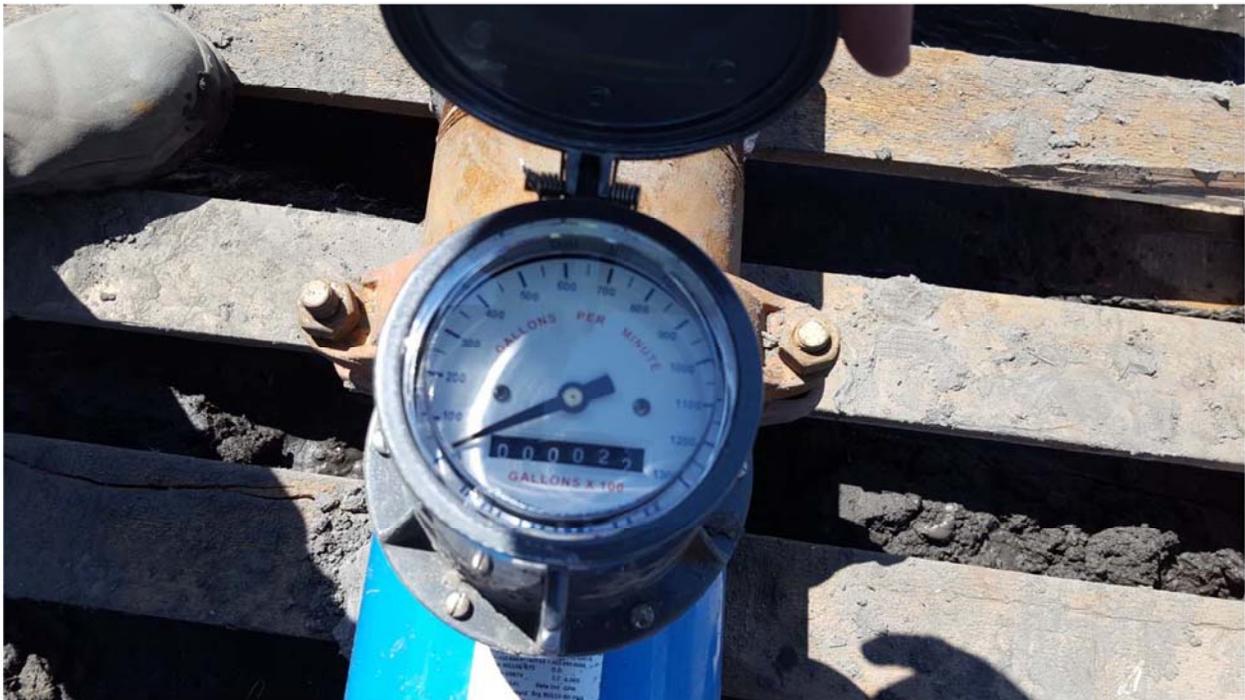
Figure 6: Flow and totalizer meter installed on the outlet pipe of the extraction system

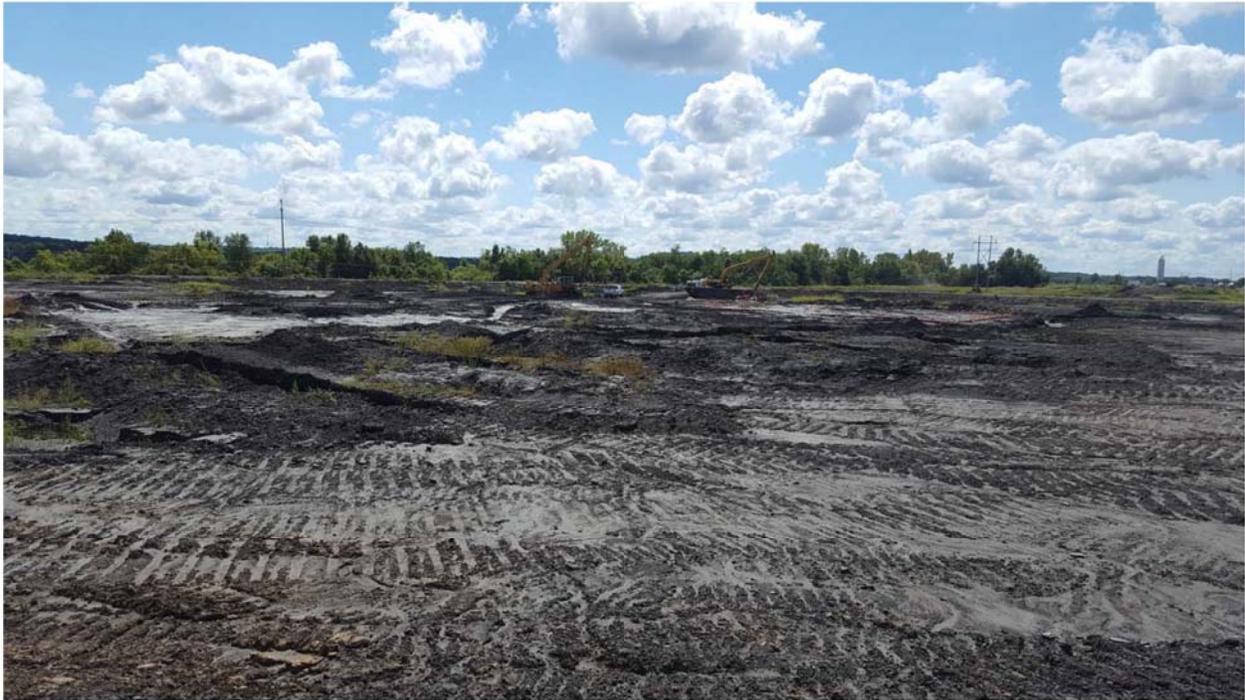
Figure 9: North side of the north pond graded and little standing water observed (facing southeast)

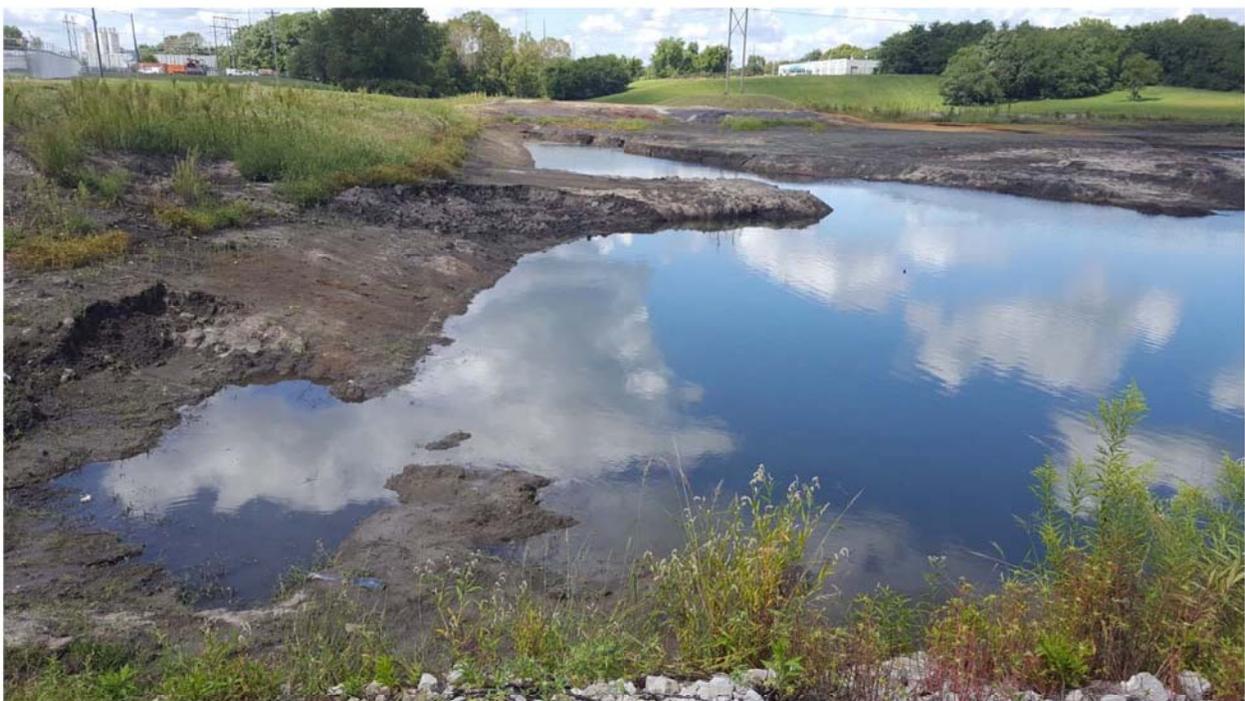
Figure 10: Standing water remaining in the south side of the southwest pond (facing west)

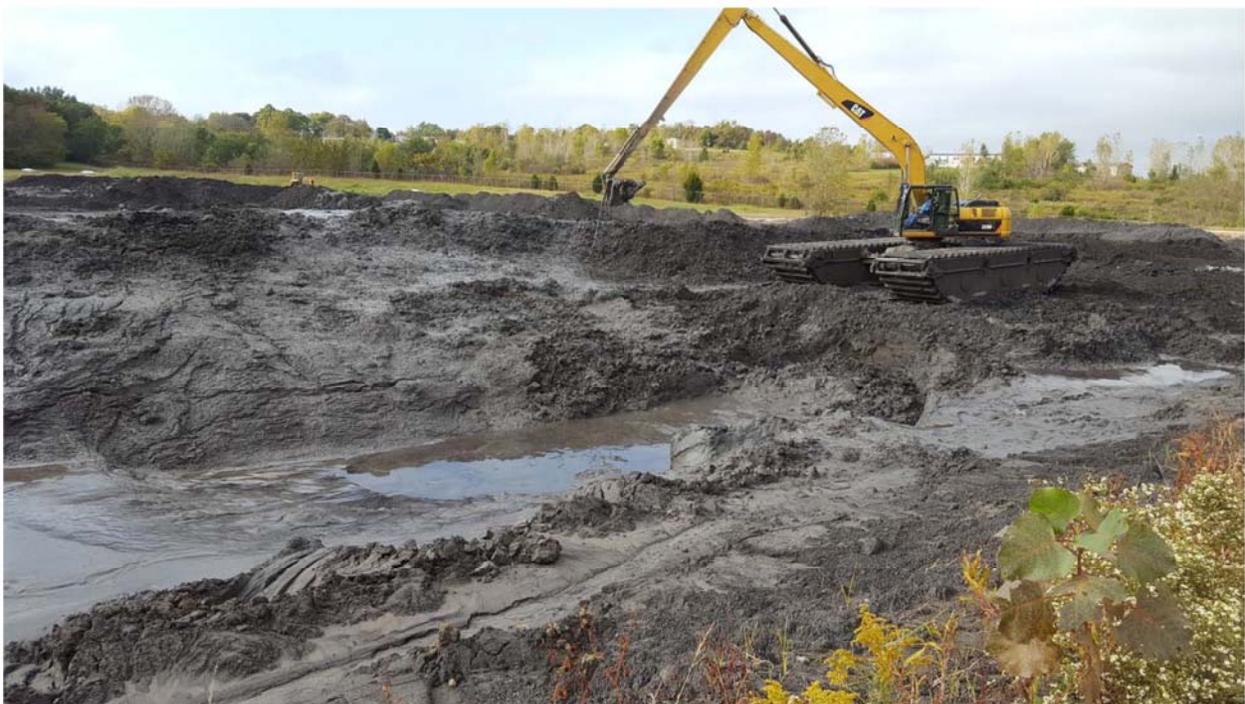
Figure 6: Excavating trenches to release trapped water in the northeast side of the north pond (facing northwest)

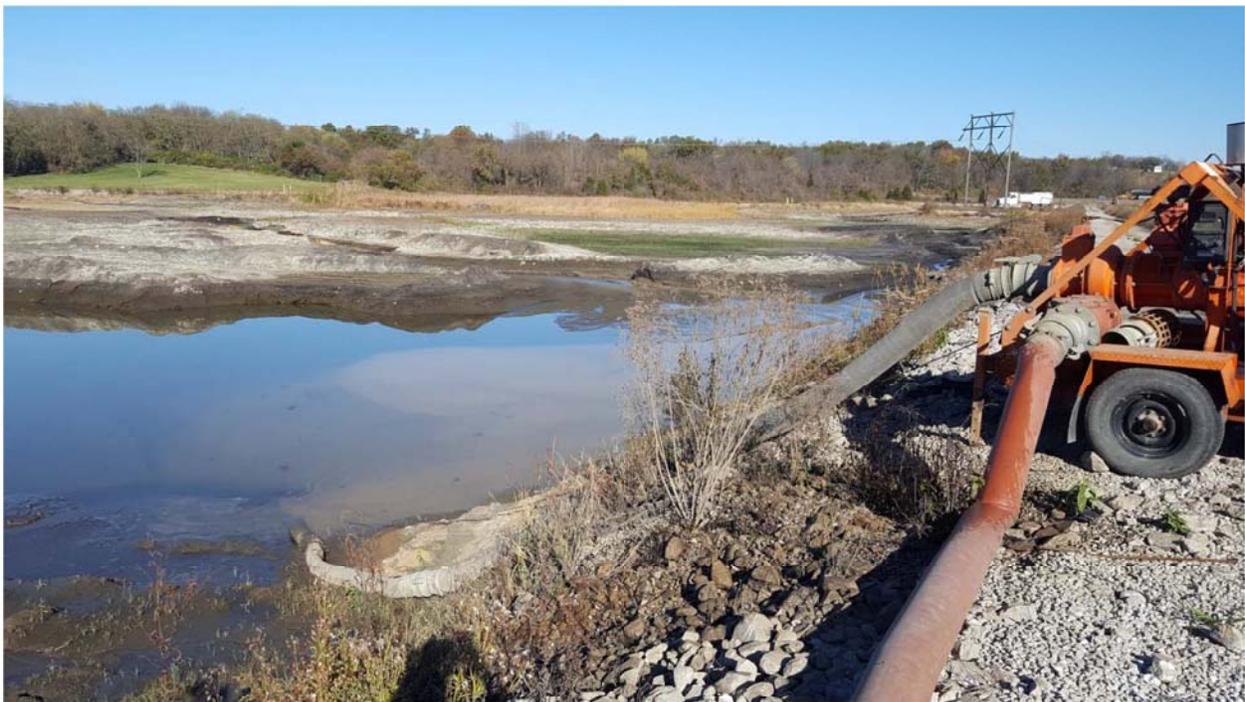
Figure 10: Pumping standing water from the southwest pond to temporary sedimentation basin prior to discharge to the LBVSD outfall (facing northwest)

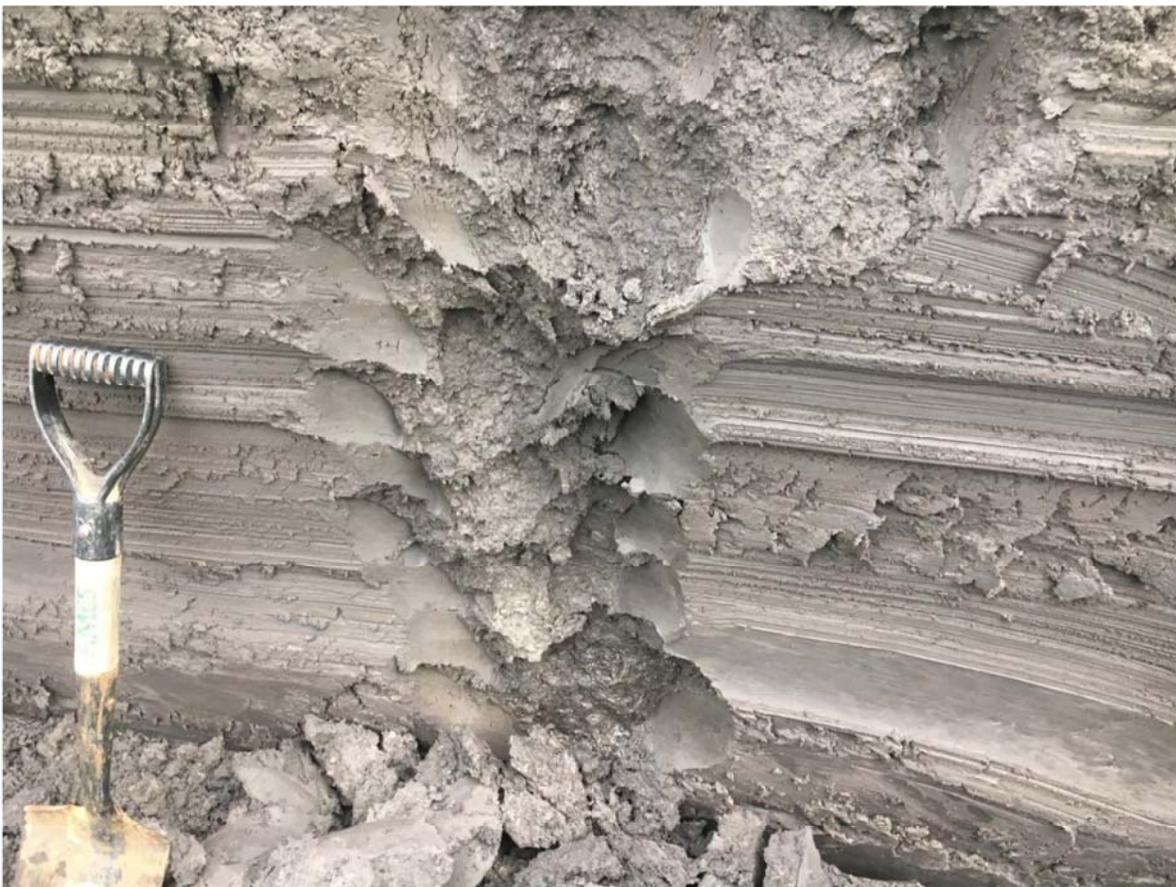
Figure 4: Clay soils encountered in test pit 2 in the northeast quadrant (facing northeast)

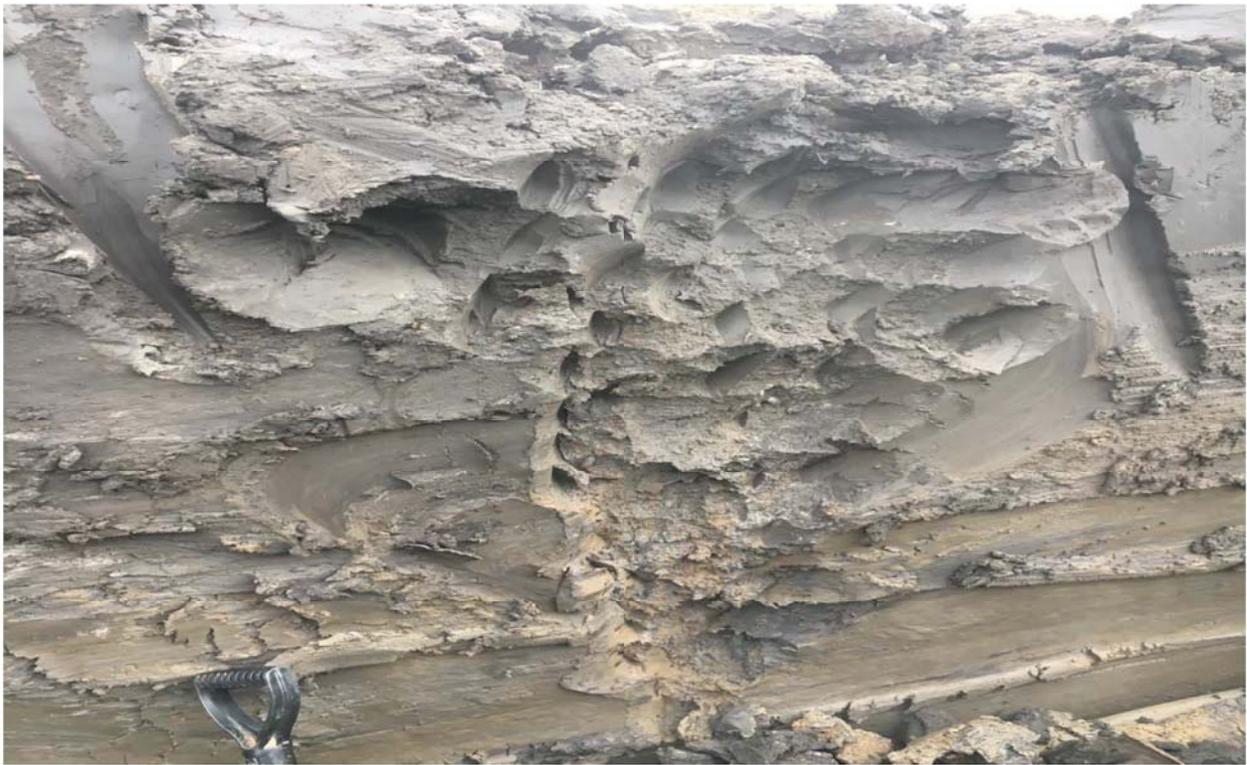
Figure 5: Clay soils encountered in test pit 4 in the northwest quadrant (facing north)

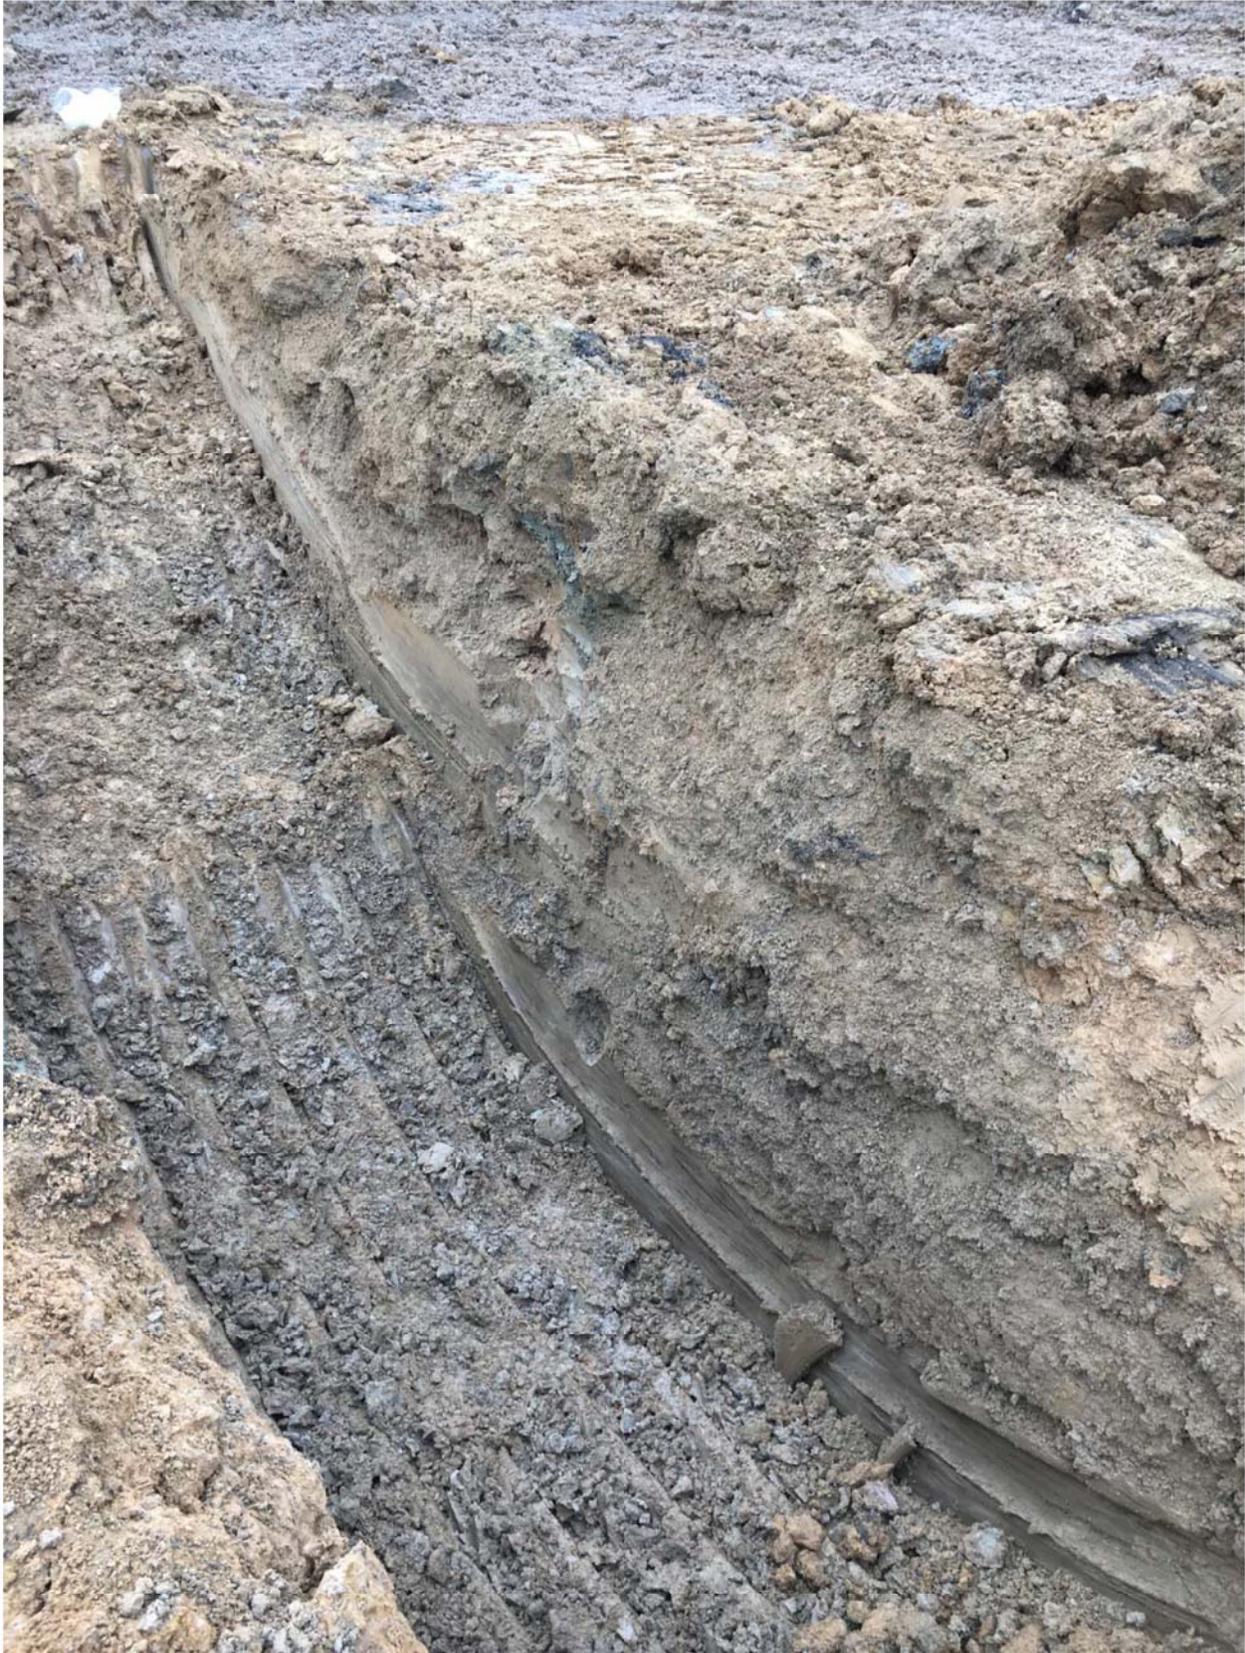
Figure 3: TP-5, located in southwest corner of sedimentation pond. Looking at north wall.

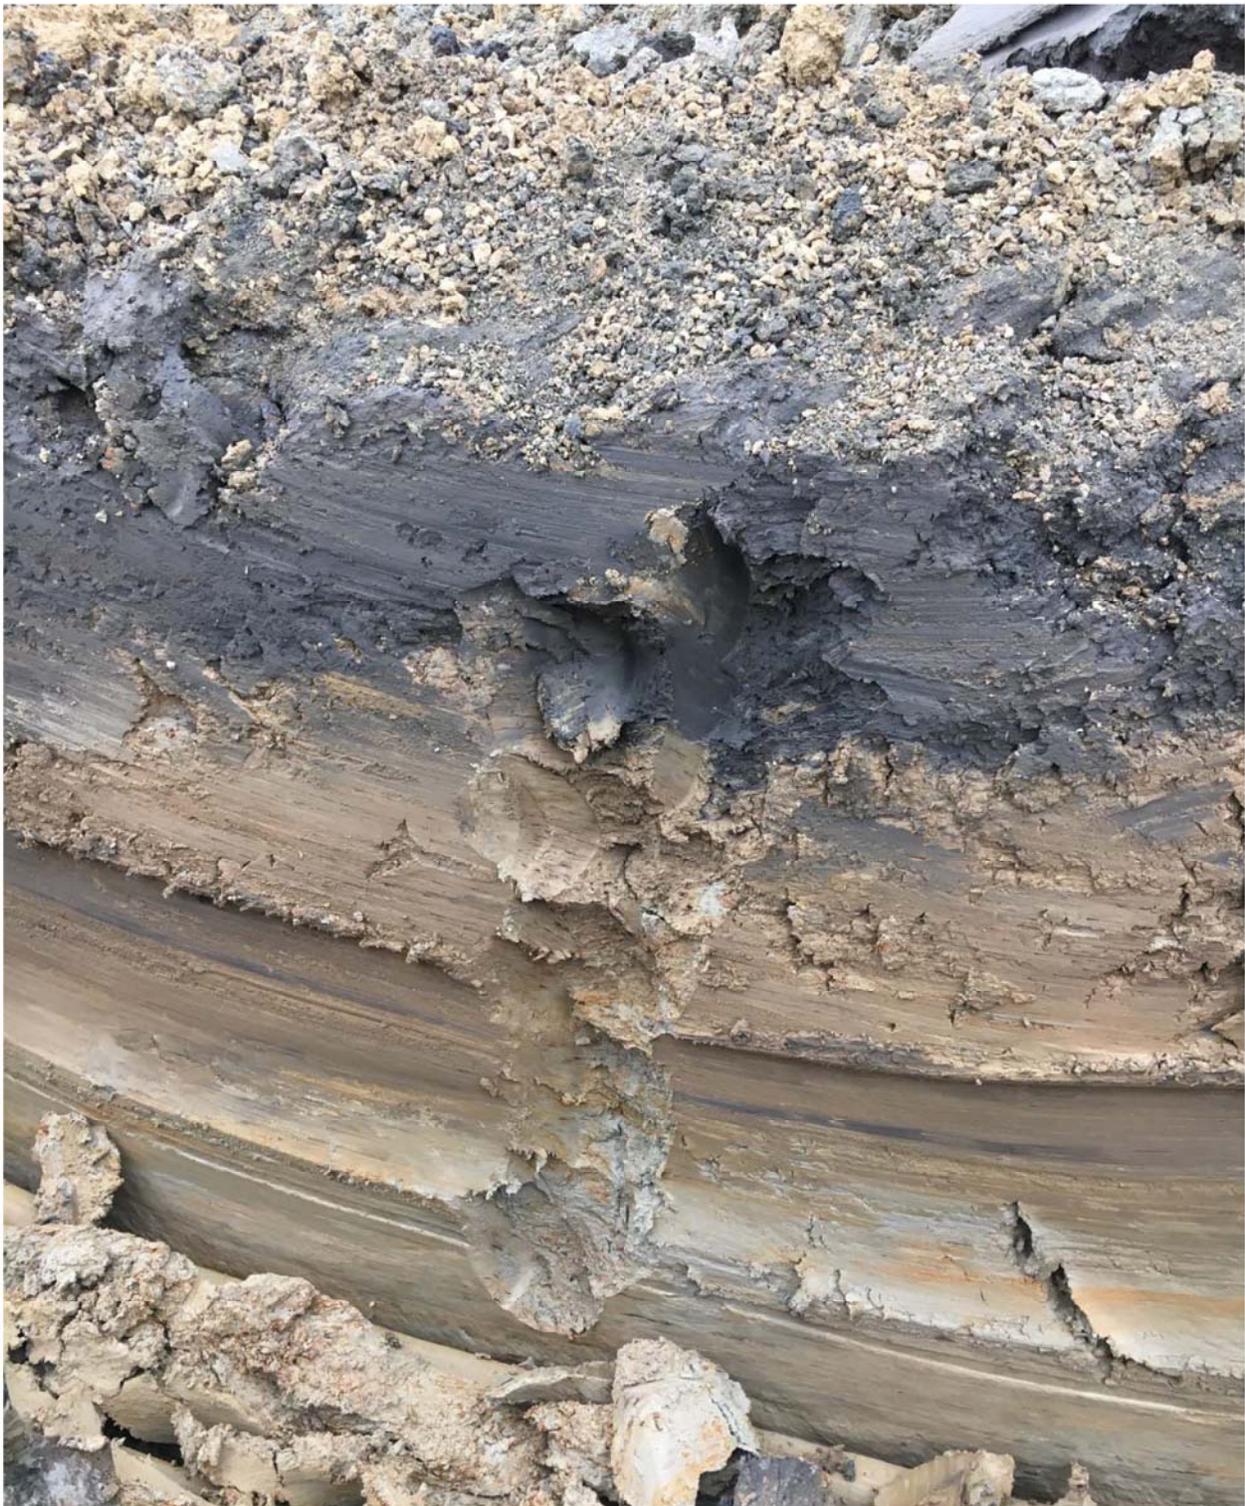
Figure 4: Possible waste soil on top of native brown and gray mottle clay soil encountered in TP-6 in the northwest quadrant (north wall)

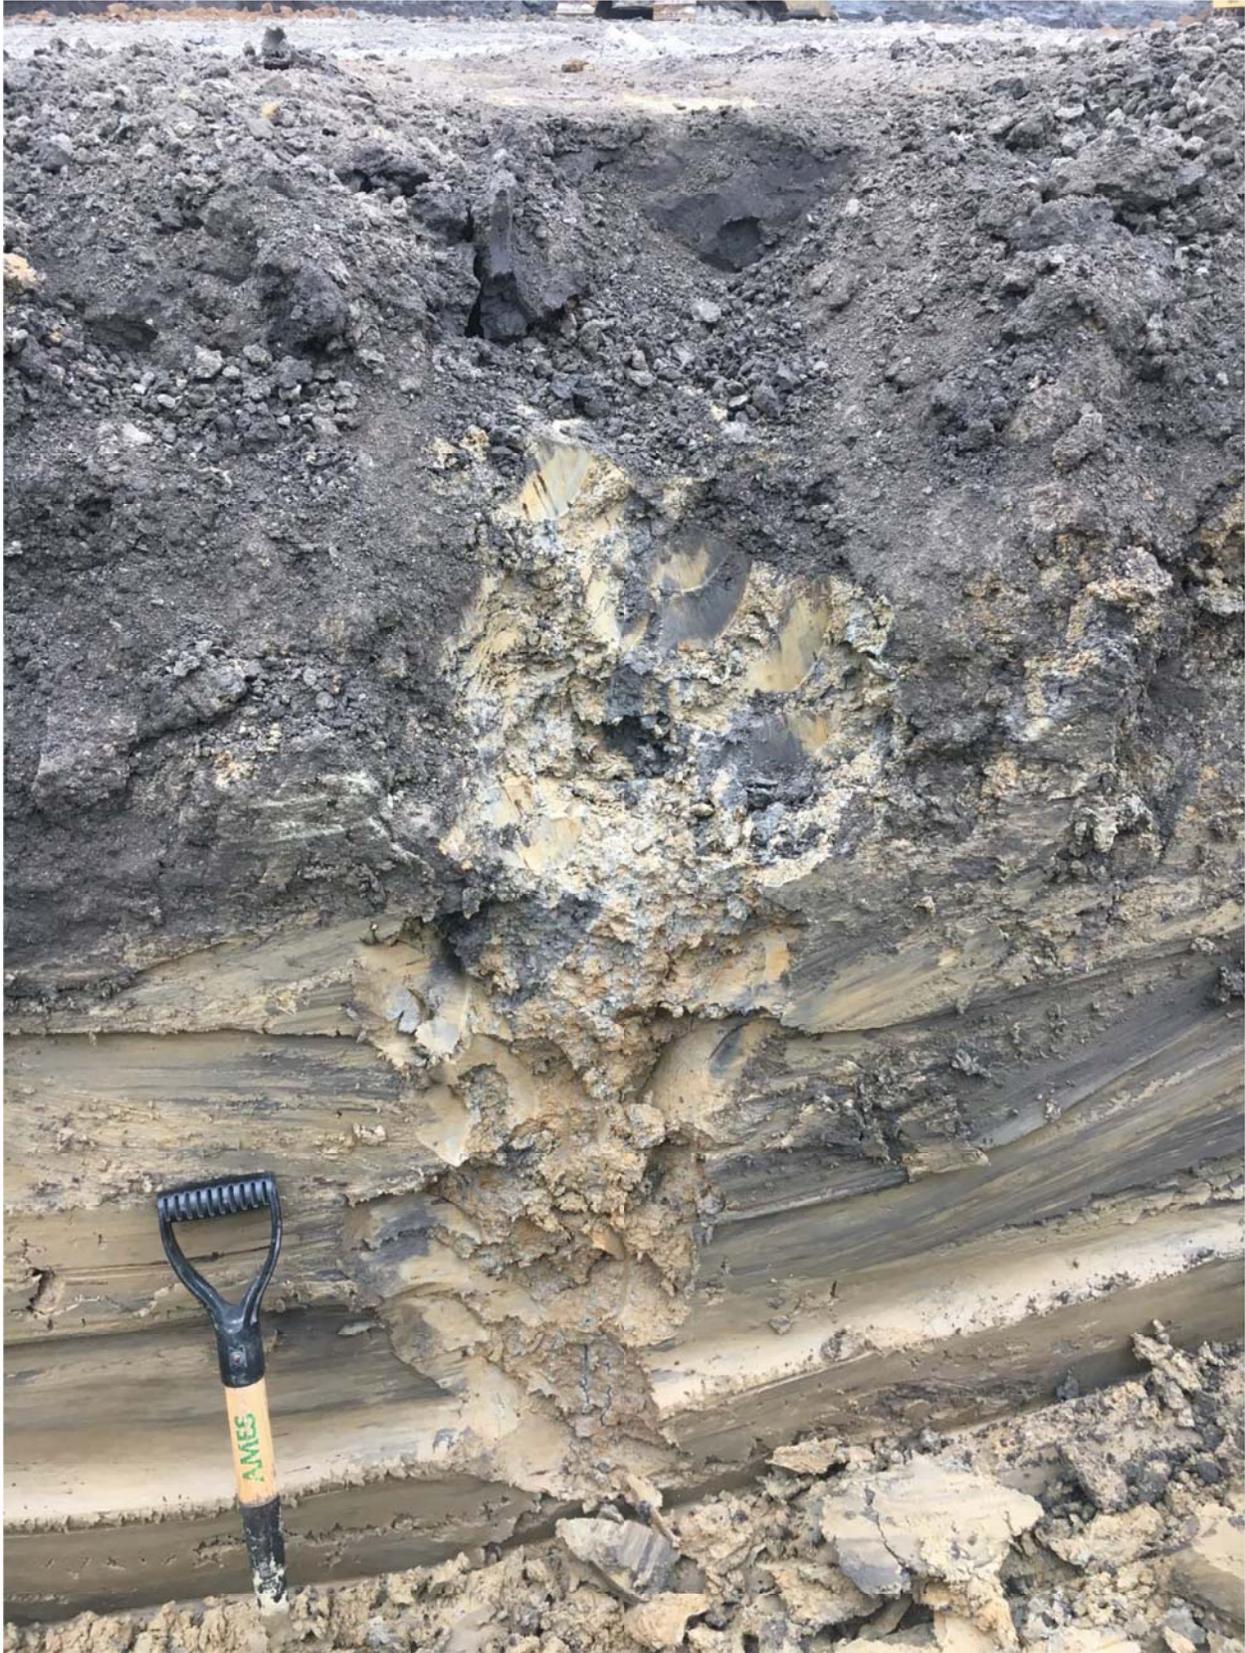
Figure 5: Gray clay soils overlying brown and gray clay in TP-7.

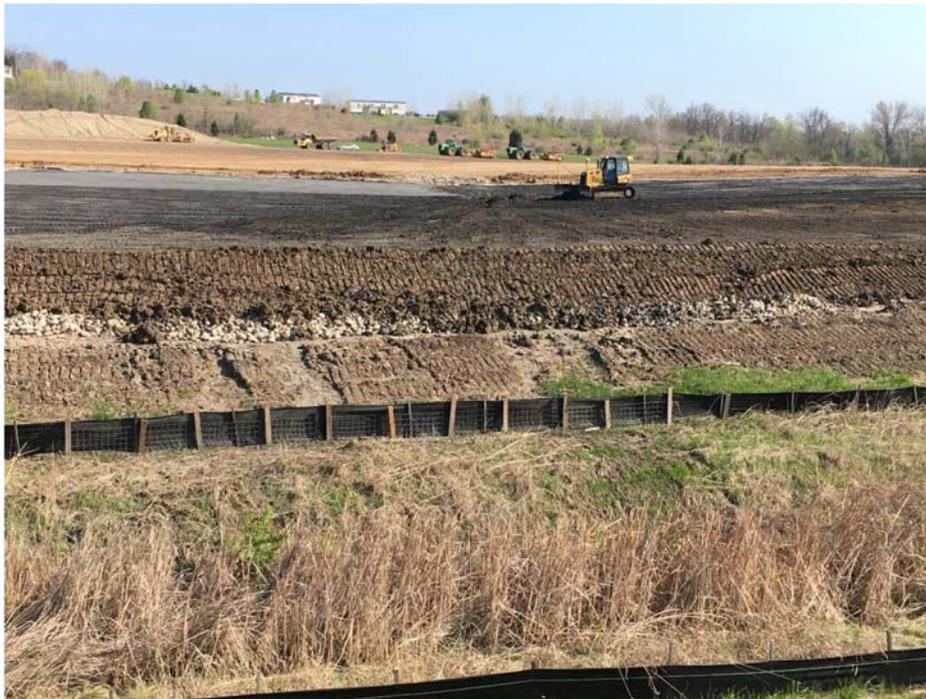
Figure 4: Repaired storm water berm and silt fencing (facing north)

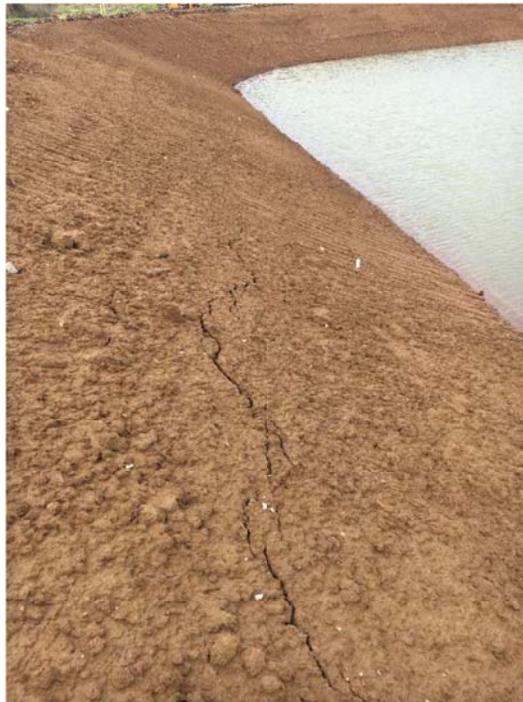
Figure 15: Cracking of clay on the west berm of the sedimentation basin.  
(facing north – 4/14/2017)

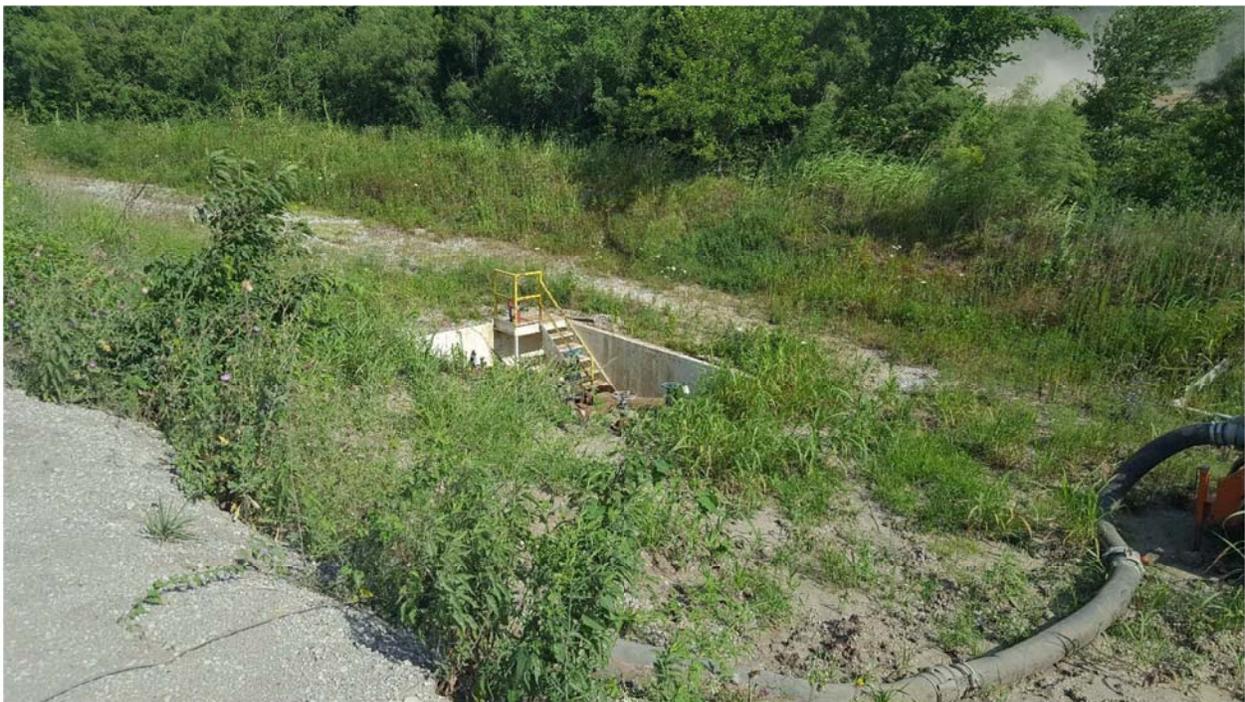
Figure 6: Outer building shell removed from the pump valve house (facing northwest)

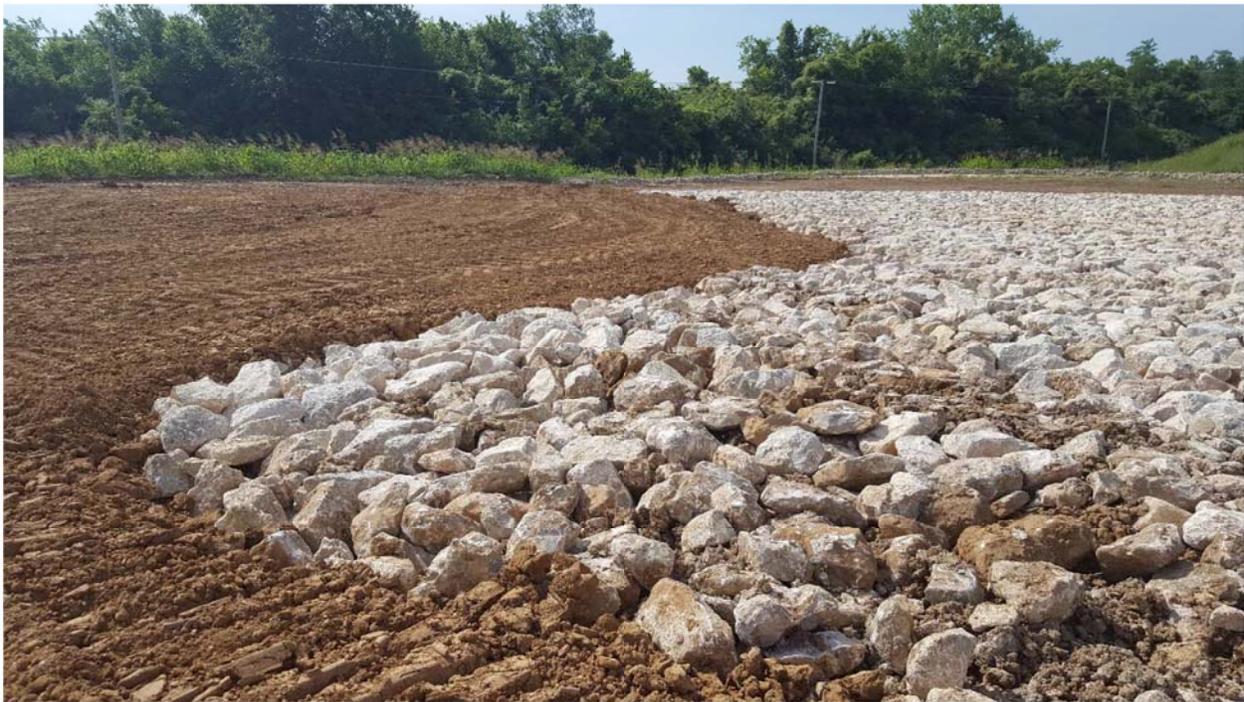
Figure 8: Close-up view of the rip-rap rock placed in the southeast drainage area of the north fly ash pond (facing southeast)

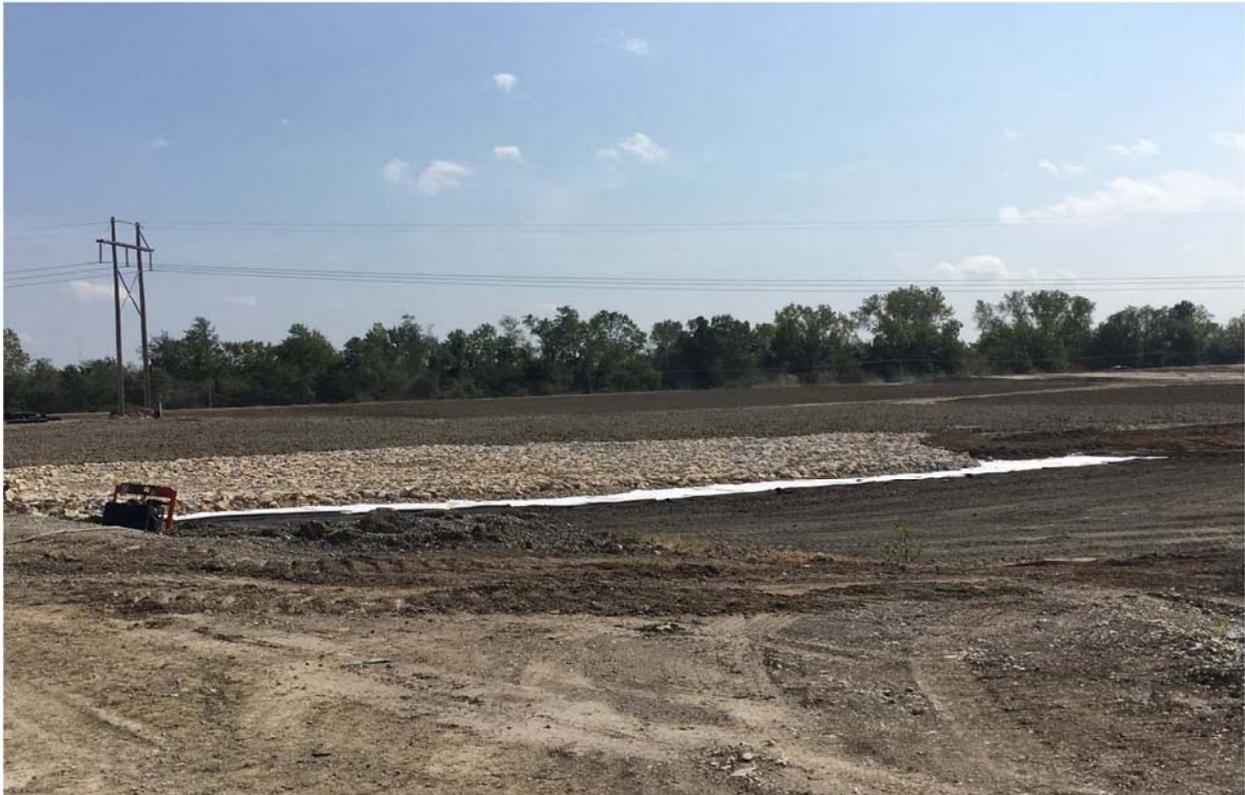
Figure 2: Coal-ash resistant GCL material and rip-rap rock placed on the southeast fly ash pond.

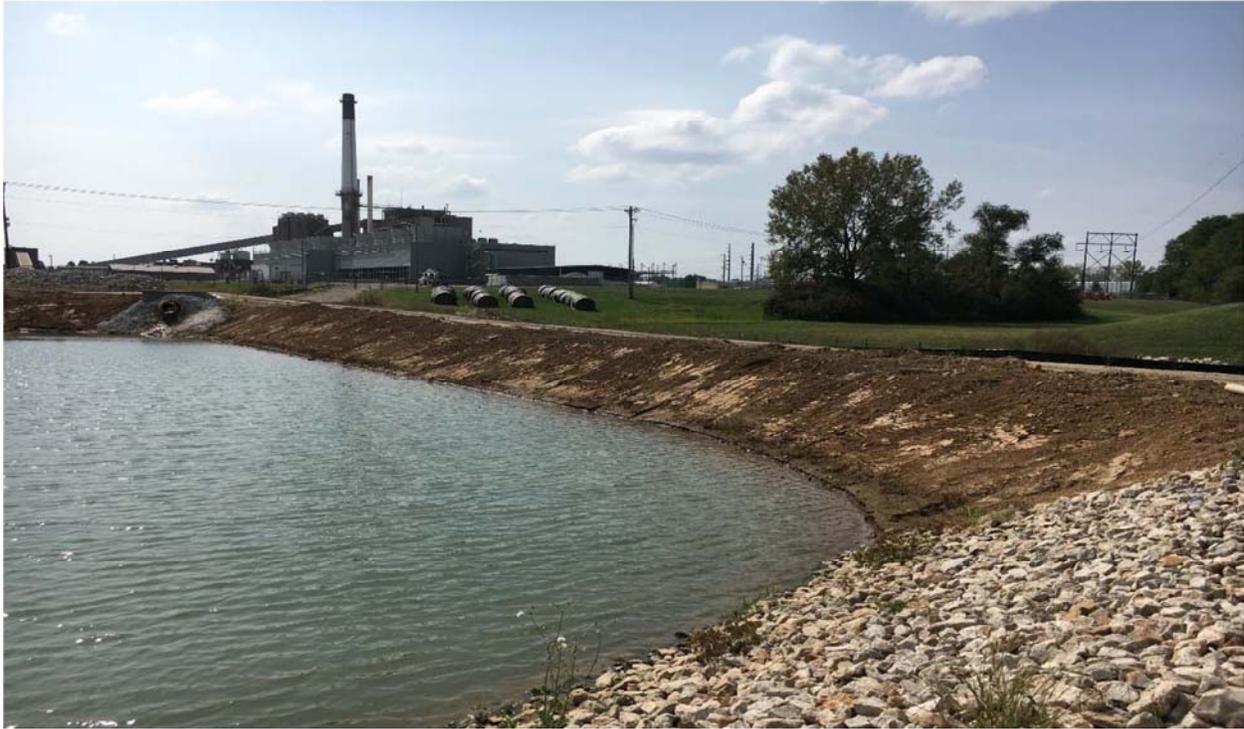
Figure 3: The west slope of the sediment pond was regraded by a dozer after the intercept trench was completed.

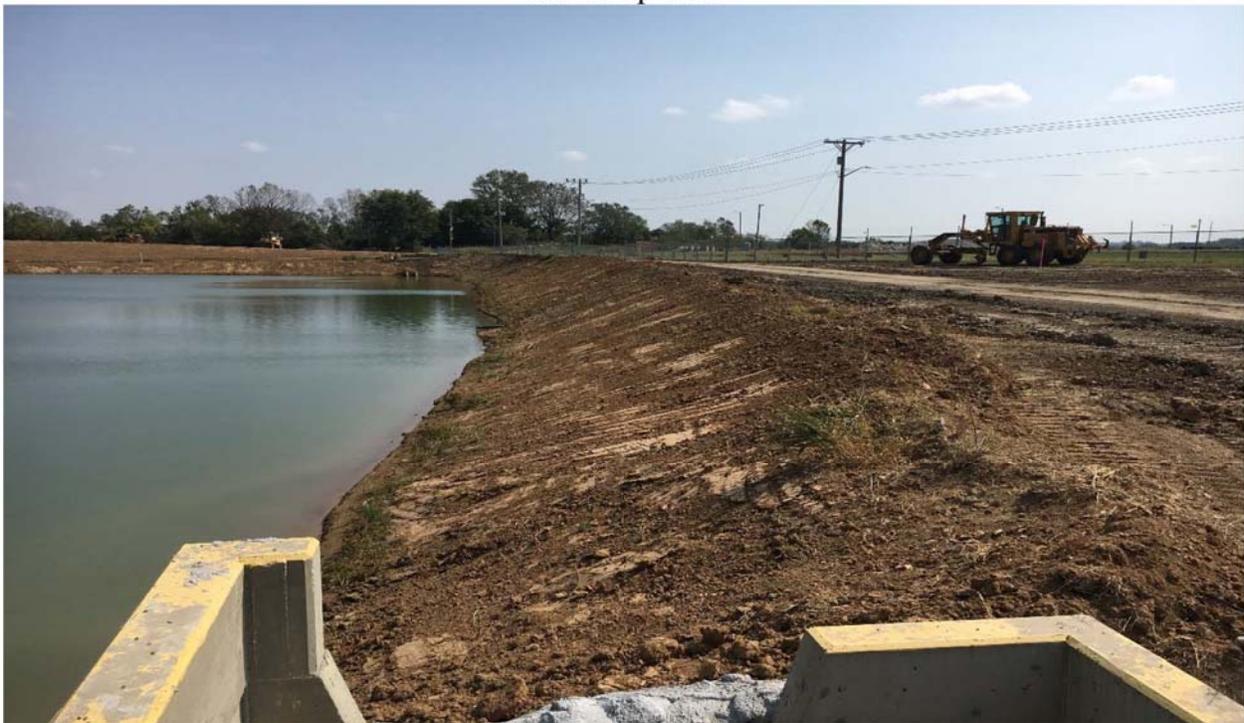
Figure 4: The south slope of the sediment pond was regraded by a dozer after the intercept trench was completed.
