CCR Surface Impoundment Post-Closure Care Plan

Independence Power & Light
Blue Valley Power Station
21500 E. Truman Road
Independence, Missouri 64056

January 2018
File No. 27215142.00

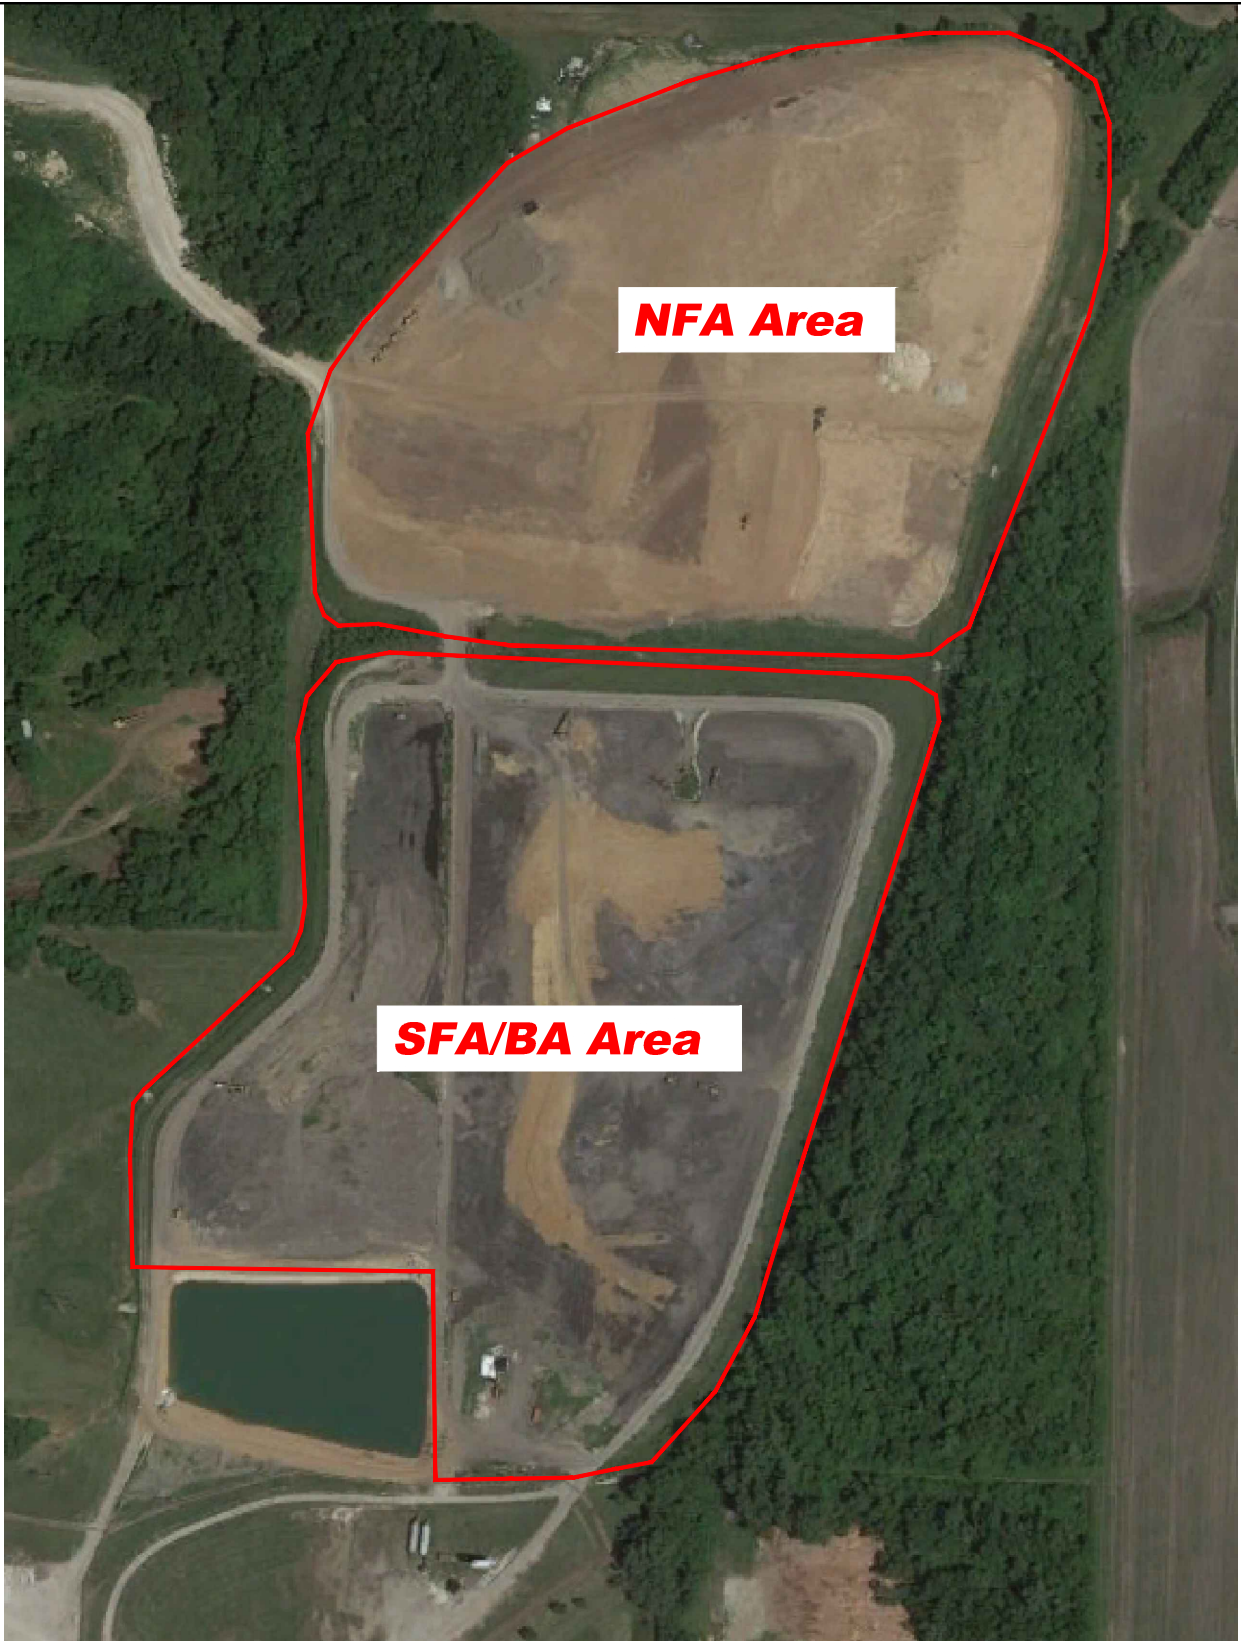
NFA Area

SFA/BA Area

SCS ENGINEERS ENVIRONMENTAL CONSULTANTS AND CONTRACTORS 7311 West 130th Street Overland Park, Kansas 66213			
Figure 2 Site Plan Independence Power & Light – Blue Valley Plant 21500 E. Truman Road, Independence, Missouri			
Project Mgr.	PMG	Date	1/29/18
File Name	Gridley SSA WP.dwg		Proj No.
Scale:		File Name	Gridley SSA WP.dwg
			27215142.00

The site location is shown on **Figure 1**, and **Figure 2** shows the current conditions at the facility and monitoring locations.
