## **Ash Impoundment Closure Report**

Independence Power & Light  
Blue Valley Power Station  
21500 East Truman Road  
Independence, Missouri 64056

**SCS ENGINEERS**  
7311 West 130th Street, Suite 100  
Overland Park, Kansas 66213  
(913) 681-0030

April 2018  
Revised June 2018  
File No. 27215142.00

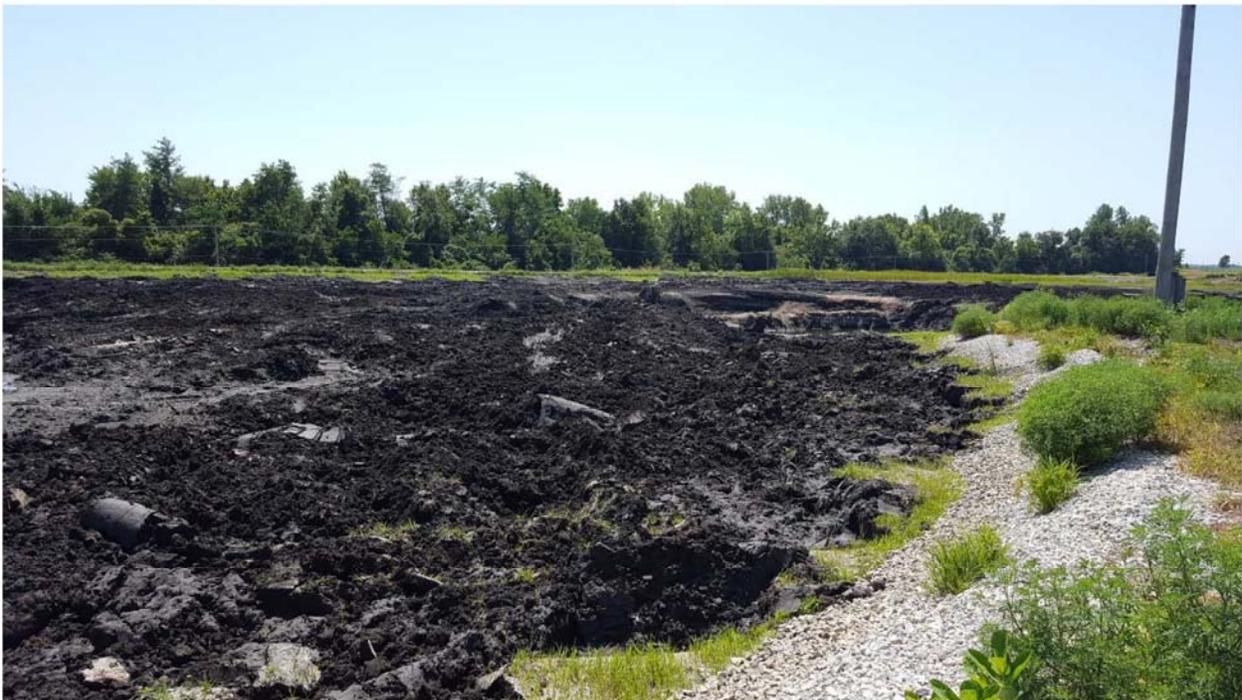
Figure 2: Wet ash stockpiled to dry in the southeast pond (facing southeast)

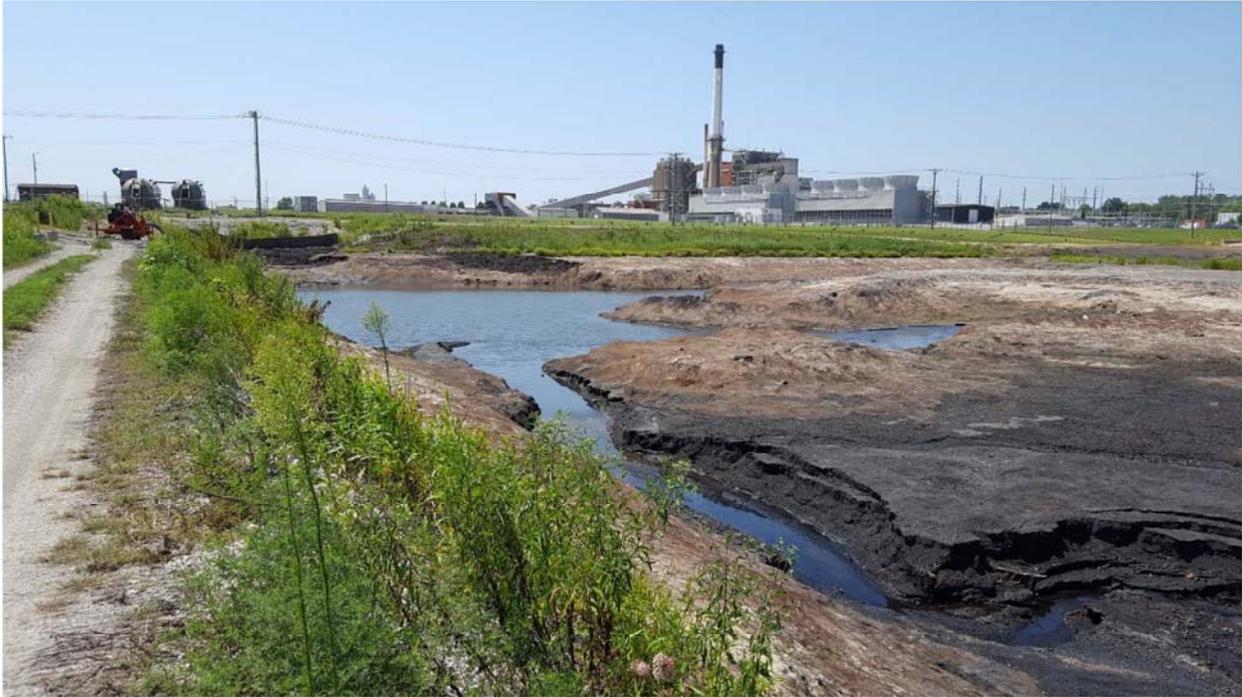
Figure 5: Southwest pond standing water (facing southwest)

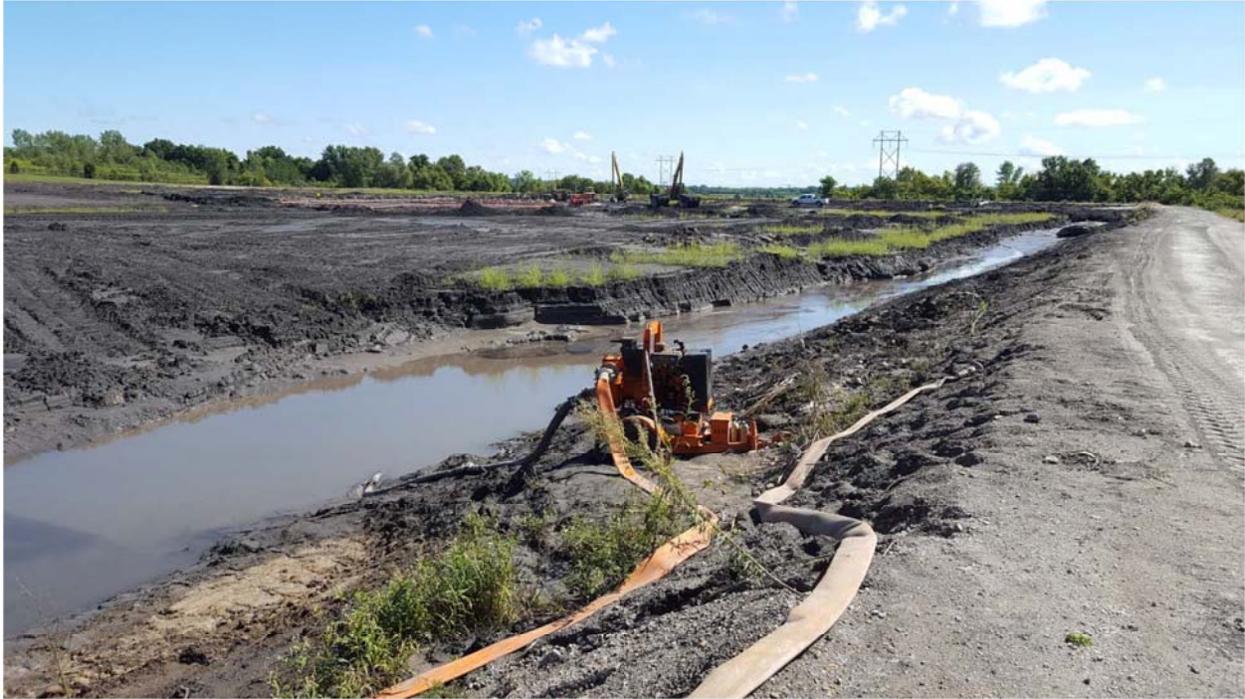
Figure 1: Pumping water from the north pond to the southwest fly ash pond (facing east)

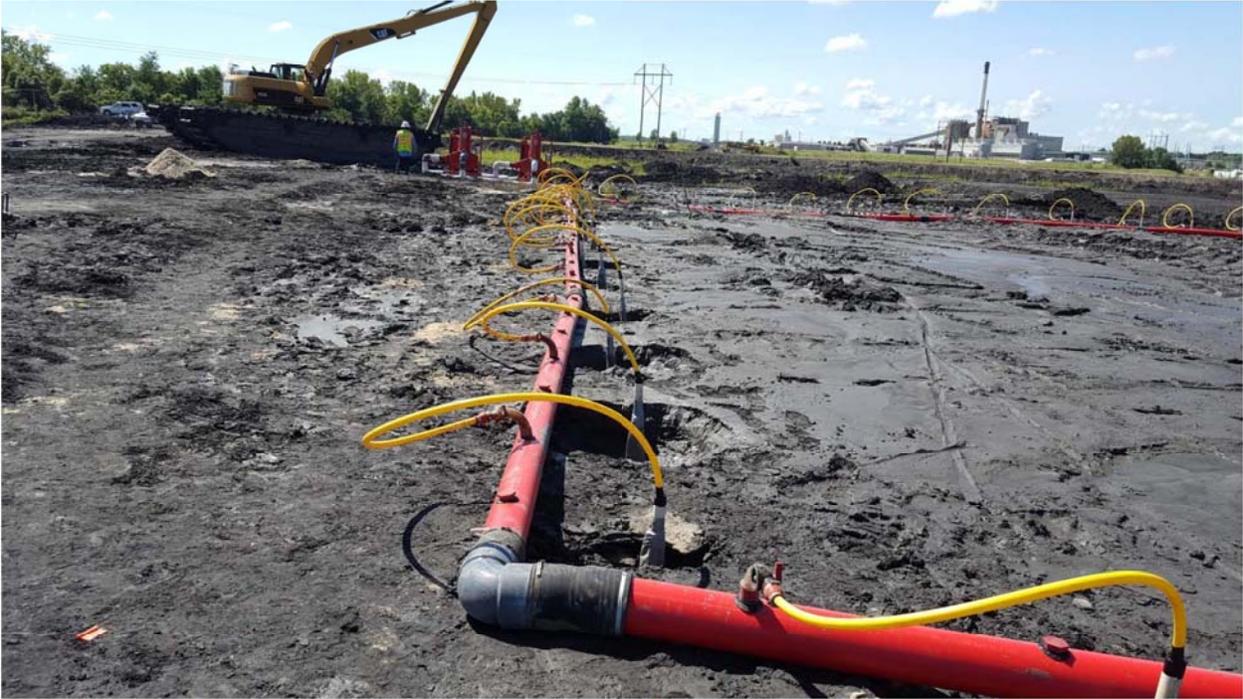
Figure 3: Griffin well pumping system in north pond with about 15 wells on each side (facing south)

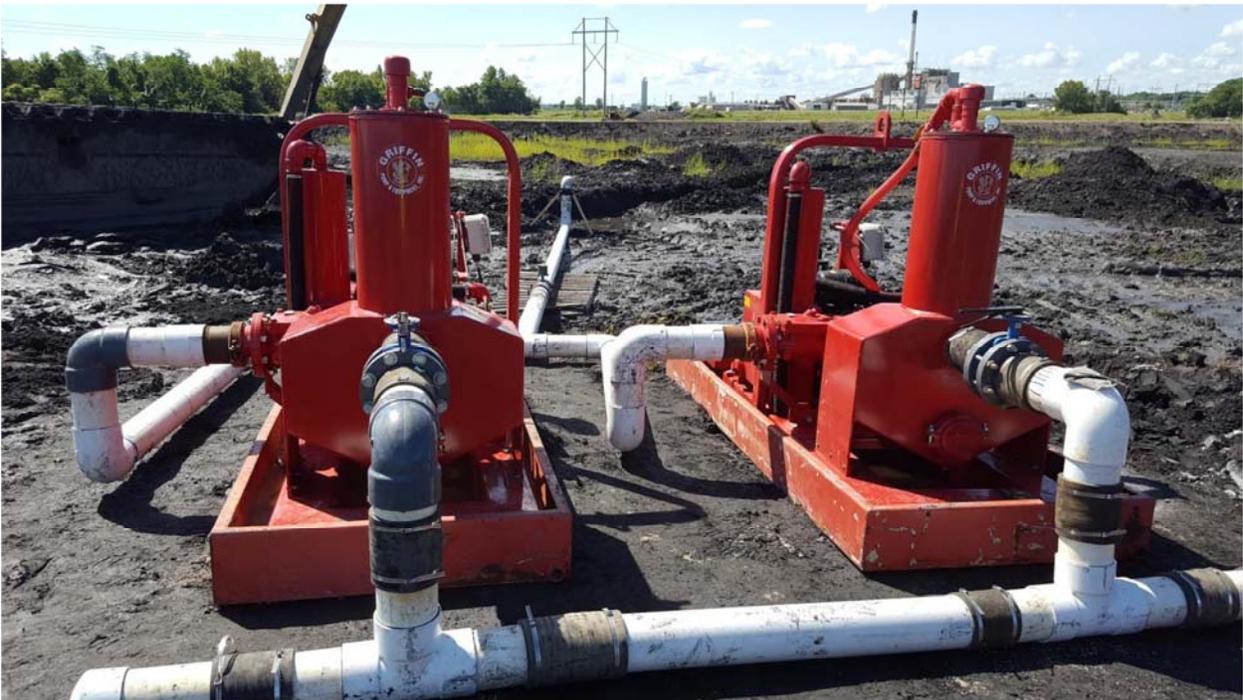
Figure 4: Main vacuum engines located east of the well pumping system; pulling about 16 psi to extract water from the fly ash (facing south)

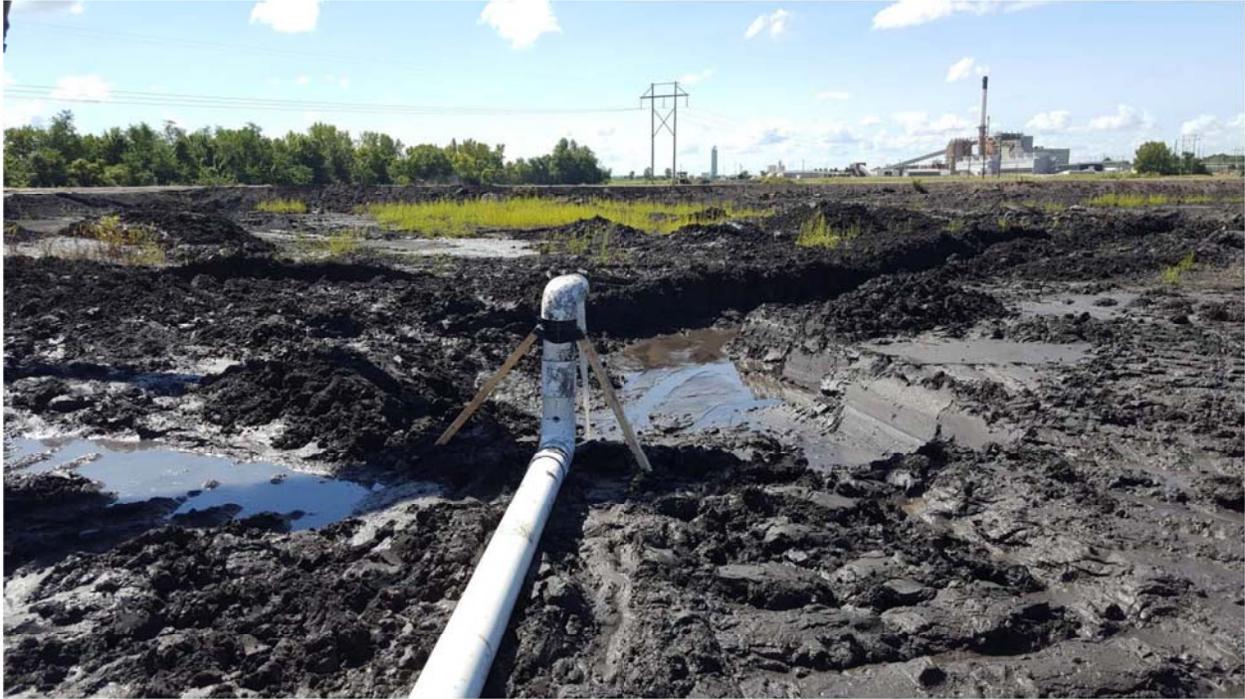
Figure 5: Water discharging from the well point extraction system towards the south berm of the north pond (facing south)

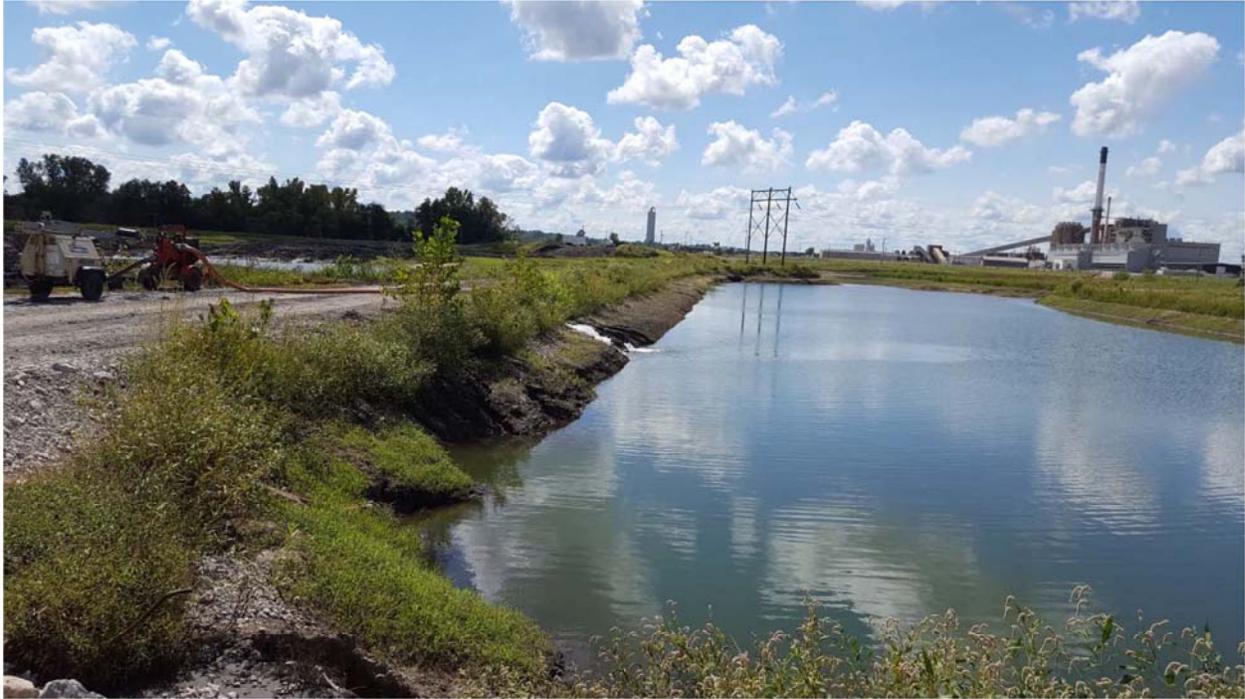
Figure 7: Pumping water from the southeast to southwest pond towards the Little Blue Valley Sewer District Outfall (facing south)

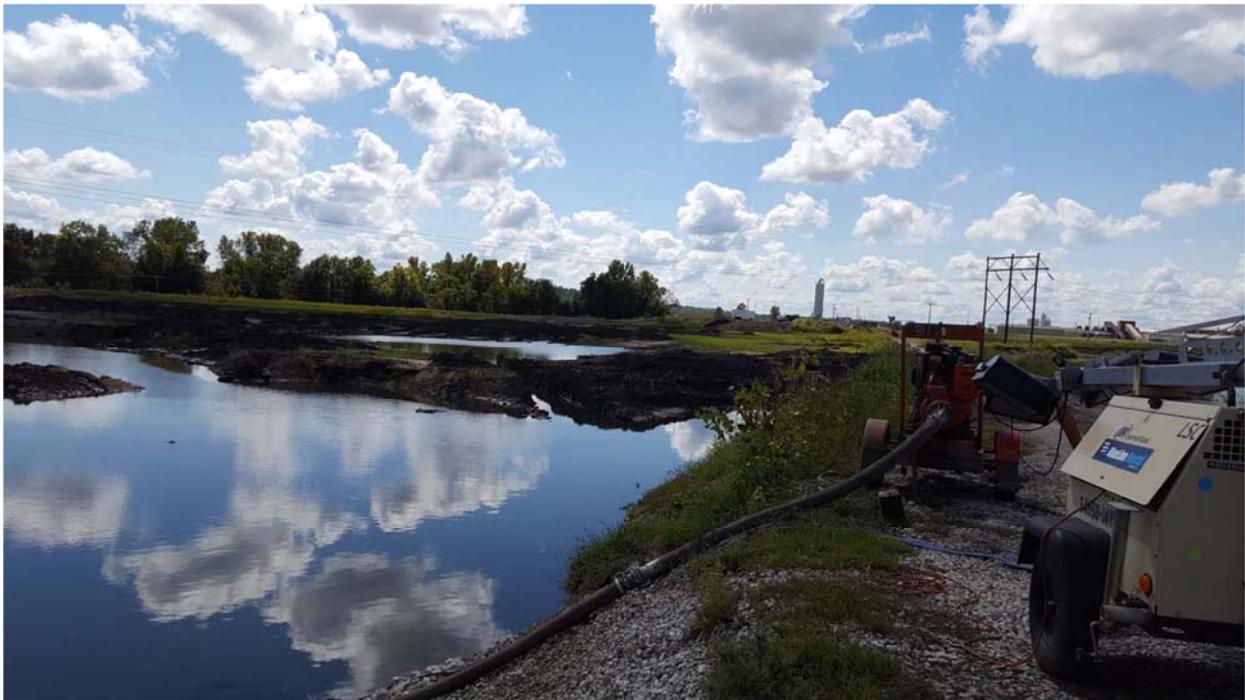
Figure 8: Standing water being removed from the southeast ash pond (facing southeast)

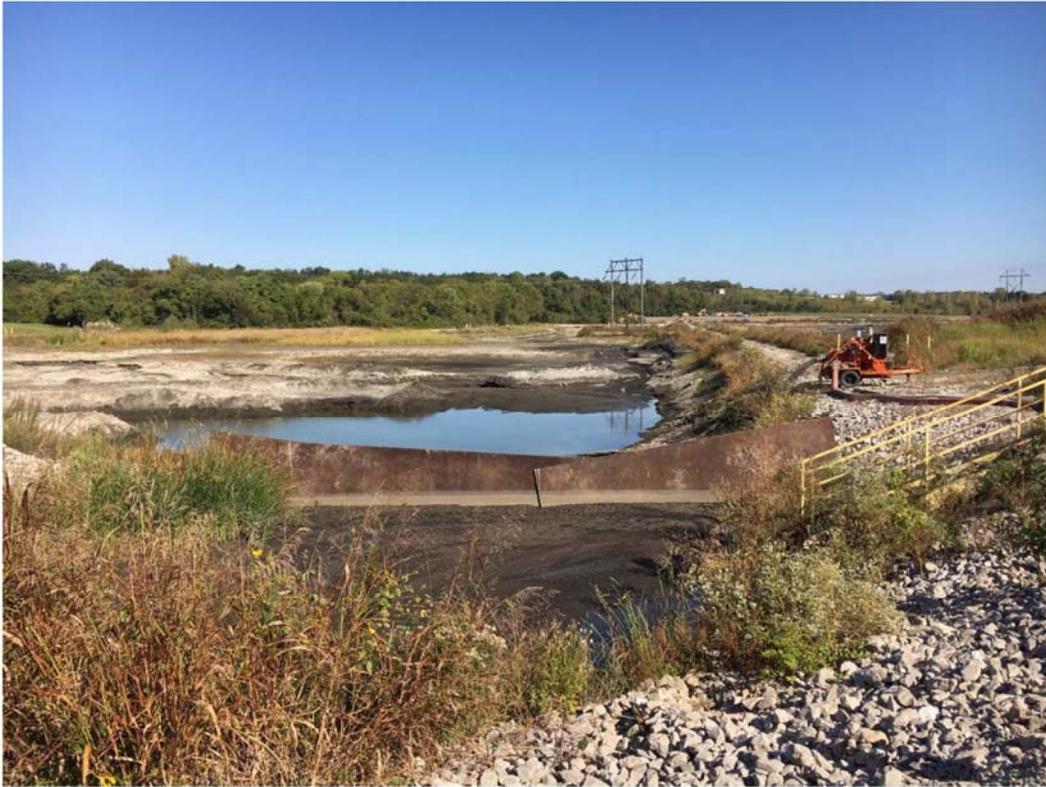
Figure 1: Overlooking the southwest pond; sediment buildup near discharge to the LBVSD at Outfall #002; (facing north)

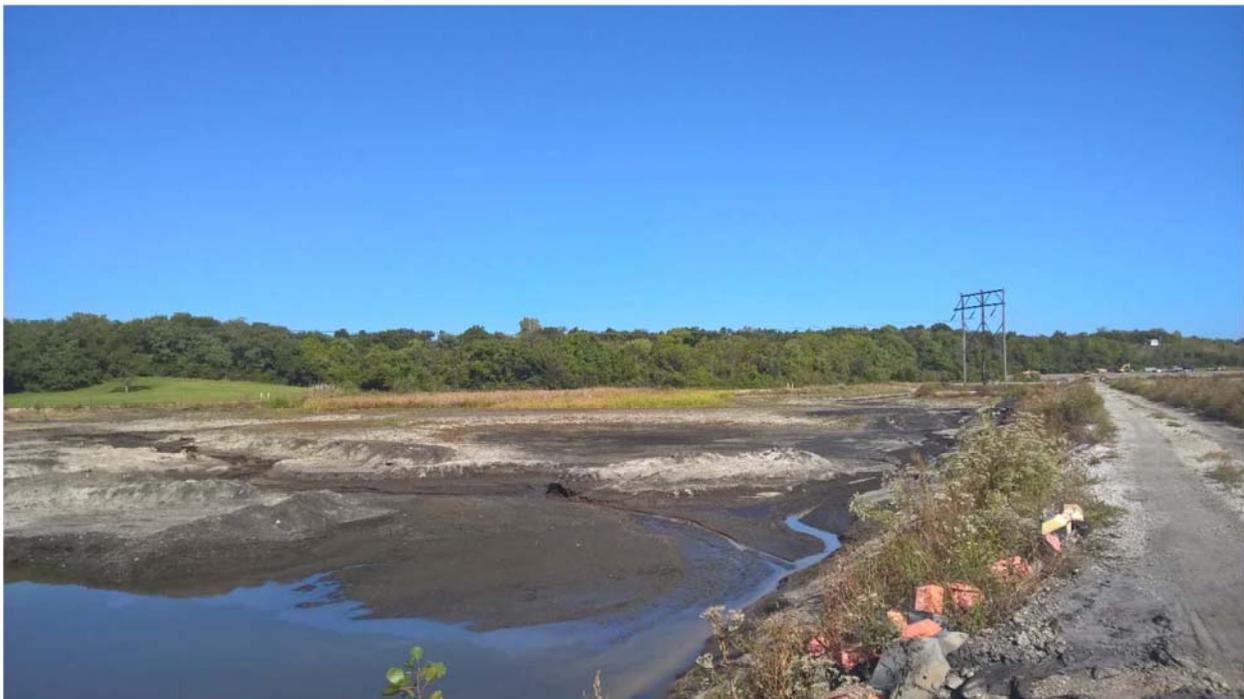
Figure 2: Standing water in southeastern edge of the southwest pond (facing north/northwest)

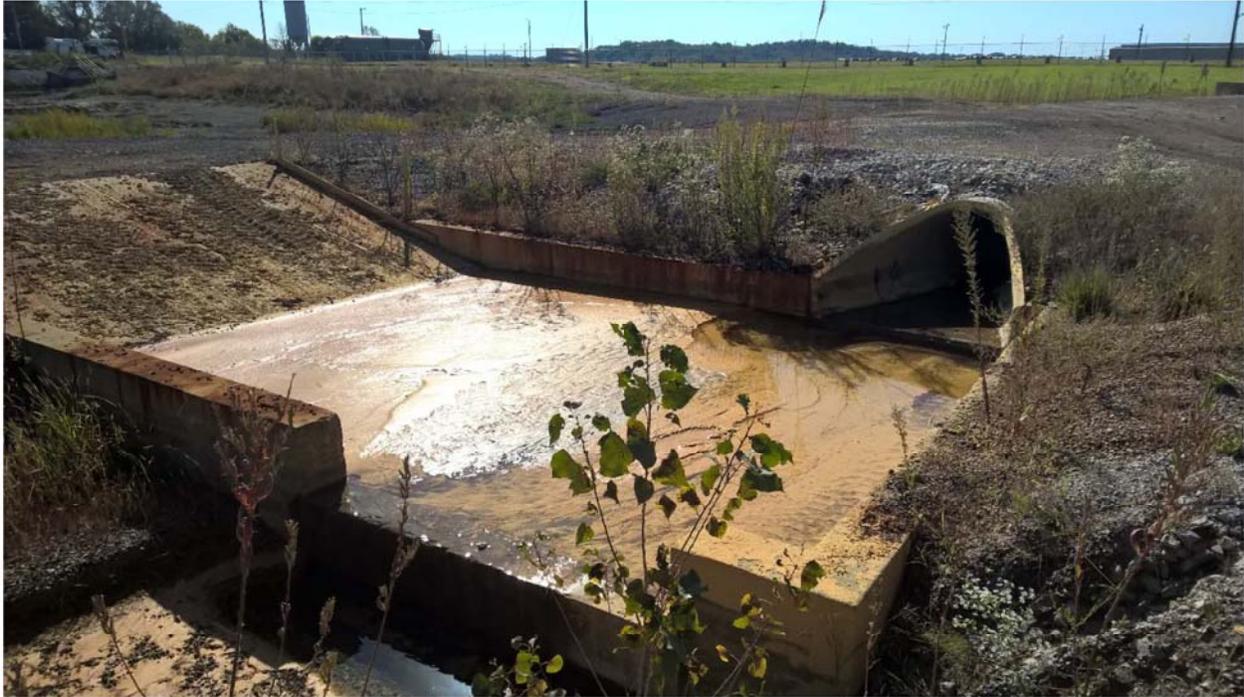
Figure 3: Discharge pipe from the plan/coal yard with water exiting into southwest corner of southwest pond (facing south)

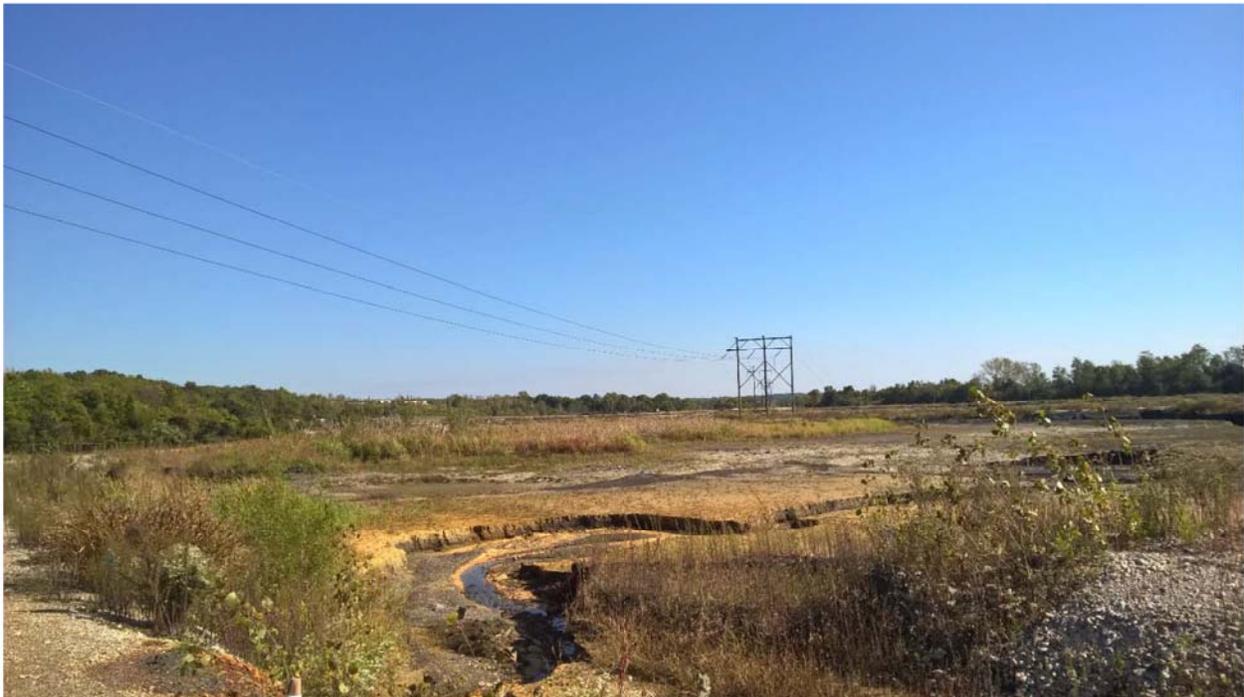
Figure 4: Minimal water in trench of southwestern area of the southwest pond (facing northeast)

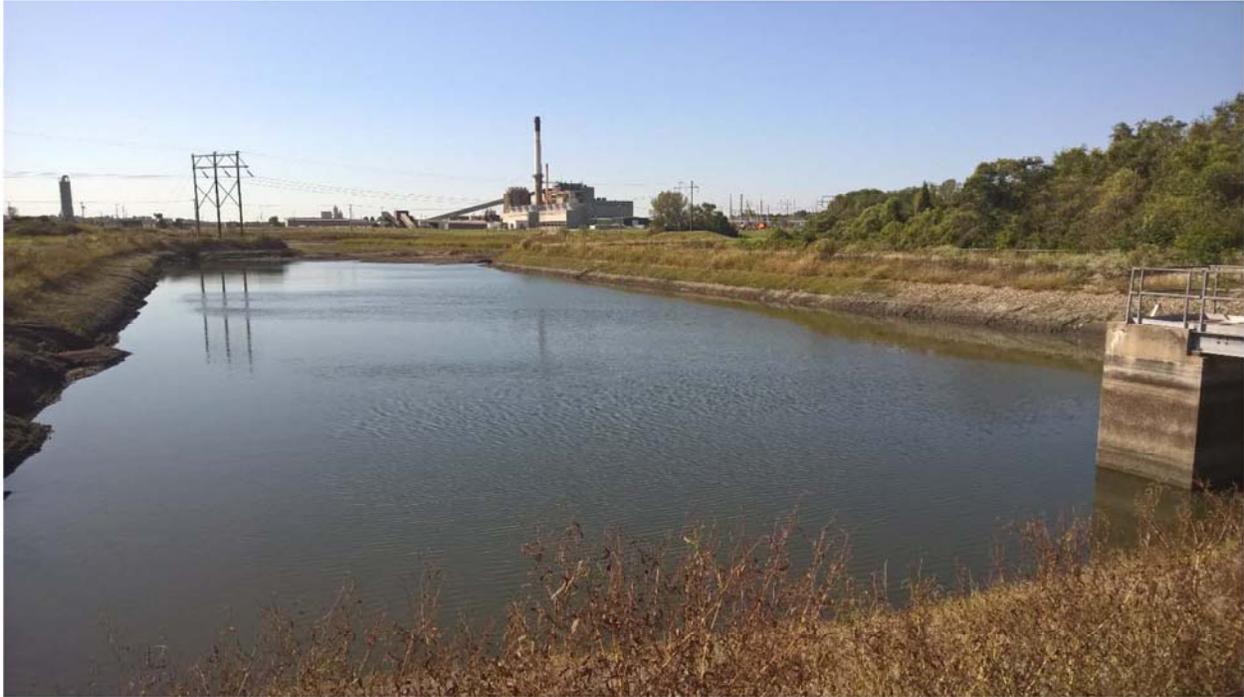
Figure 5: Overlooking northern half of the southwestern pond; standing water present (facing south)

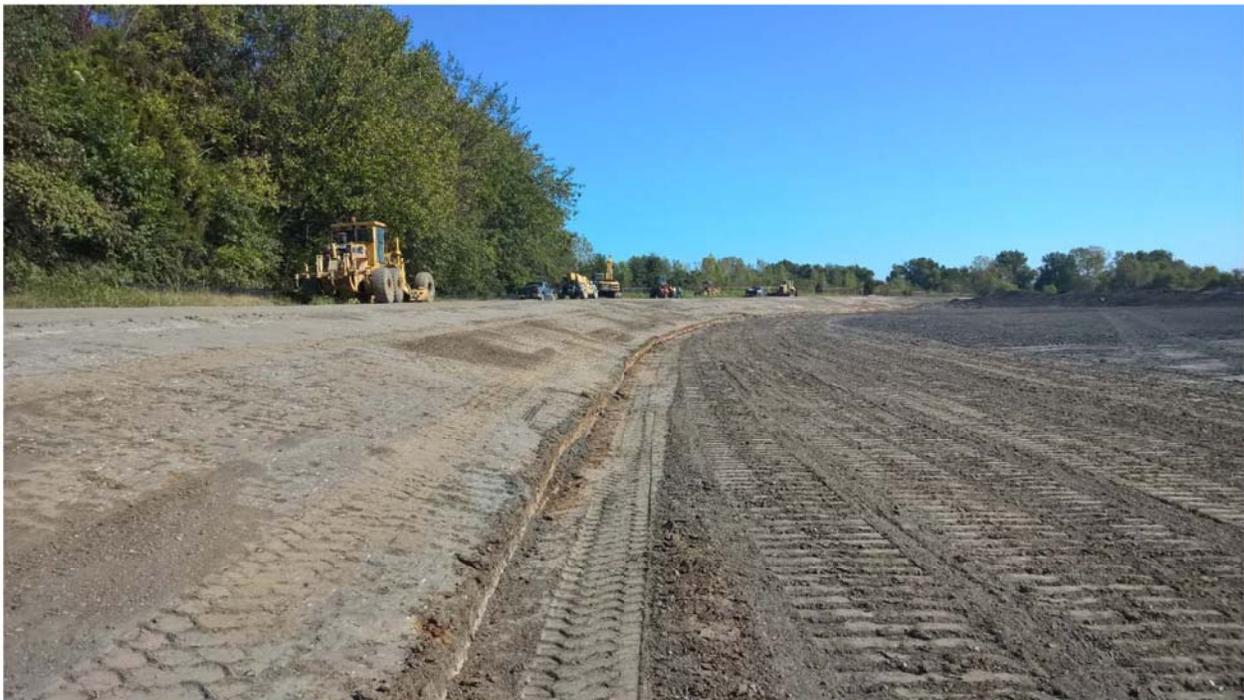
Figure 8: Western edge of the north ash pond, ash and embankment; subgrade preparation for GCL placement (facing north)

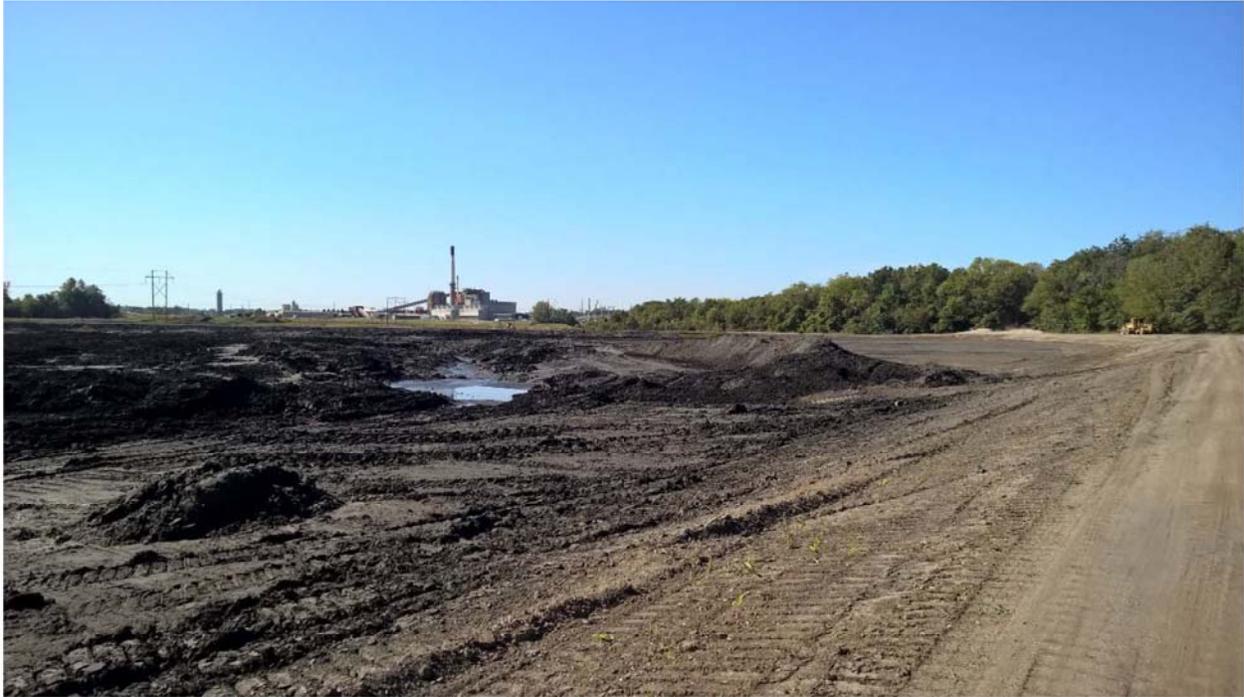
Figure 9: Northern central portion of the north ash pond; some standing water visible (facing southwest)

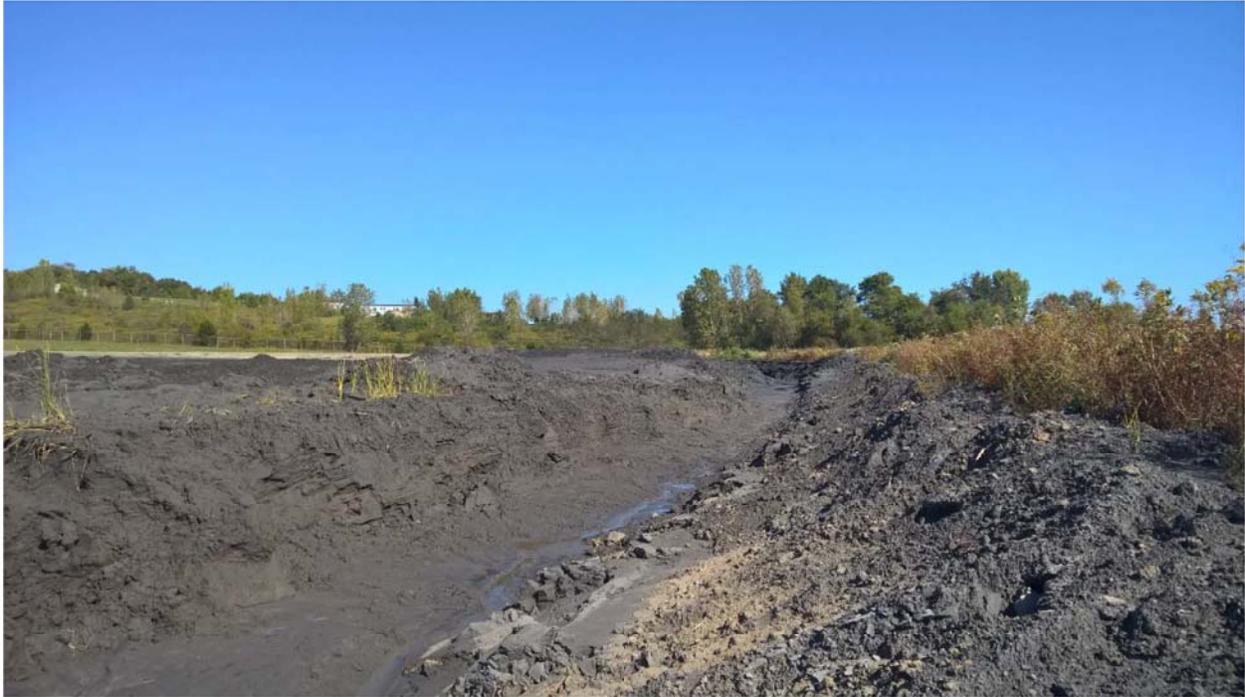
Figure 11: Eastern edge of the north ash pond, bottom of trench appears soupy and some standing water (facing north)

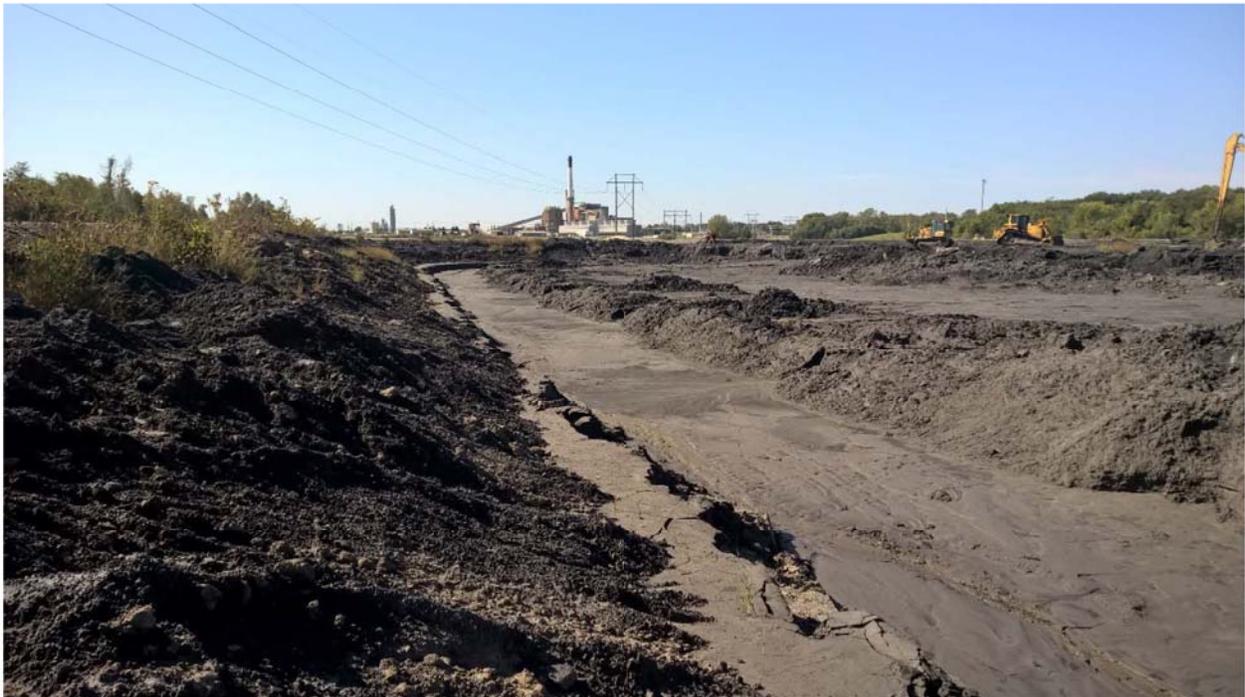
Figure 12: Eastern edge of the north ash pond, bottom of trench appears soupy (facing south)

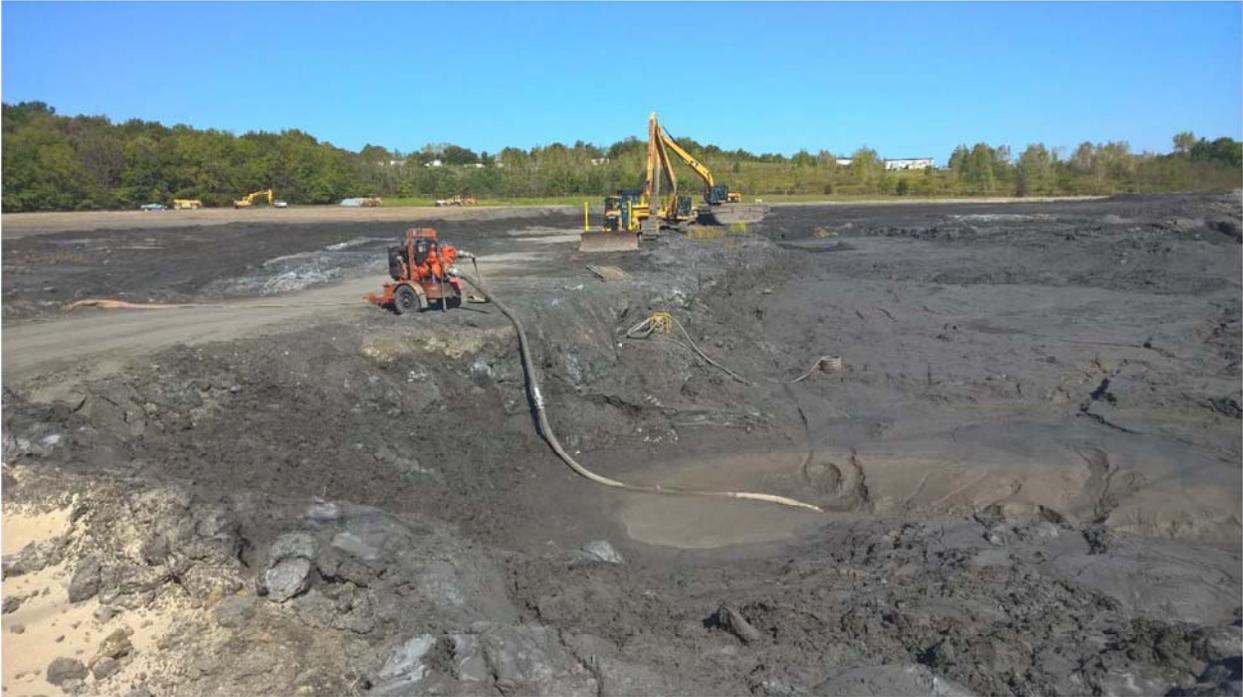
Figure 13: Southeastern low point of the north ash pond; sump and pump system to remove water in low area (facing north)

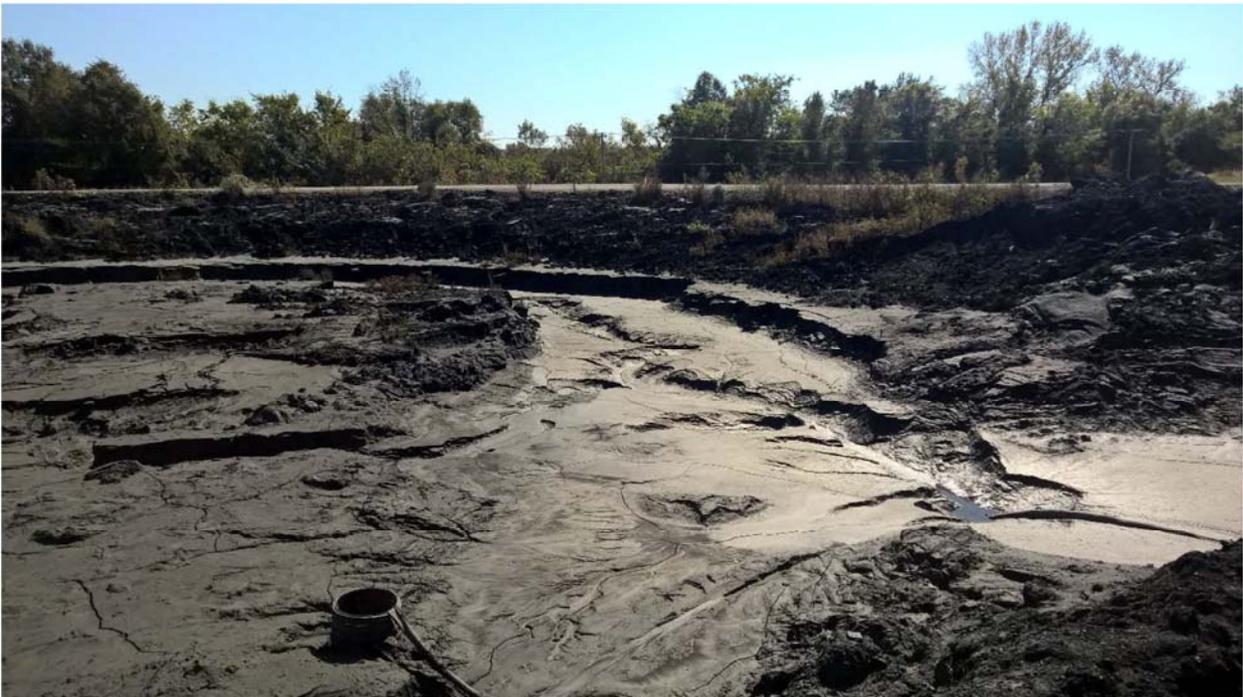
Figure 14: Southeastern low point of the north ash pond; sump and pump system to remove water in low area (facing east)

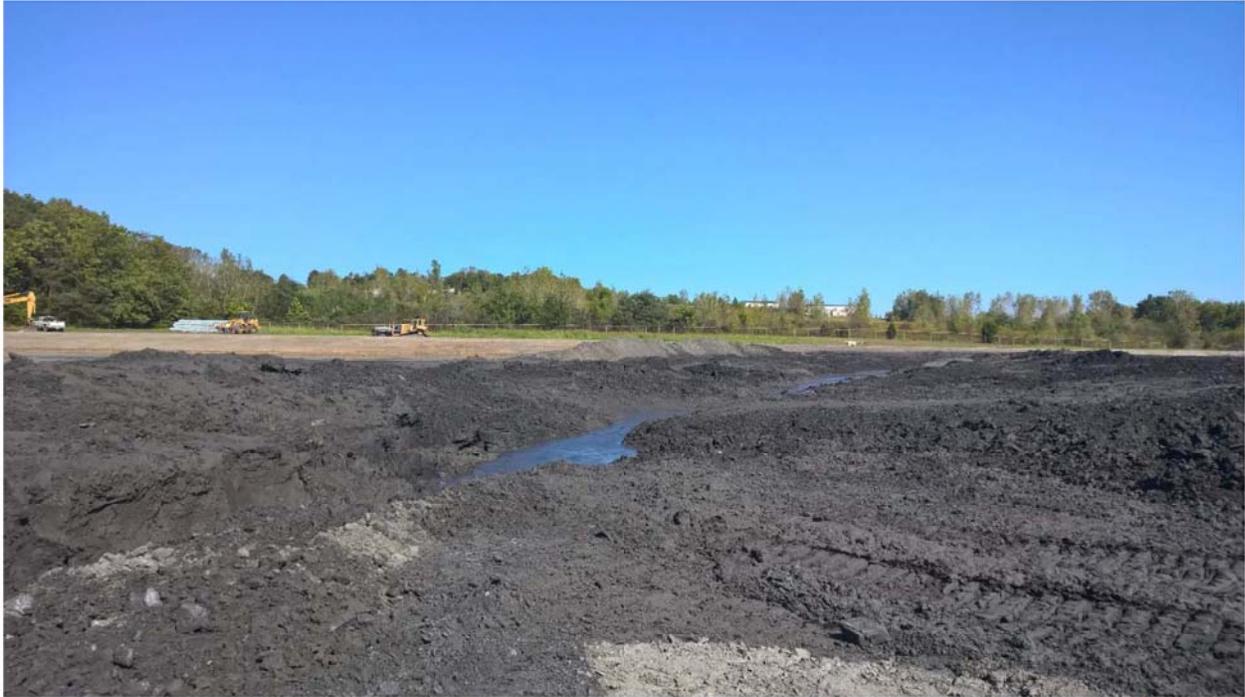
Figure 15: Trench with standing water near center of north ash pond (facing north)

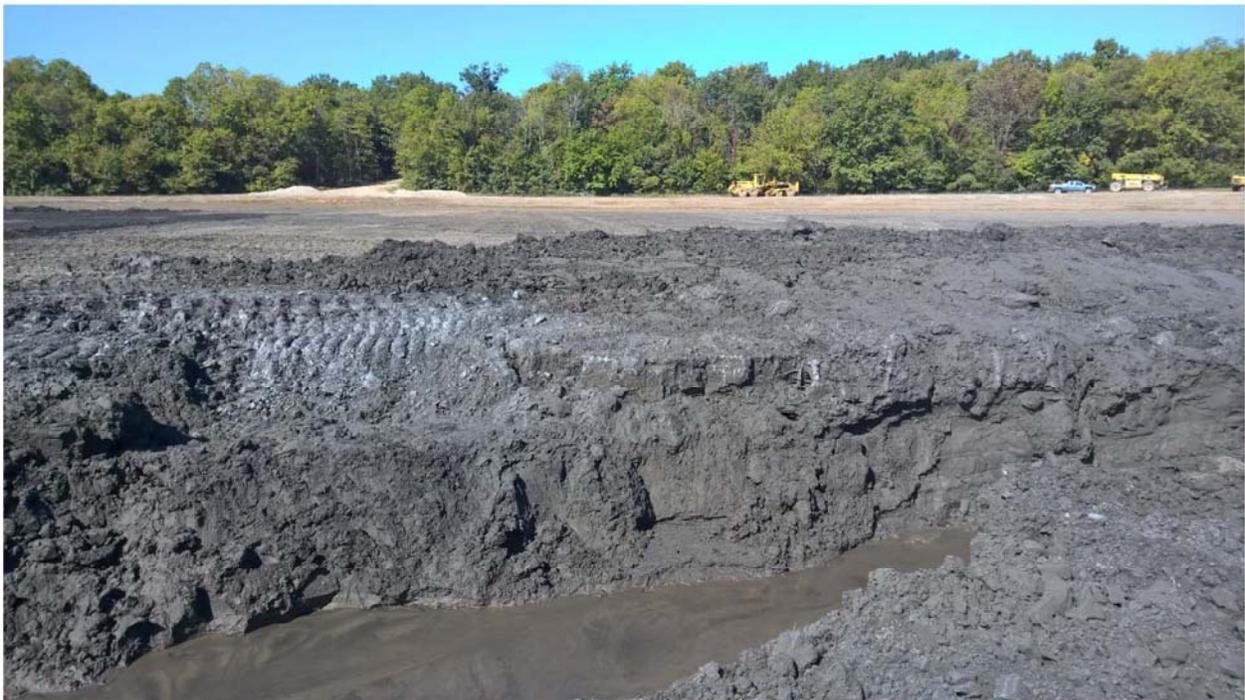
Figure 16: Trench with standing water near center of north ash pond (facing west)

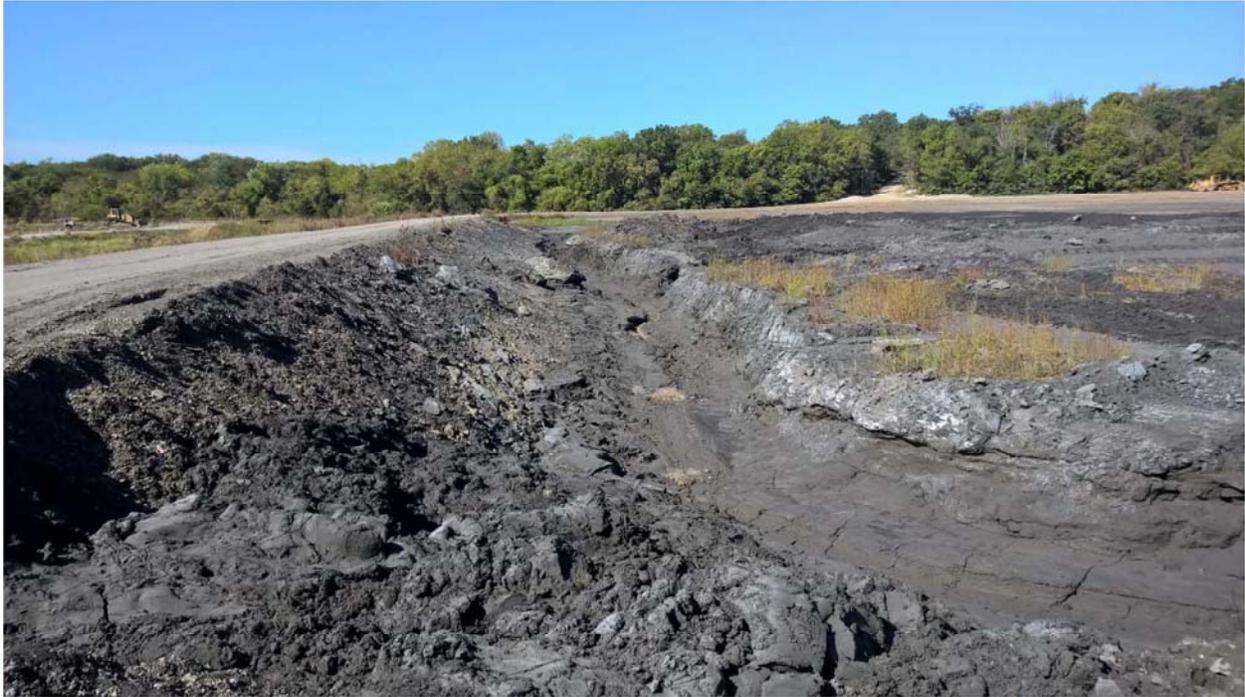
Figure 17: South central low point and trench of the north ash pond; sump and pump system to remove water in low area (facing north)

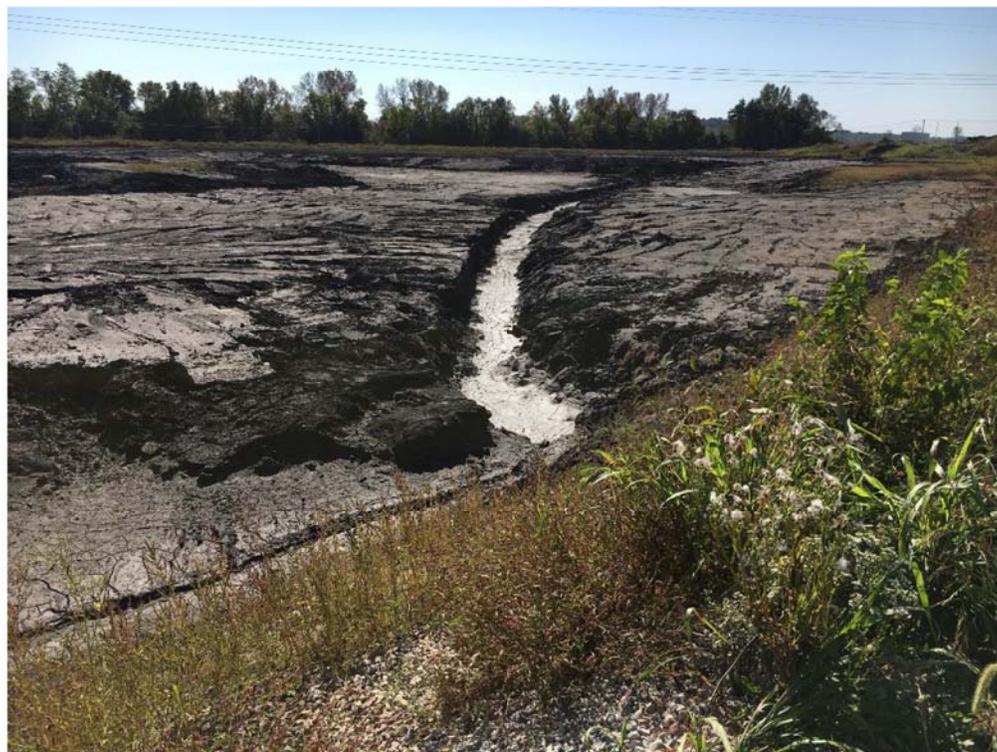
Figure 20: Trench located towards the northern end of western berm in southeast ash pond (facing southeast)

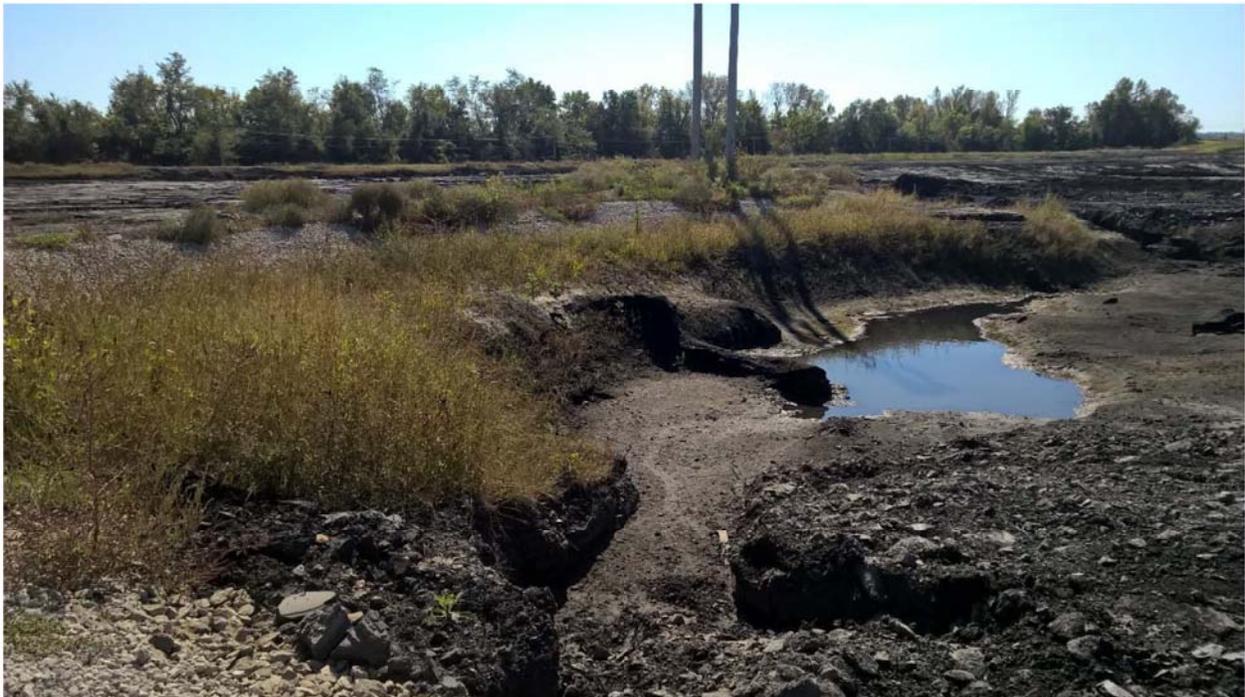
Figure 22: Standing water in northern central area of the southeast ash pond (facing southeast)

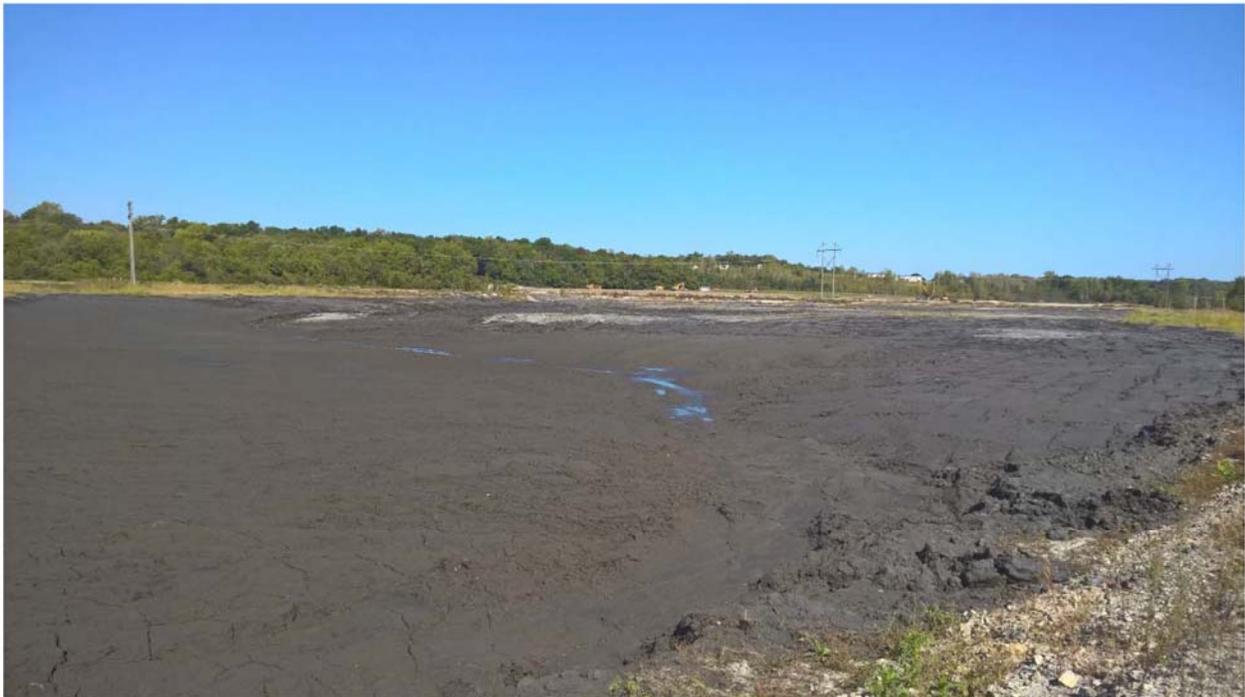
Figure 24: Southeast area of the southeast ash pond; area has standing water and appears wet and soupy (facing northwest)

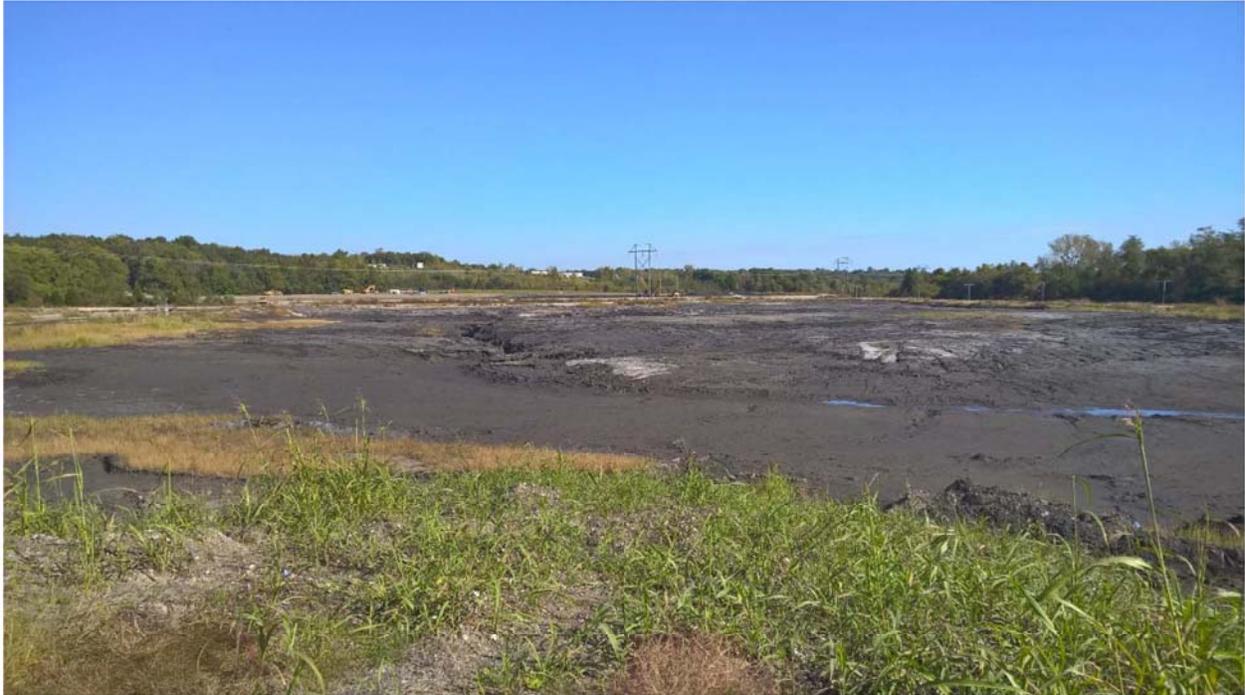
Figure 25: Overlooking the southeast ash pond; standing water in trench cutting through ash (facing north)
