## **Ash Impoundment Closure Report**

Independence Power & Light  
Blue Valley Power Station  
21500 East Truman Road  
Independence, Missouri 64056

**SCS ENGINEERS**  
7311 West 130th Street, Suite 100  
Overland Park, Kansas 66213  
(913) 681-0030

April 2018  
Revised June 2018  
File No. 27215142.00

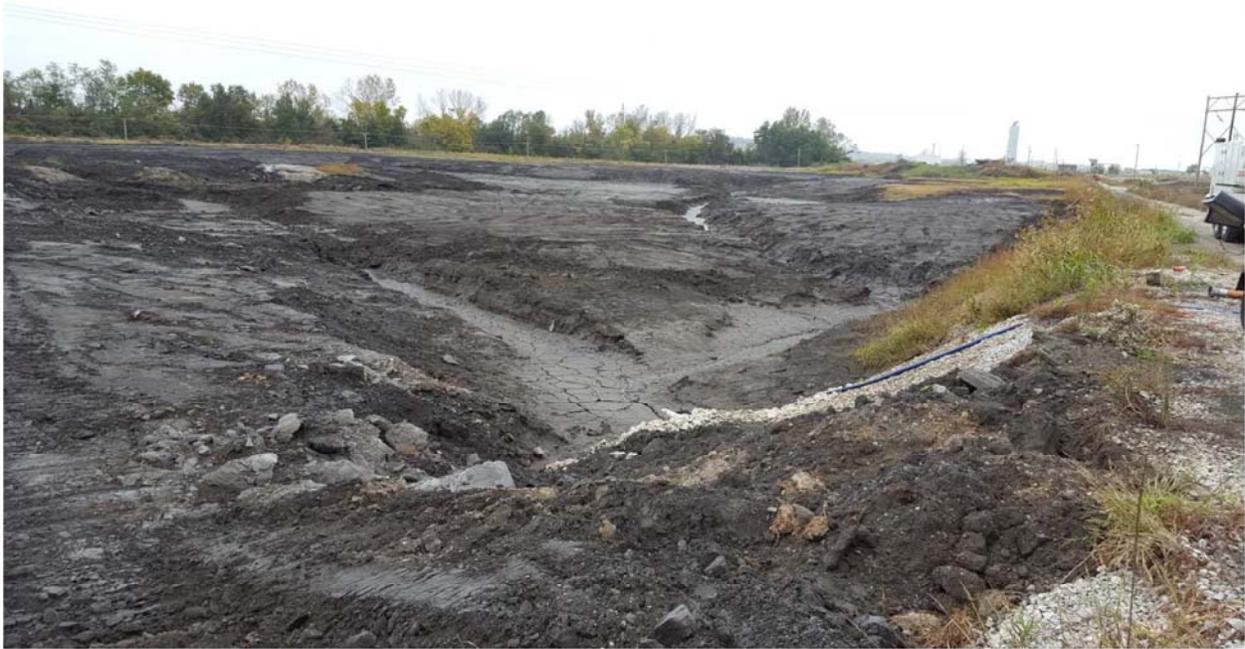
Figure 1: Low surface water in the southeast fly ash pond (facing south)

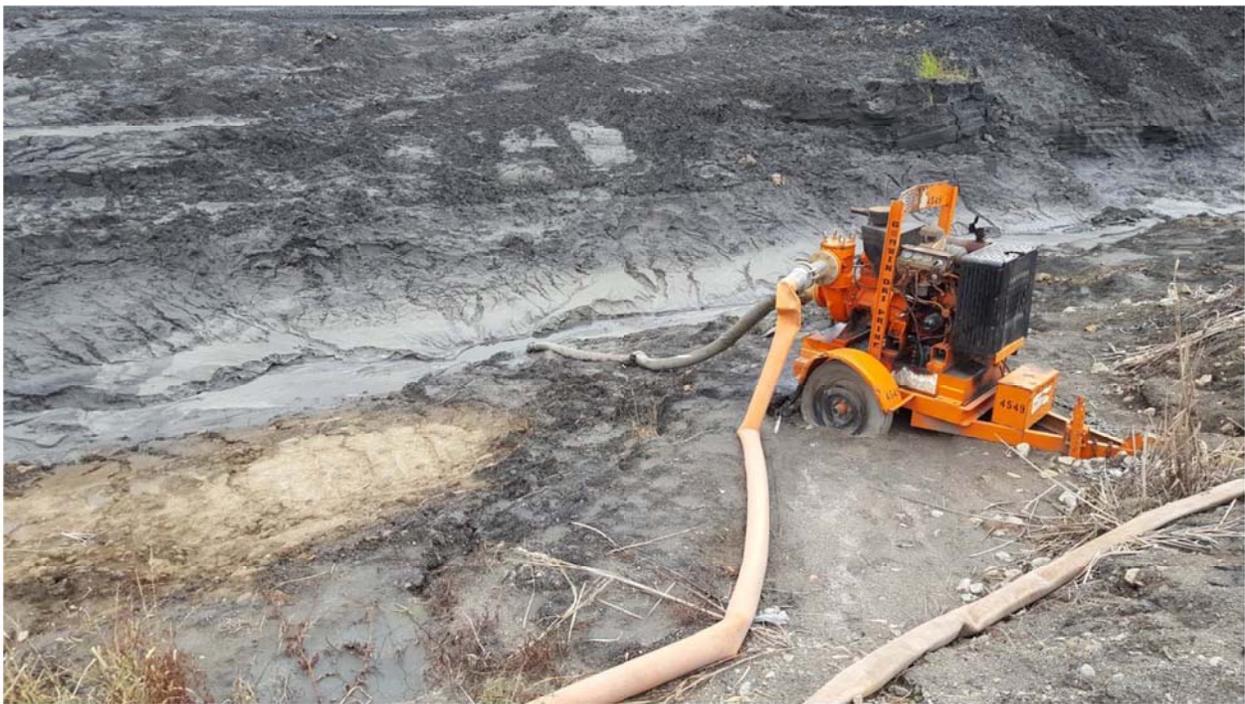
Figure 2: Pumping water from the north pond to the southwest pond (facing north)

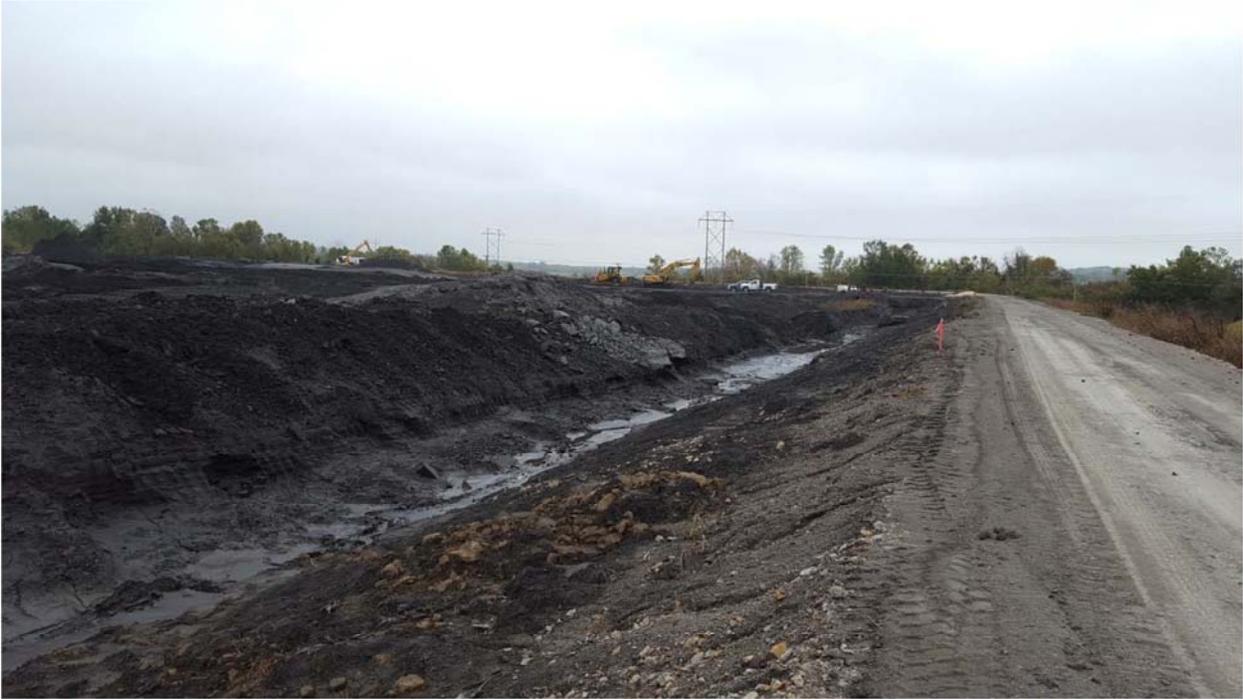
Figure 3: Water flowing in trench of north pond from northeast to southwest (facing east)

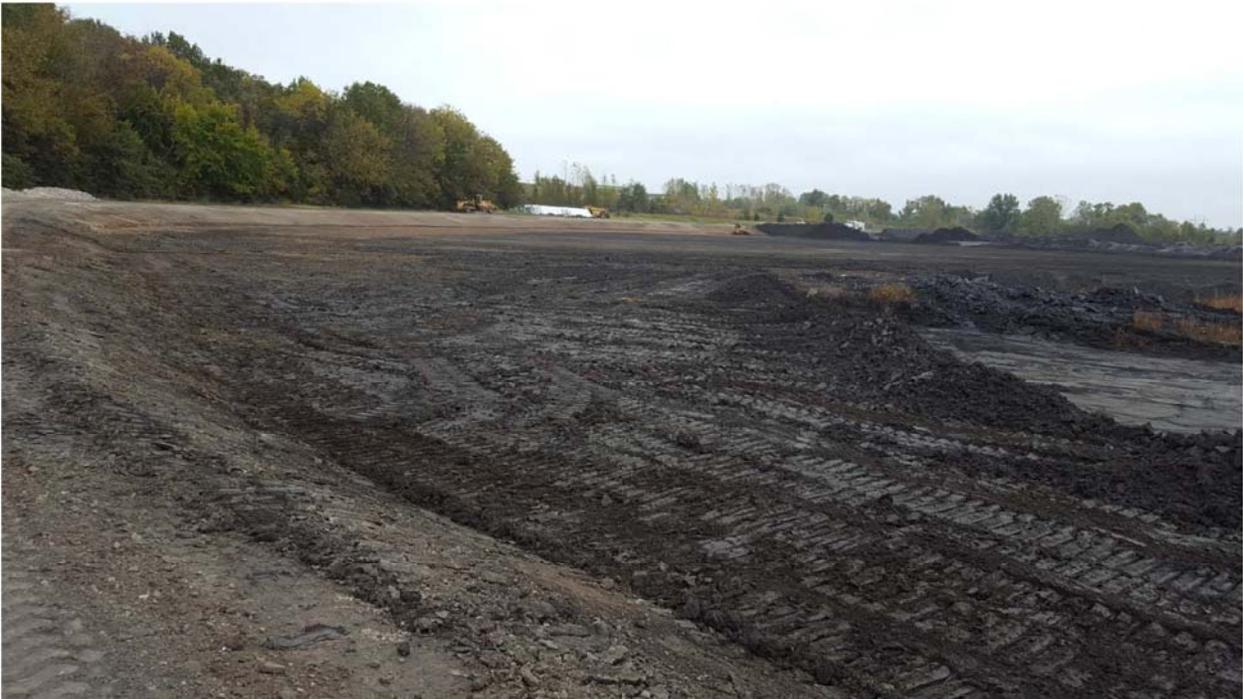
Figure 4: Area of the north pond graded and ready for GCL placement (facing north)

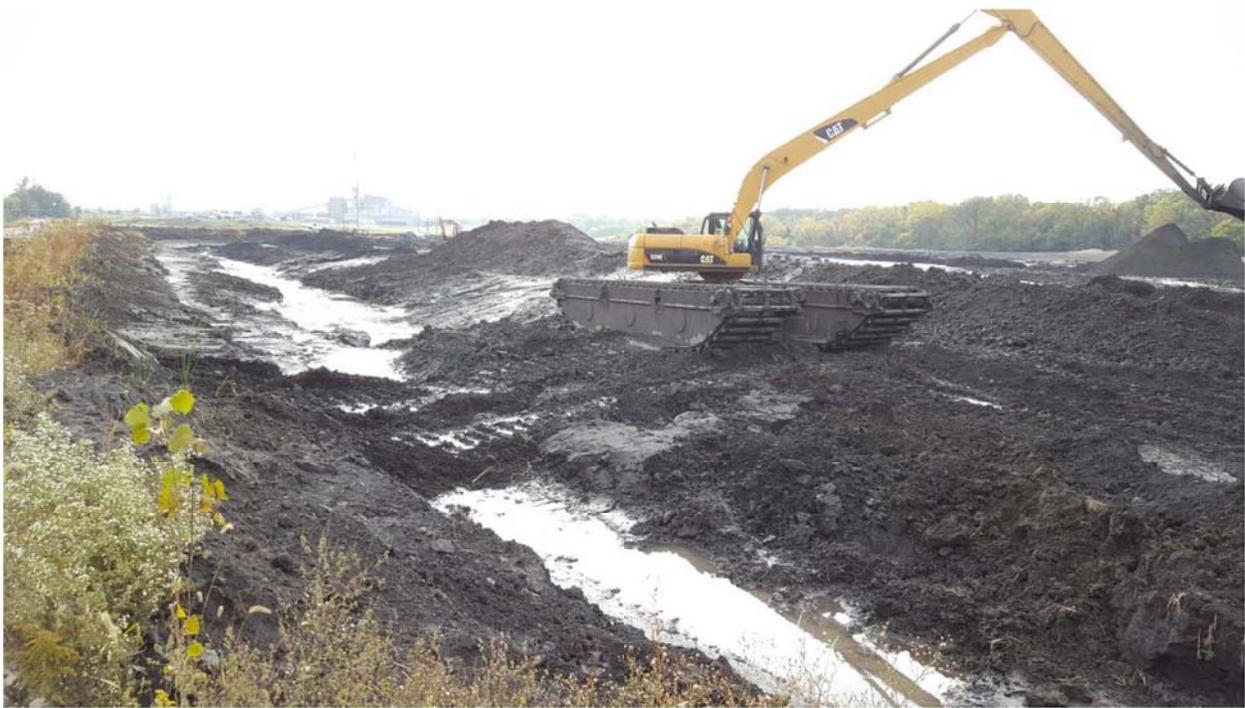
Figure 5: Excavating the trenches in the northeast side of the north pond (facing south)

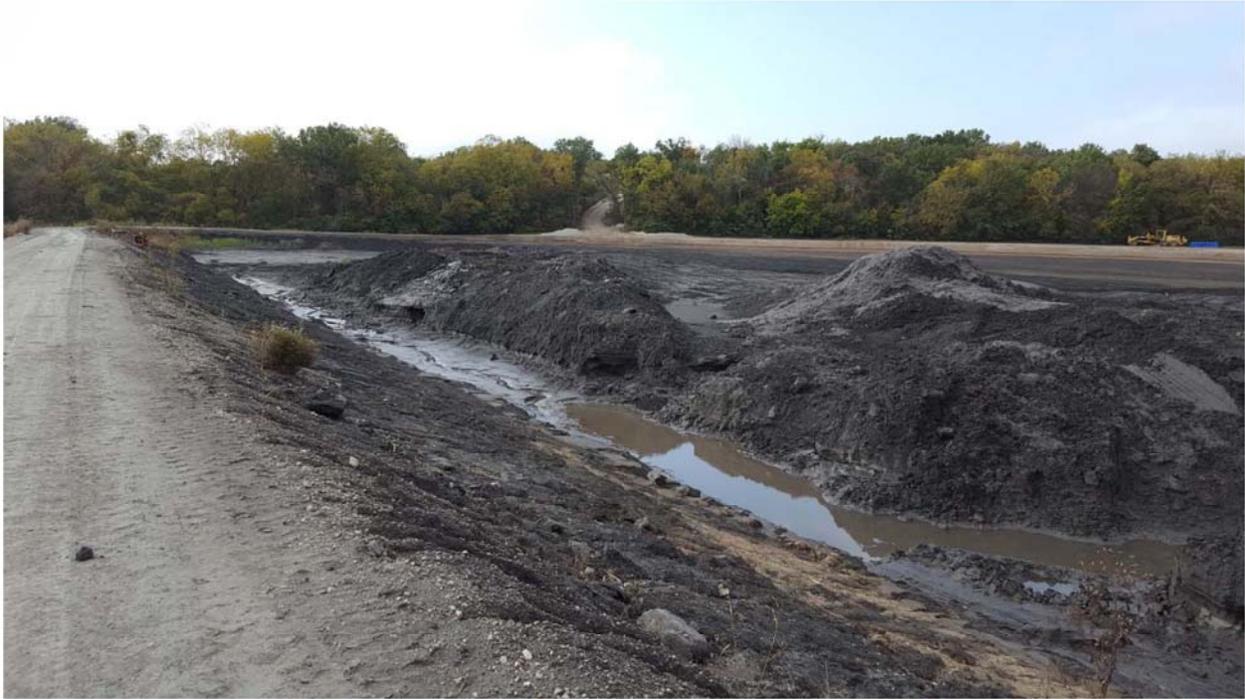
Figure 7: Water flowing from the northeast to be pumped out towards the southwest pond (facing west)

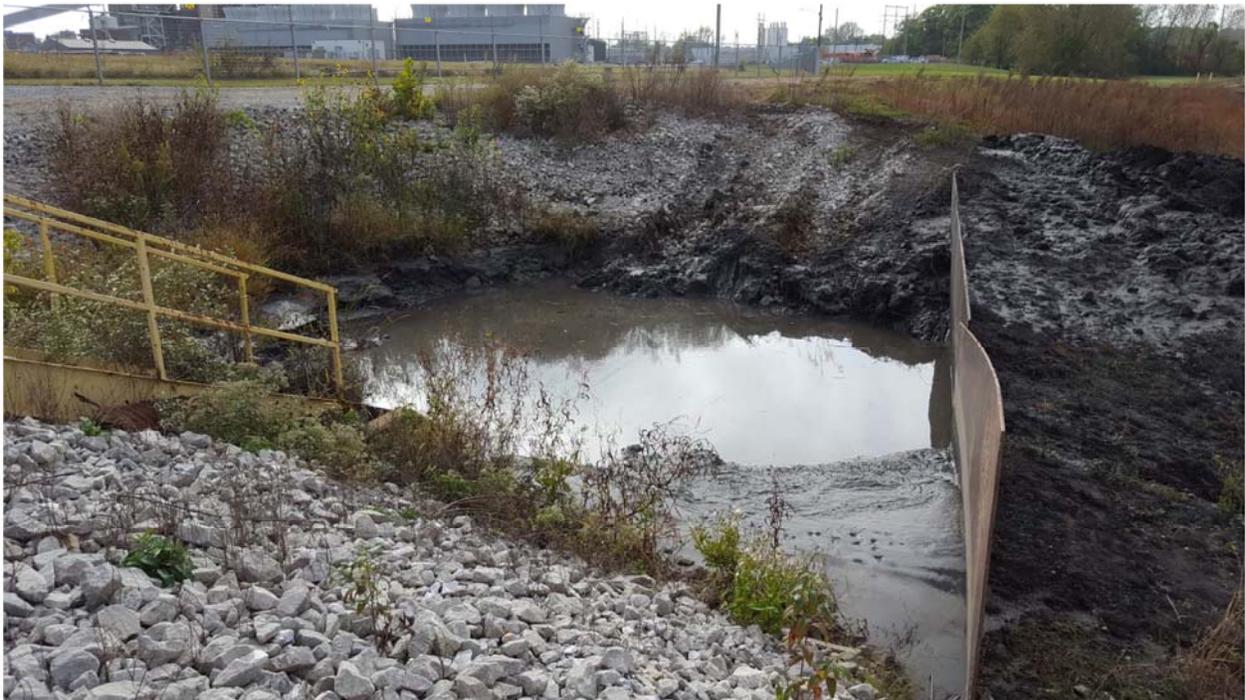
Figure 8: Sediment excavated from the holding area next to the Little Blue Valley Sewer District Outfall (facing southwest)

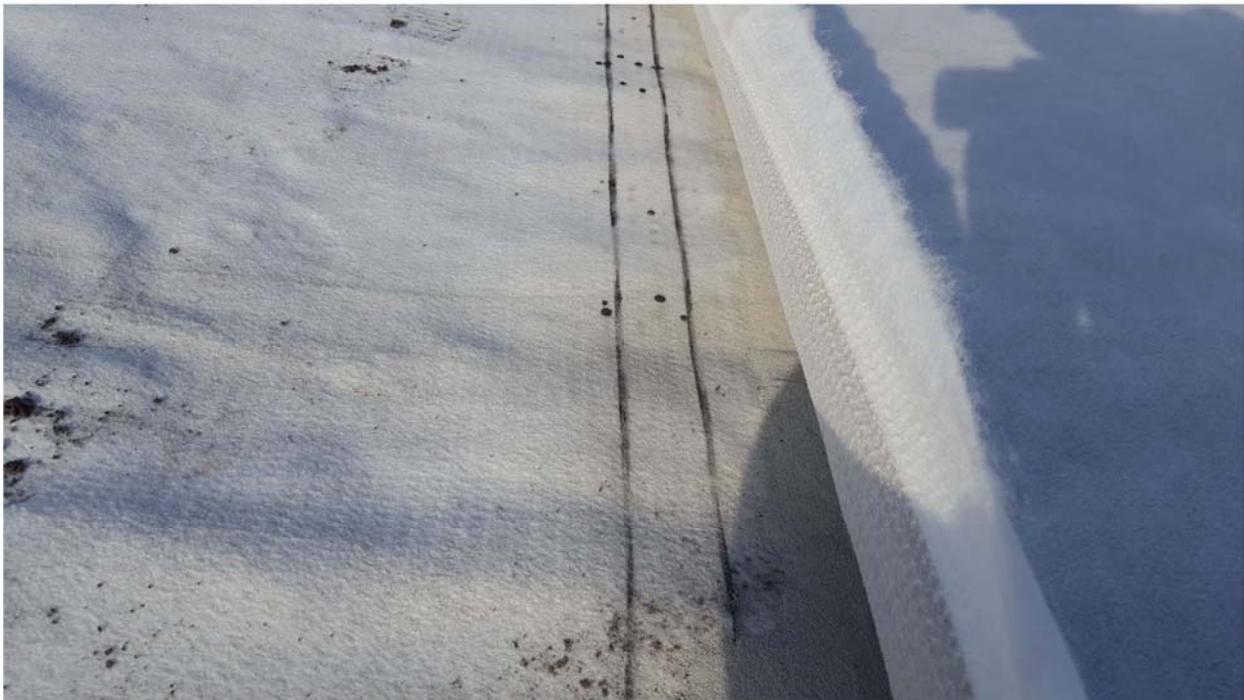
Figure 2: 10-27-16 Bentonite powder placed along the edges before overlapped (facing east)

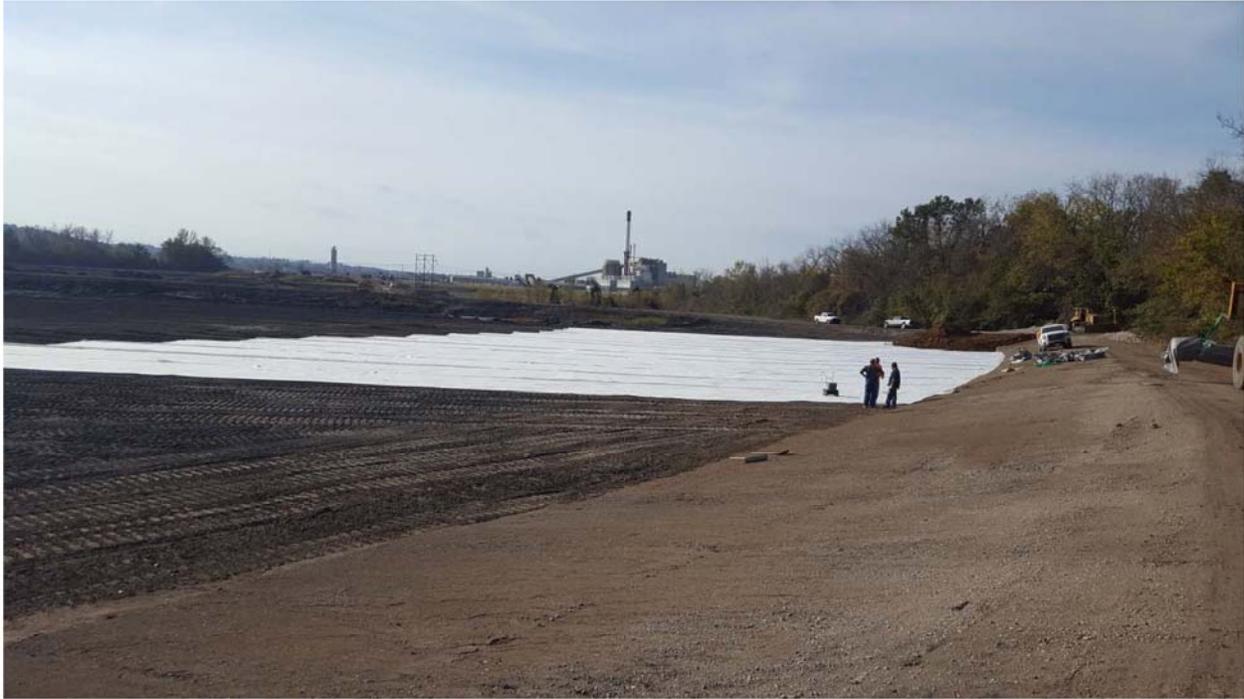
Figure 3: 10-27-16 GCL panels placed along the west side over the graded fly ash in north pond (facing south)

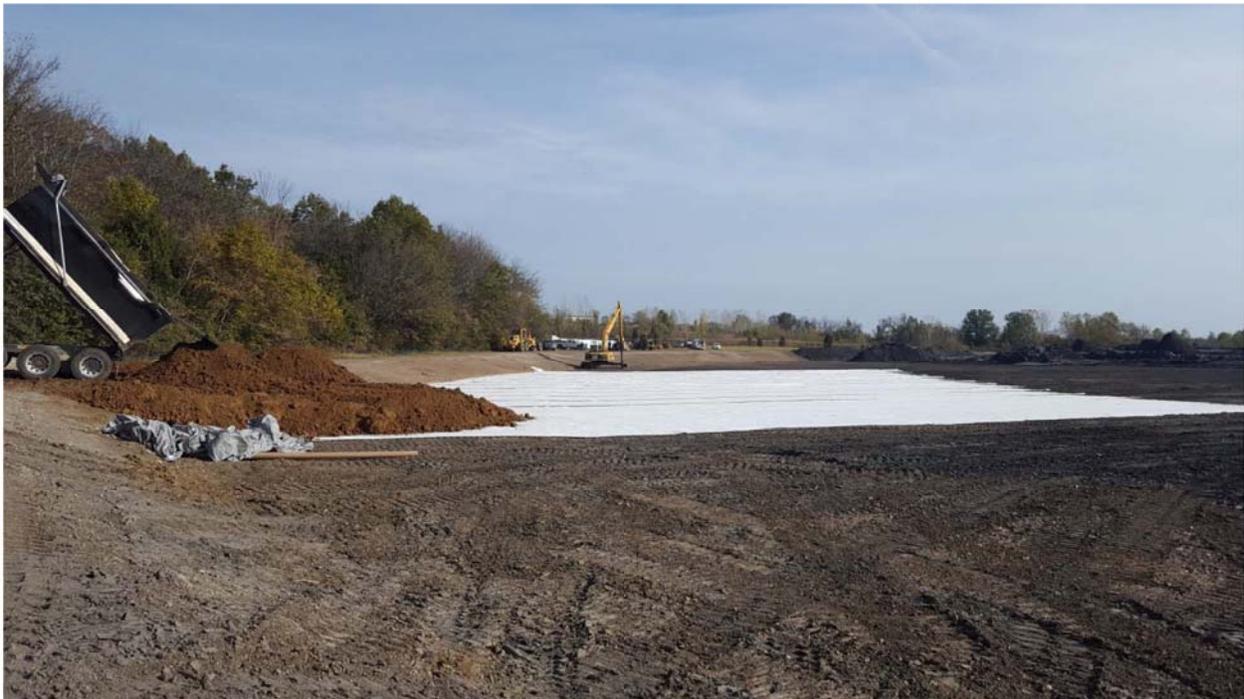
Figure 4: 10-27-16 Haul trucks dumping soil over the GCL panels (facing north)

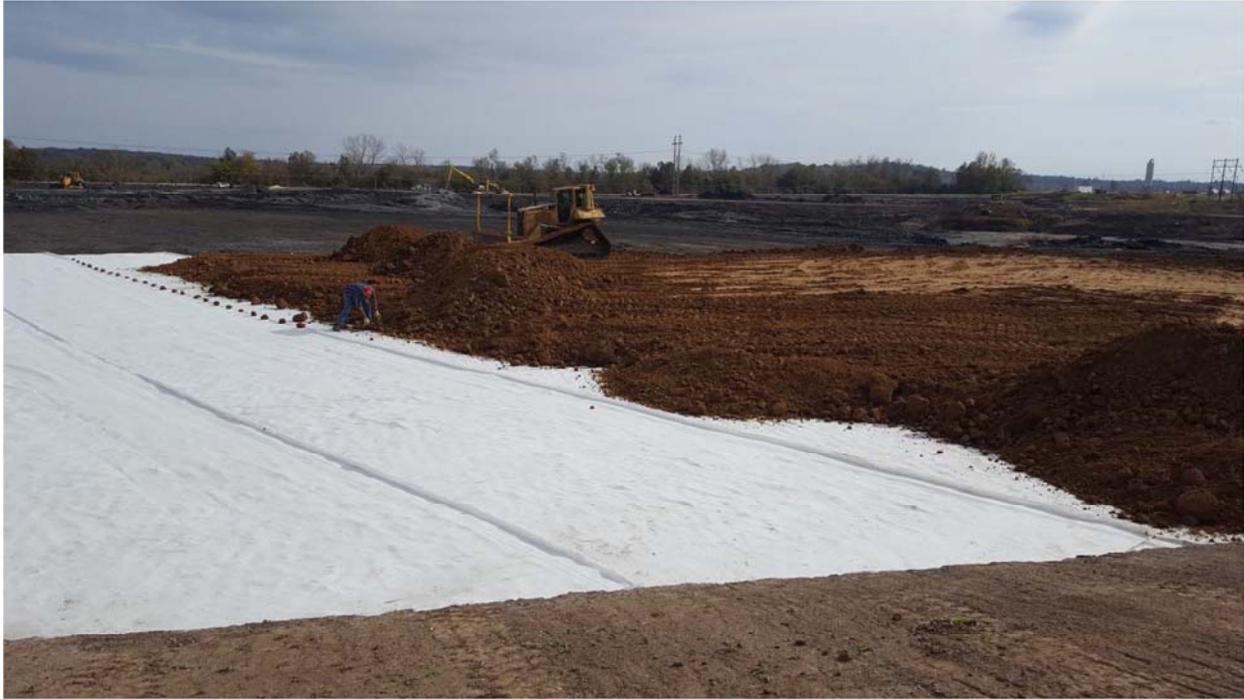
Figure 5: 10-27-16 Dozer placing soil 1 foot thick over the GCL panels in the north fly ash pond (facing southeast)

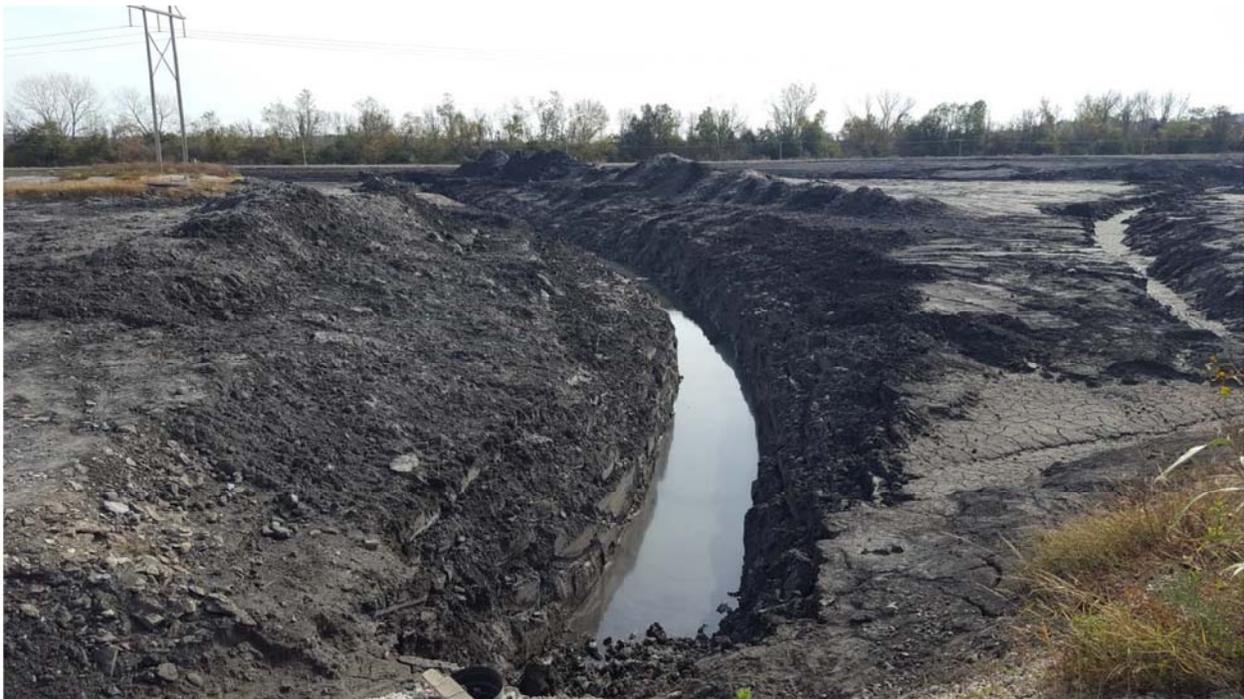
Figure 6: 10-27-16 Large trench excavated in the central/west side of the southeast pond to help dewater the fly ash (facing east)

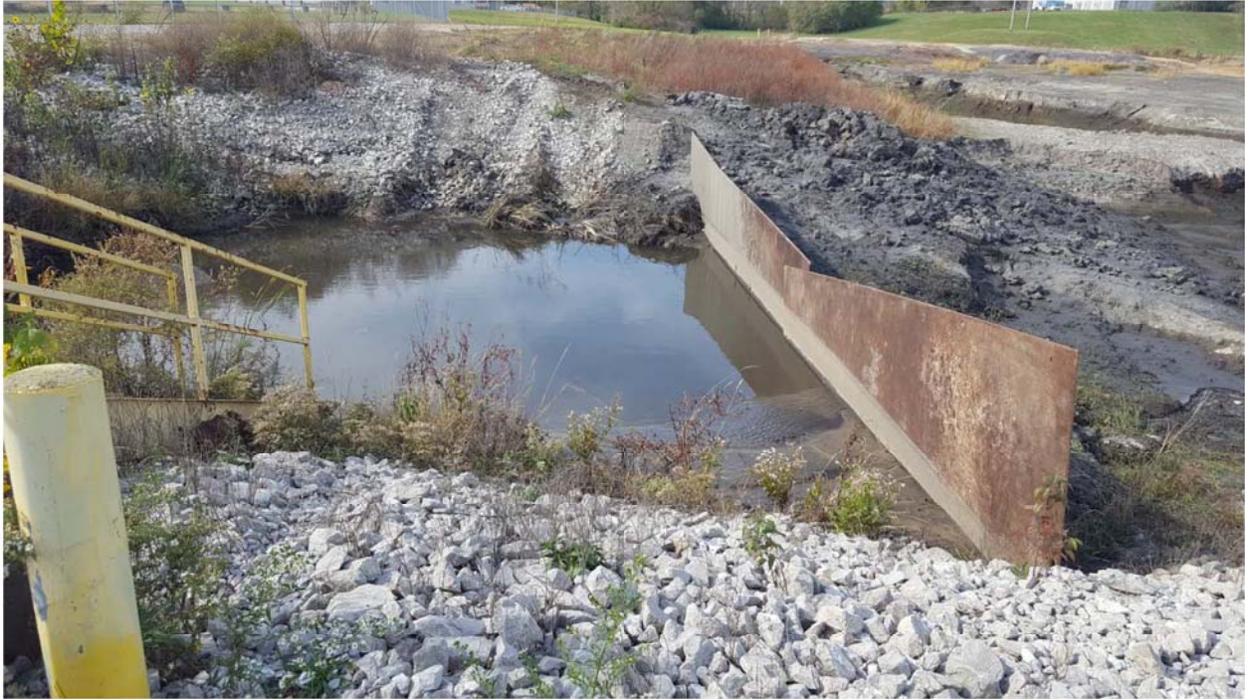
Figure 7: 10-27-16 More sediment excavated out of the holding area near the Blue Valley Sewer Outfall (facing west)

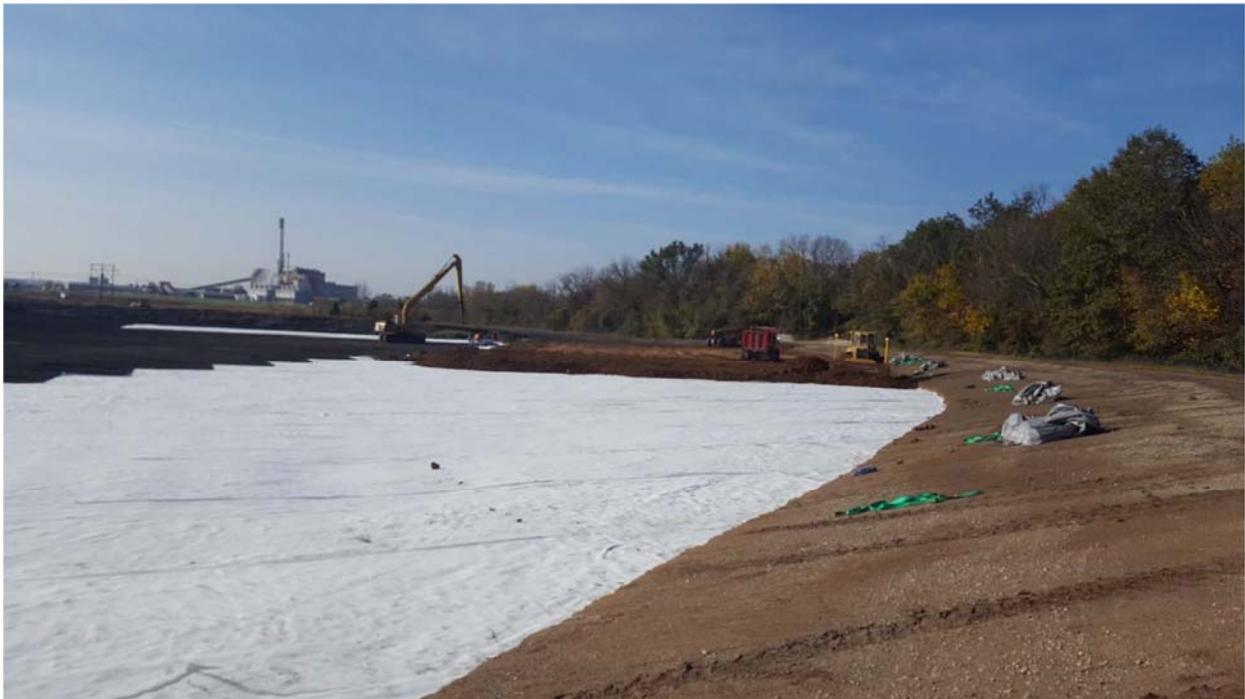
Figure 8: 10-27-16 GCL deployed farther to the north and placing soil over panels; north ash pond (facing southwest)

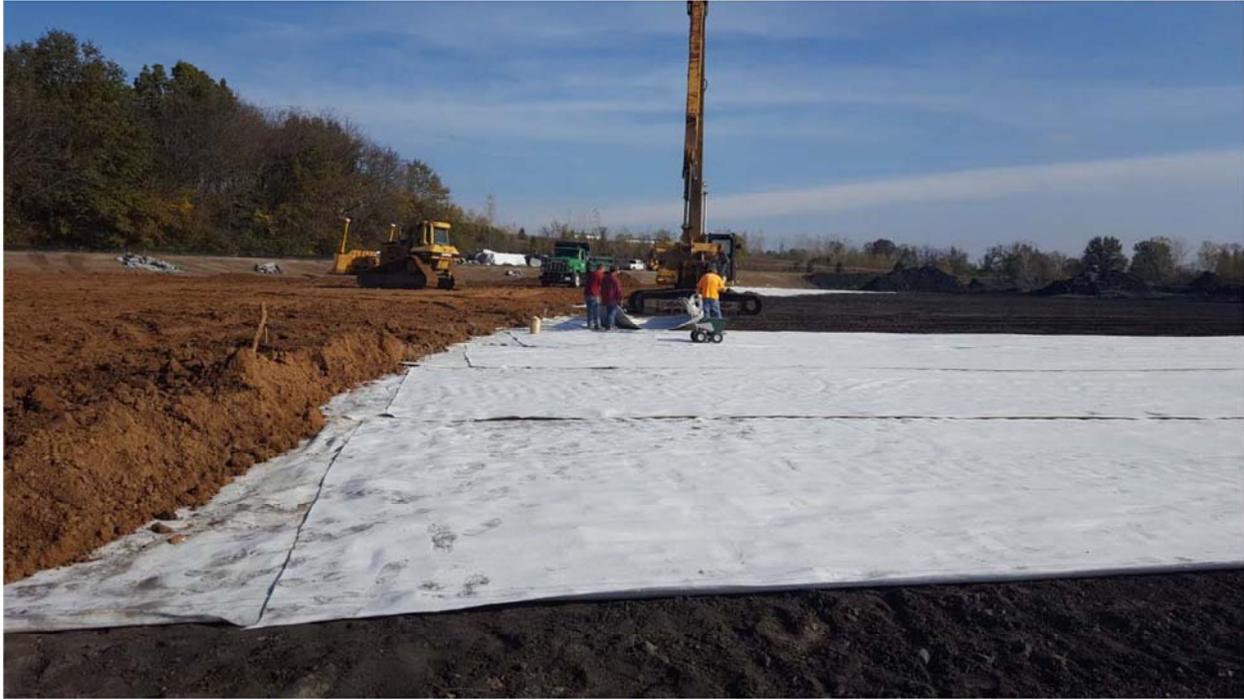
Figure 9: 10-27-16 Deploying more GCL panels to the east of what was placed on 10/25/16 in north ash pond (facing north)

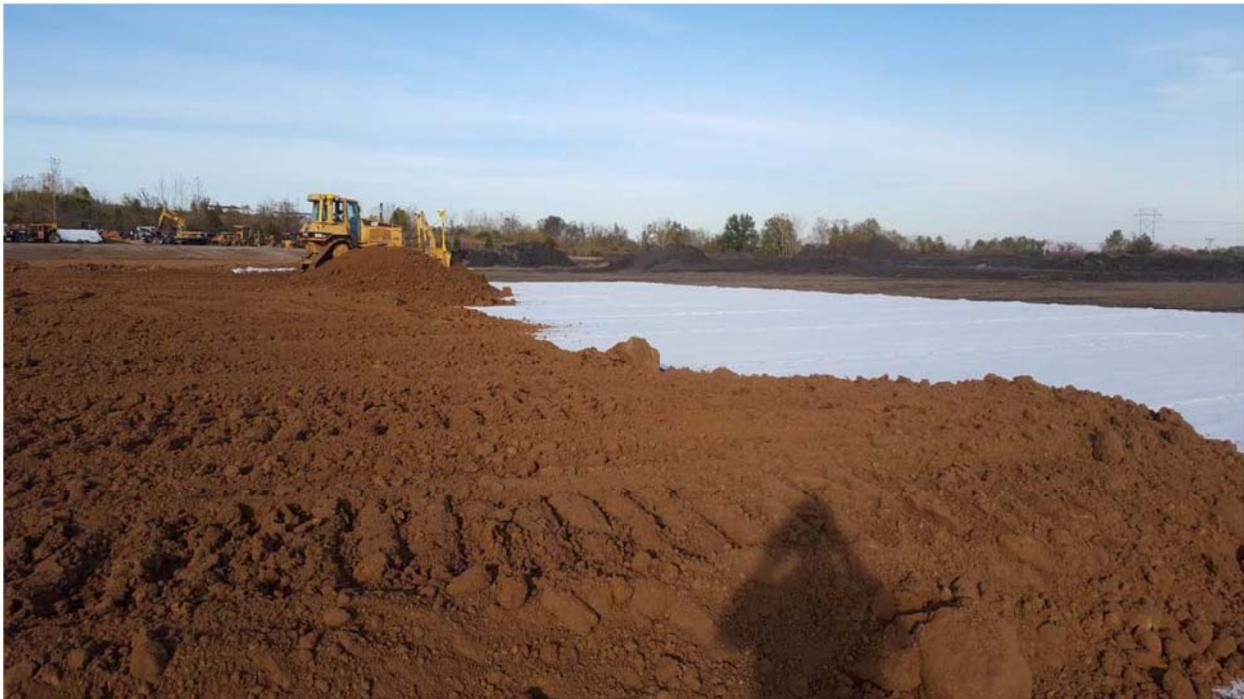
Figure 10: 10-27-16 Dozer placing soil 1-foot thick soil over the deployed GCL panels to the east; north ash pond (facing north)

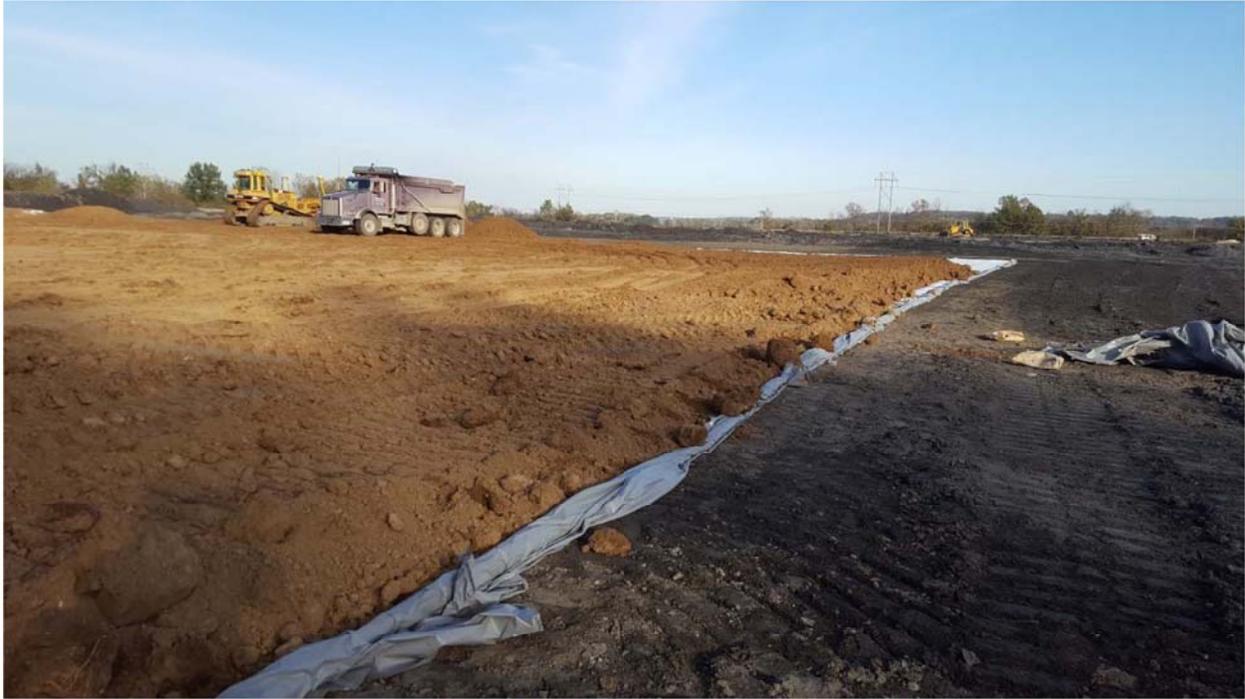
Figure 11: 10-27-16 The edge of the GCL was rolled up and covered in with plastic to protect from the weather; north ash pond (facing northeast)

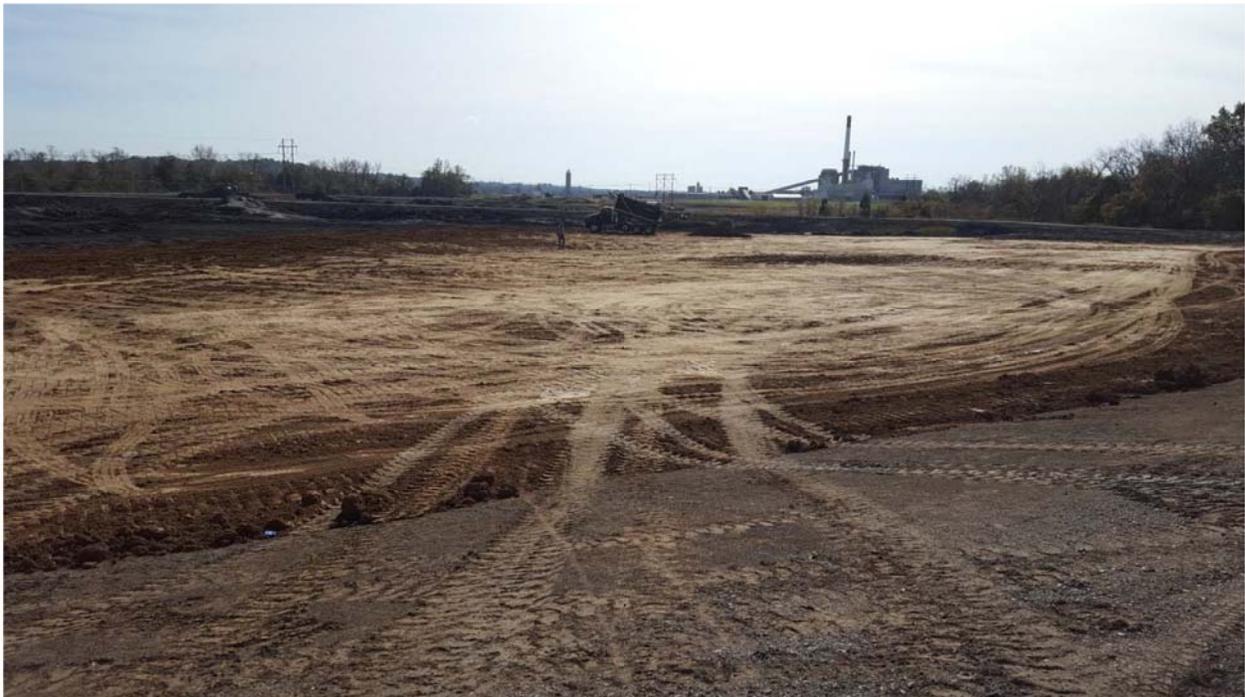
Figure 12: 10-28-16 GCL panels completely covered with 1-foot of soil in the north fly ash pond (facing south)

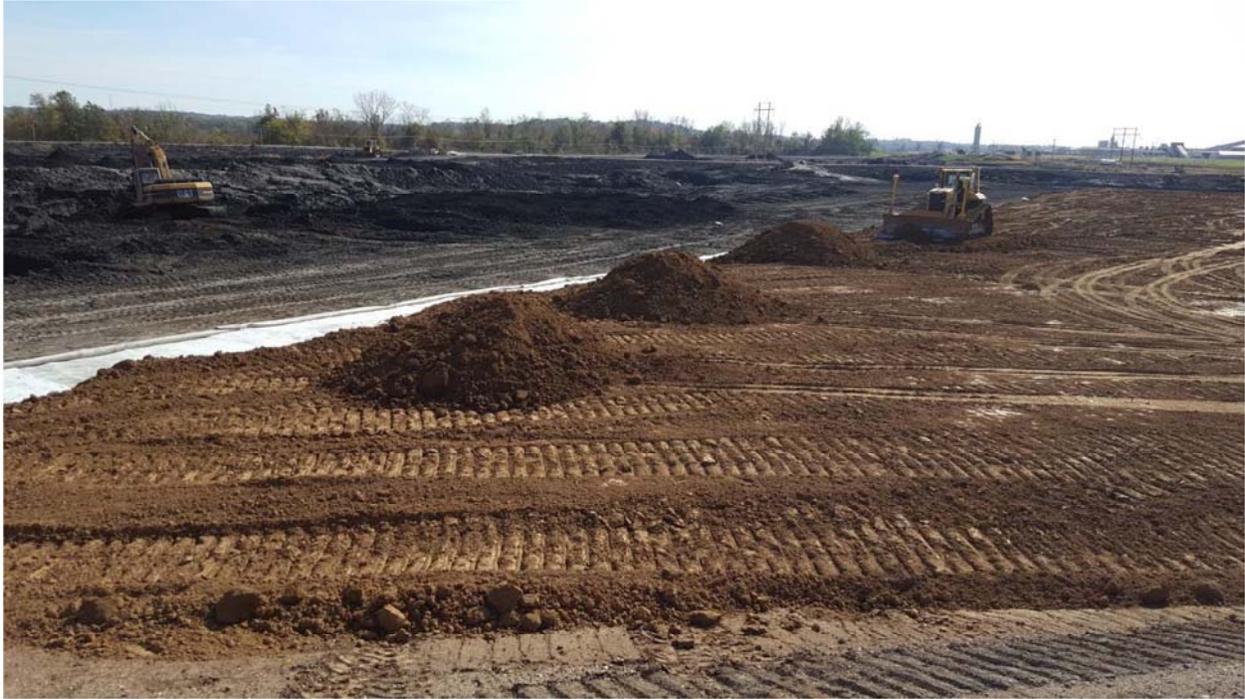
Figure 13: 10-28-16 Dozer placing soil to the east edge of the GCL;  
north fly ash pond (facing southeast)

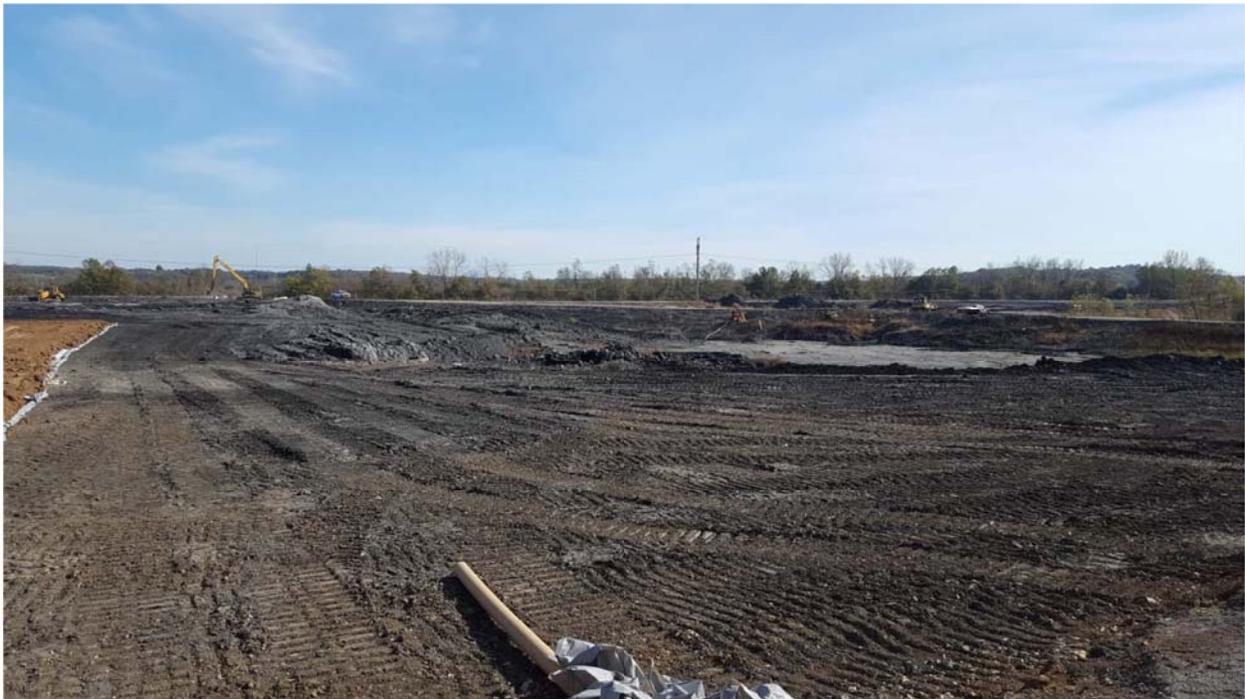
Figure 14: 10-28-16 Dried out fly ash along the south side of the north fly ash pond near edge of  
GCL placement (facing southeast)

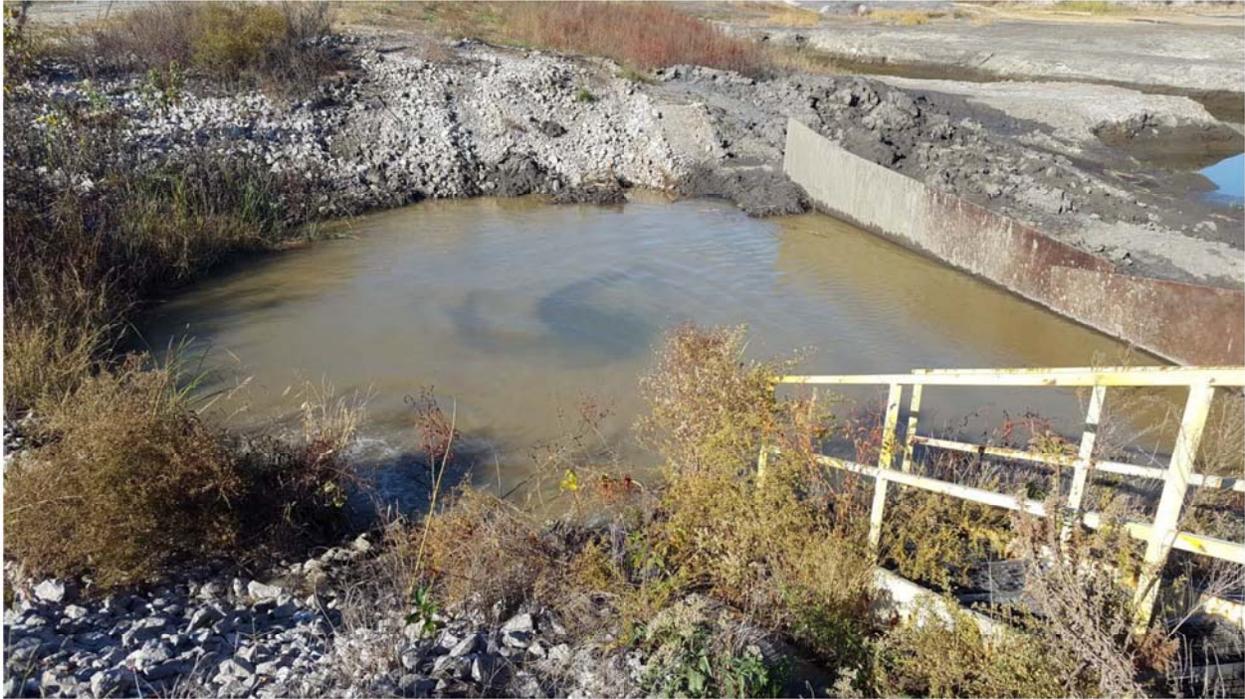
Figure 1: Discharging water to the LBVSD outfall. Sediment removed earlier in the week (facing west)

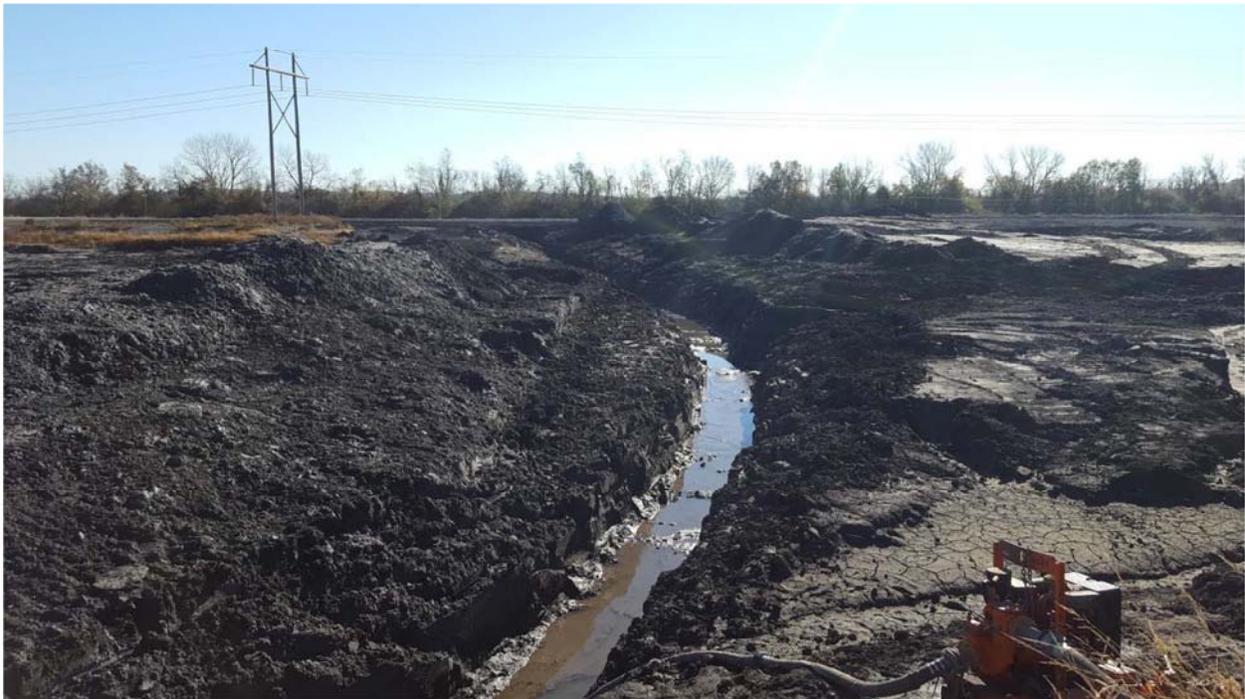
Figure 2: Trench excavated in the middle of the southeast fly ash pond to help dewater fly ash (facing east)

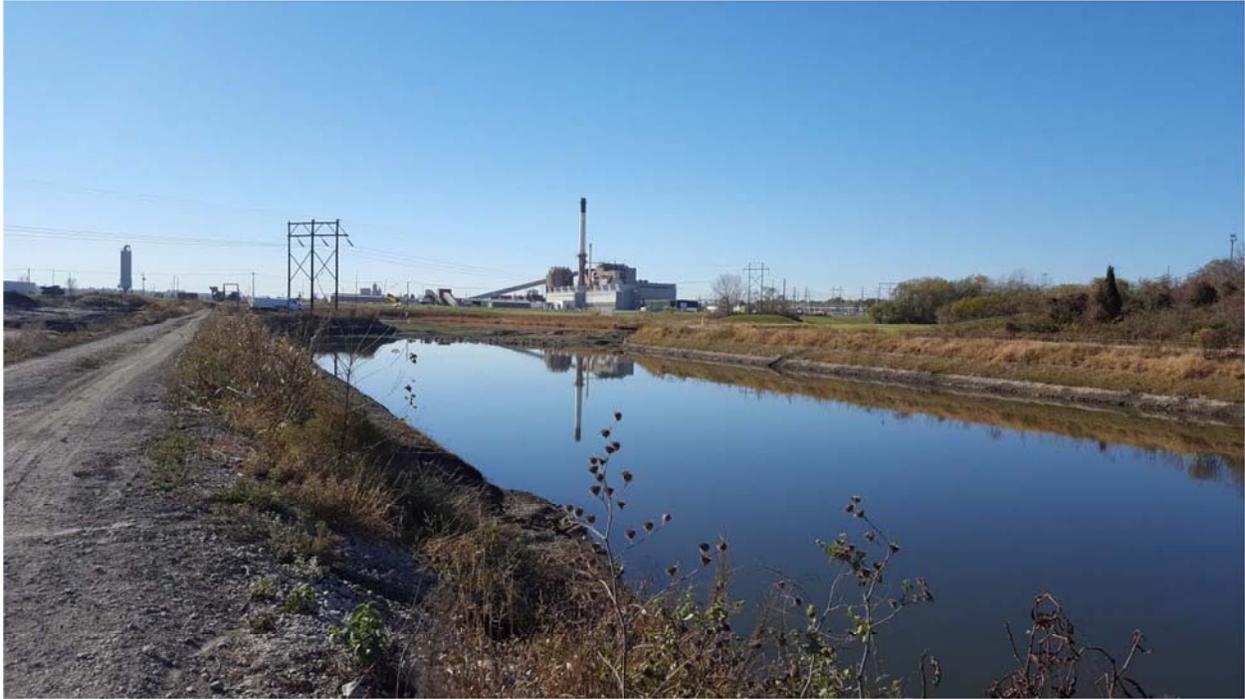
Figure 3: Southwest pond where water is being pumped from the southeast pond (facing south)

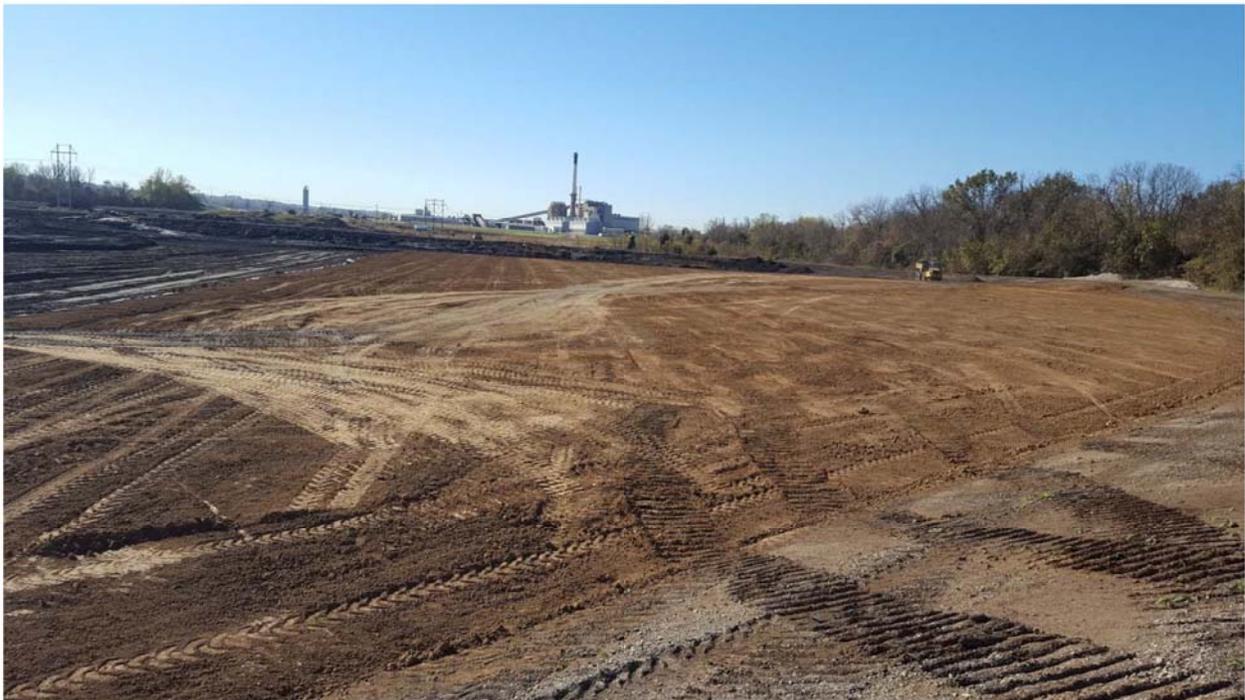
Figure 4: Haul truck driving across the soil cover on the GCL to move fly ash (facing south)

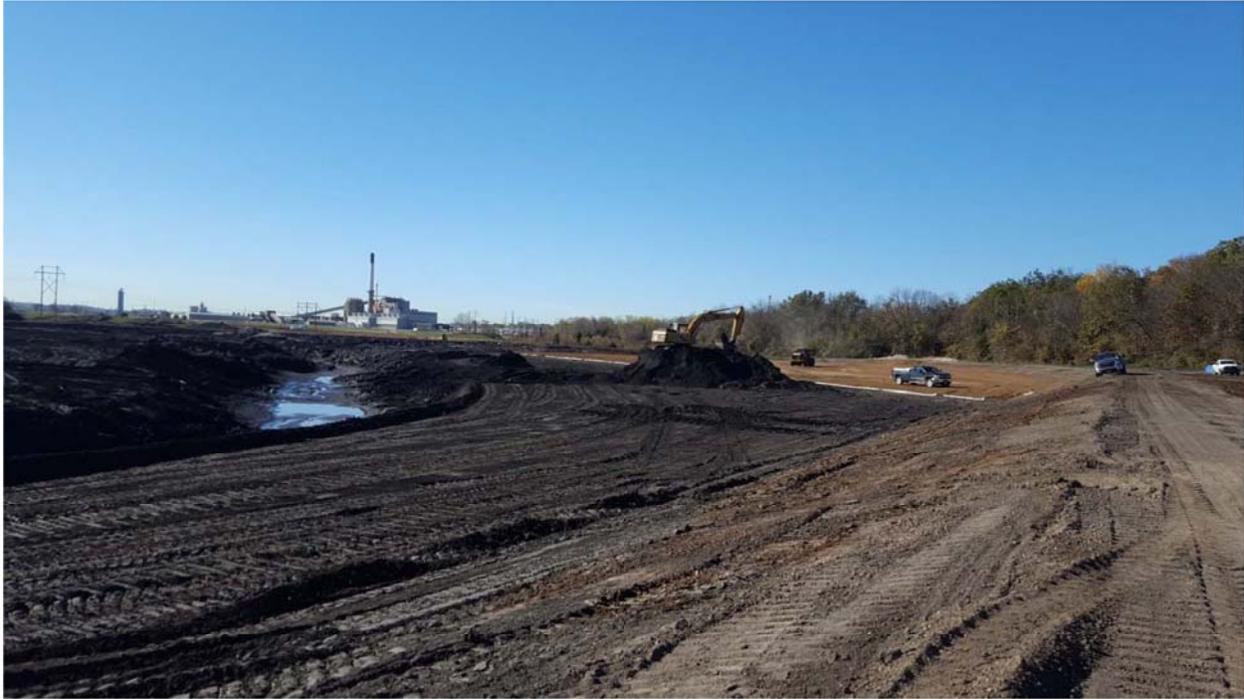
Figure 5: Fly ash being graded out and fly ash stockpile being moved in the north fly ash pond (facing southeast)
