## **Ash Impoundment Closure Report**

Independence Power & Light  
Blue Valley Power Station  
21500 East Truman Road  
Independence, Missouri 64056

**SCS ENGINEERS**  
7311 West 130th Street, Suite 100  
Overland Park, Kansas 66213  
(913) 681-0030

April 2018  
Revised June 2018  
File No. 27215142.00

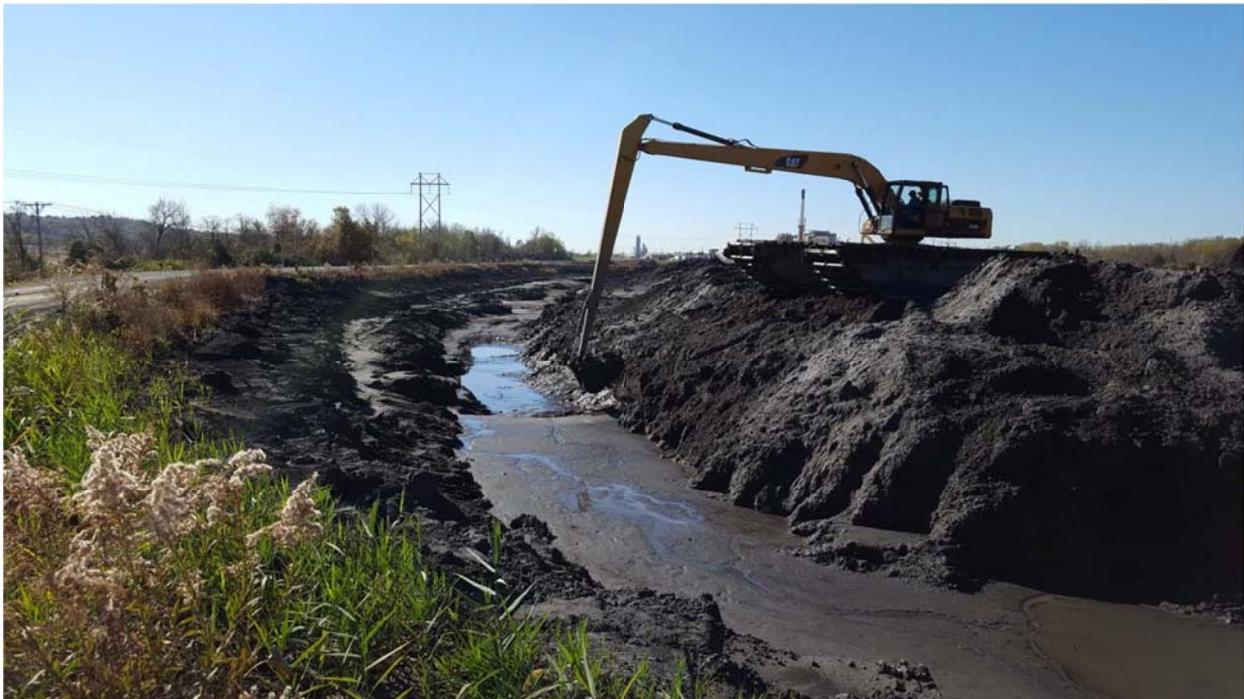
Figure 6: Continuing to excavate saturated fly ash from the northeast side of the north fly ash pond (facing south)

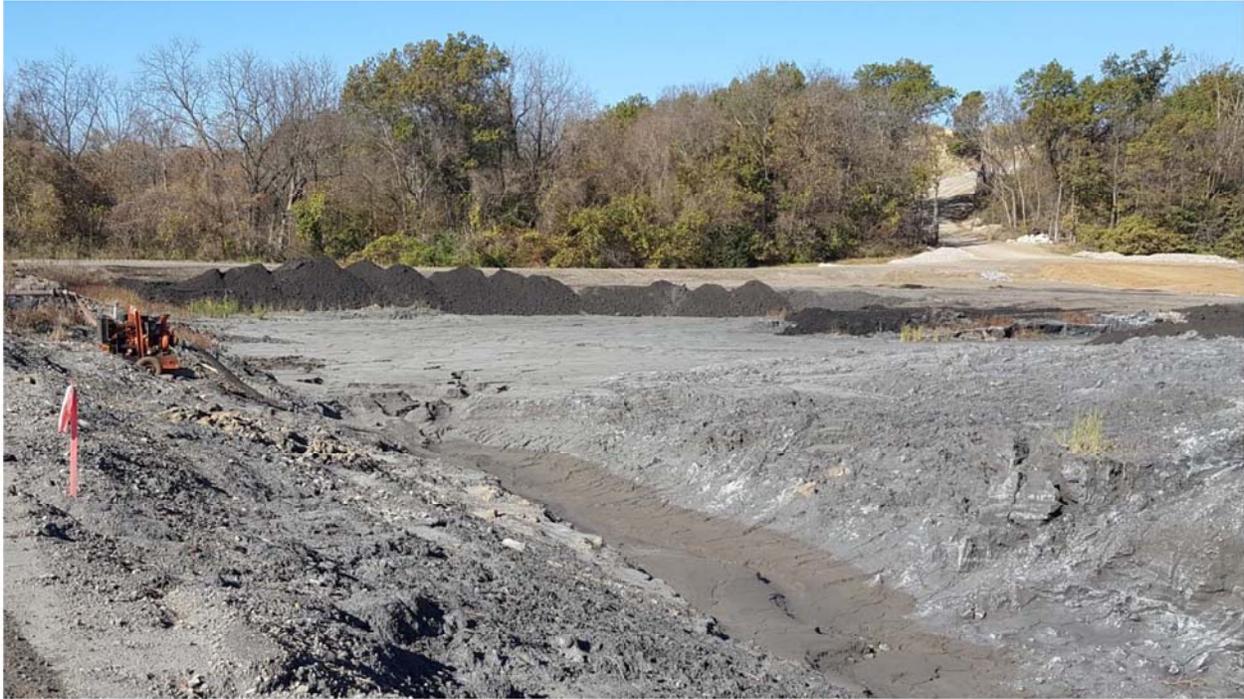
Figure 7: Fly ash being relocated to the southwest side of the north pond to be graded (facing west)

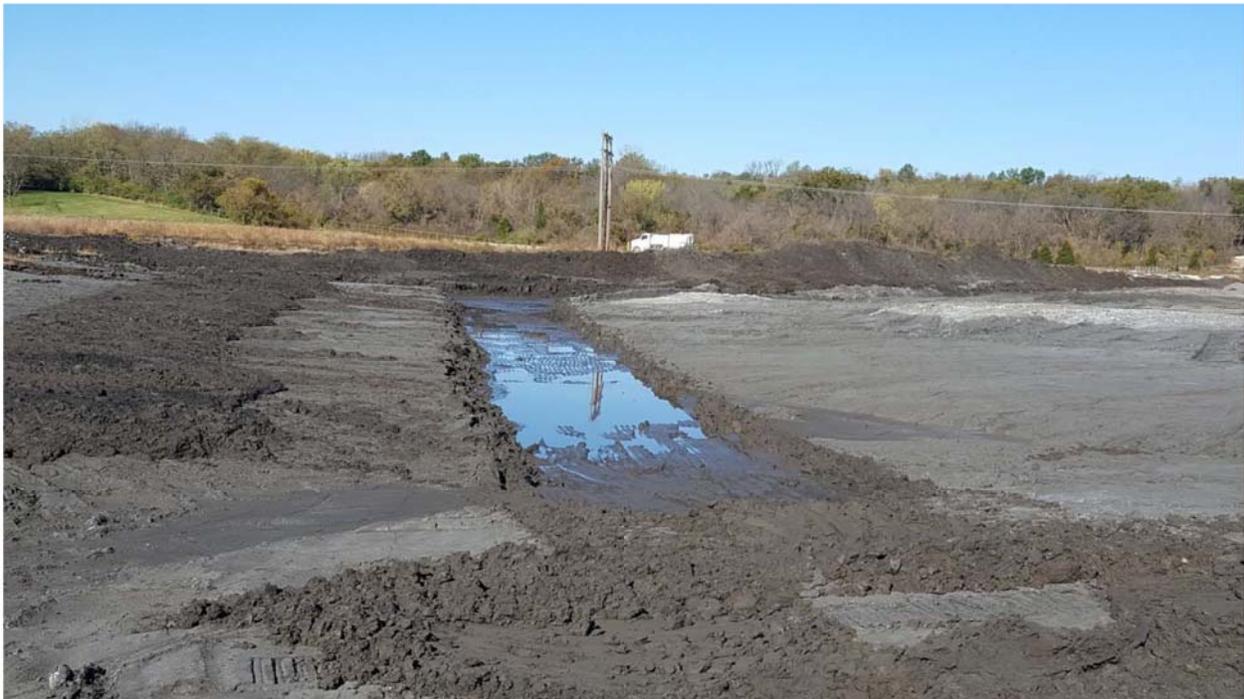
Figure 8: Excavated trench to release trapped water in the southeast fly ash pond (facing west)

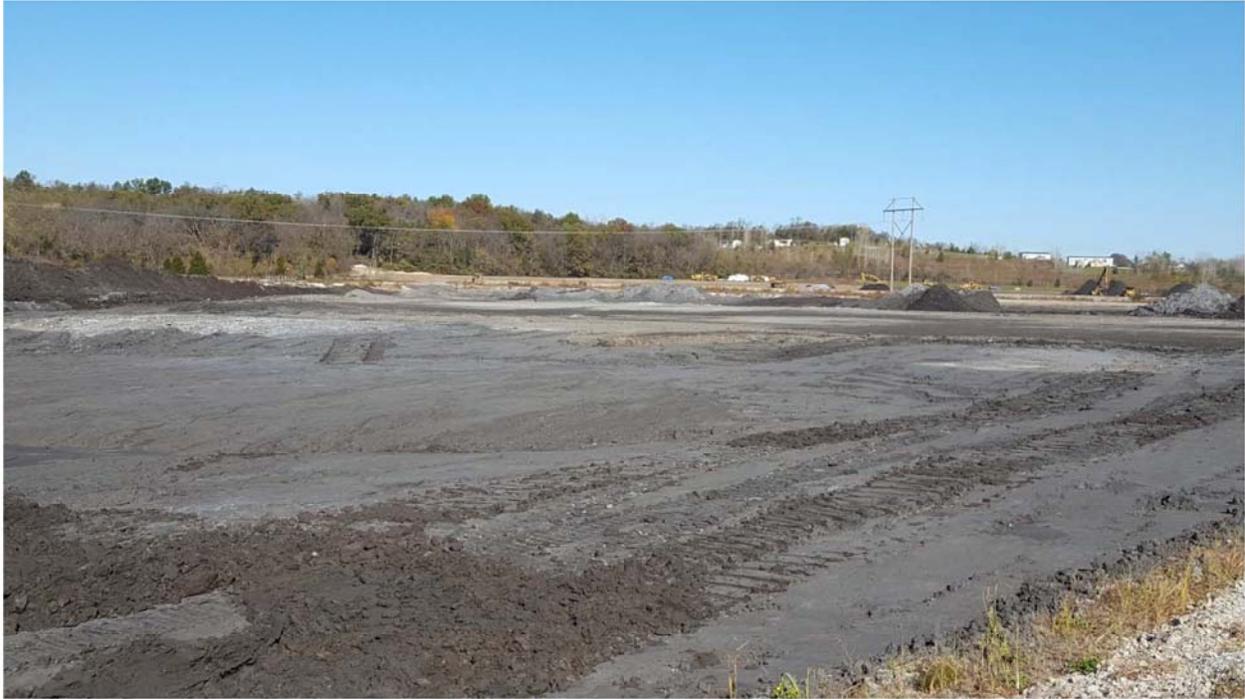
Figure 9: Southeast fly ash pond graded out on the south half (facing northwest)

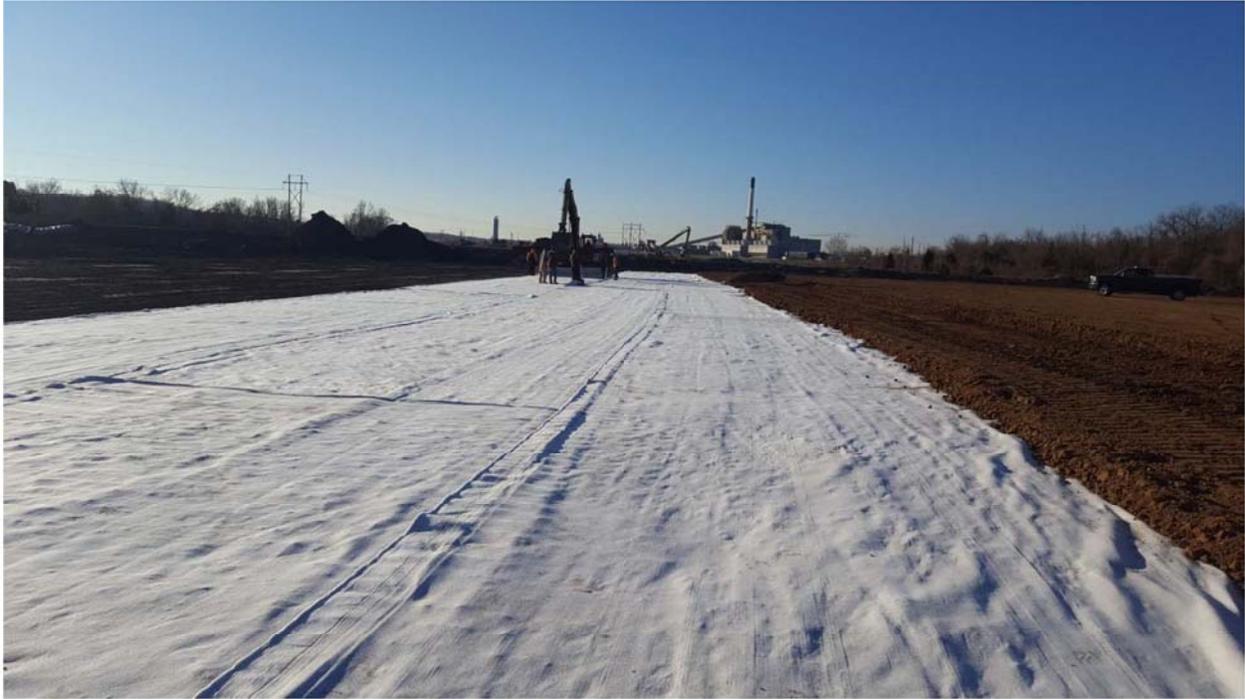
Figure 1: Installing new panels of GCL on the north side of the north pond (facing south)

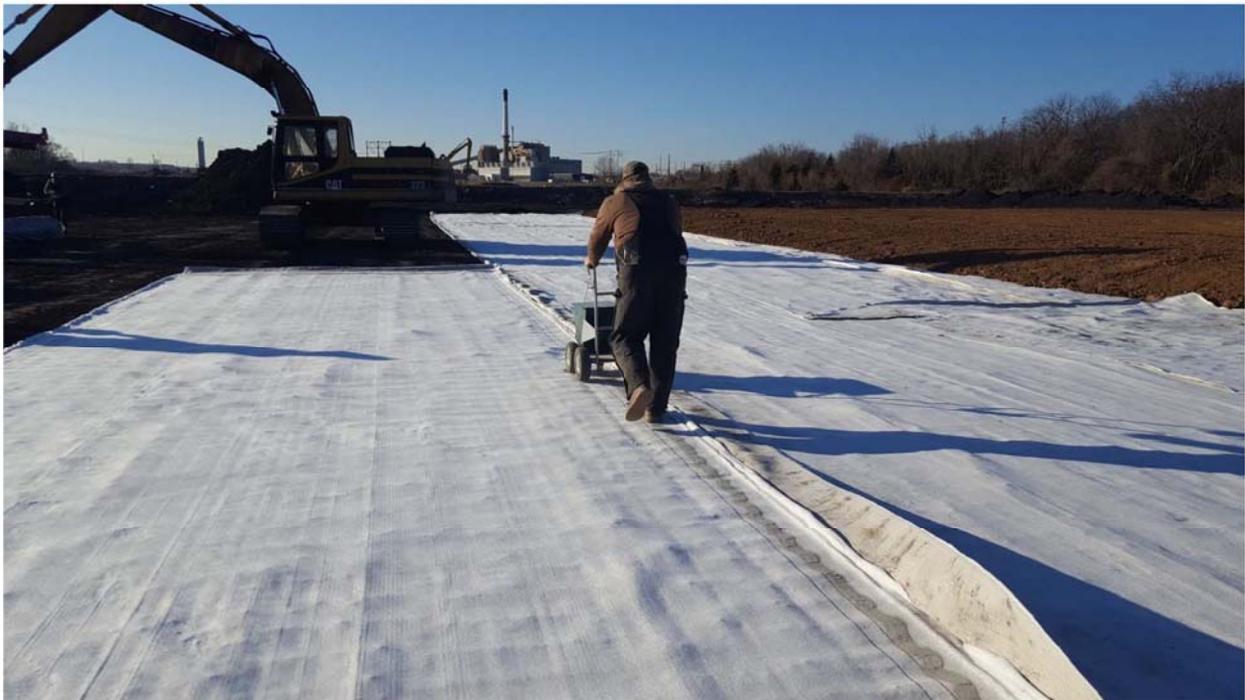
Figure 2: Placing bentonite powder along the long ends of the panels under the overlap (facing south)

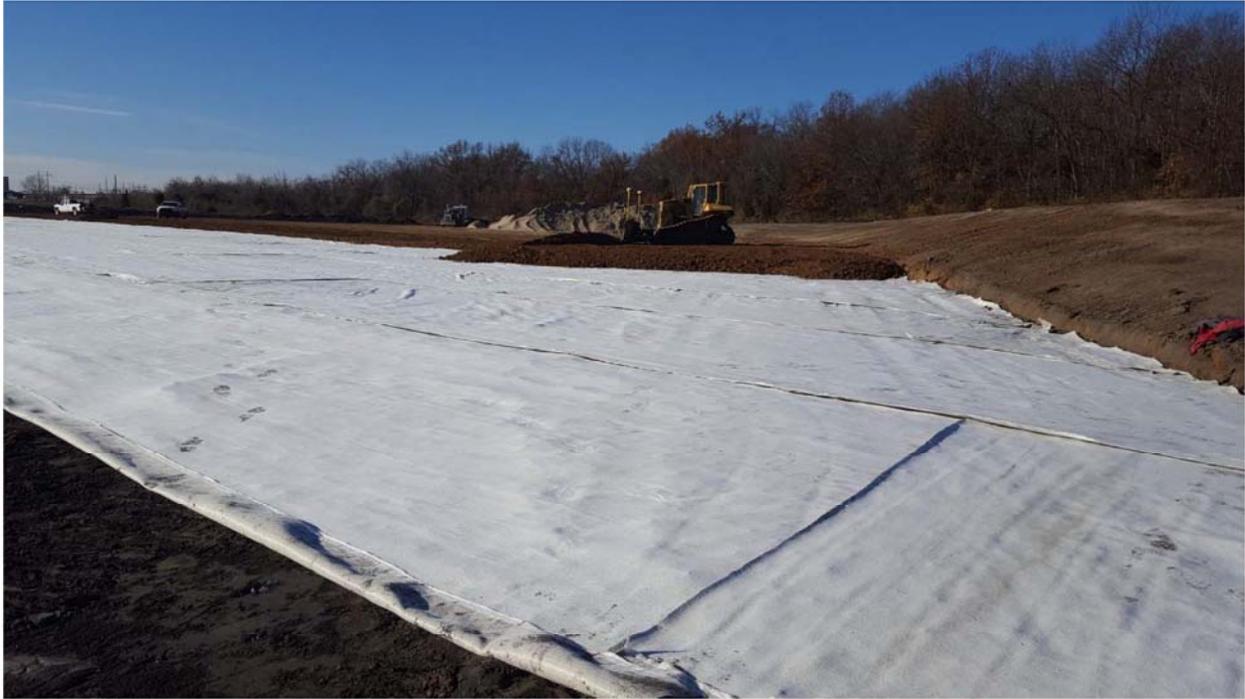
Figure 3: Dozer placing soil hauled from the borrow area over the GCL panels  
(facing southwest)

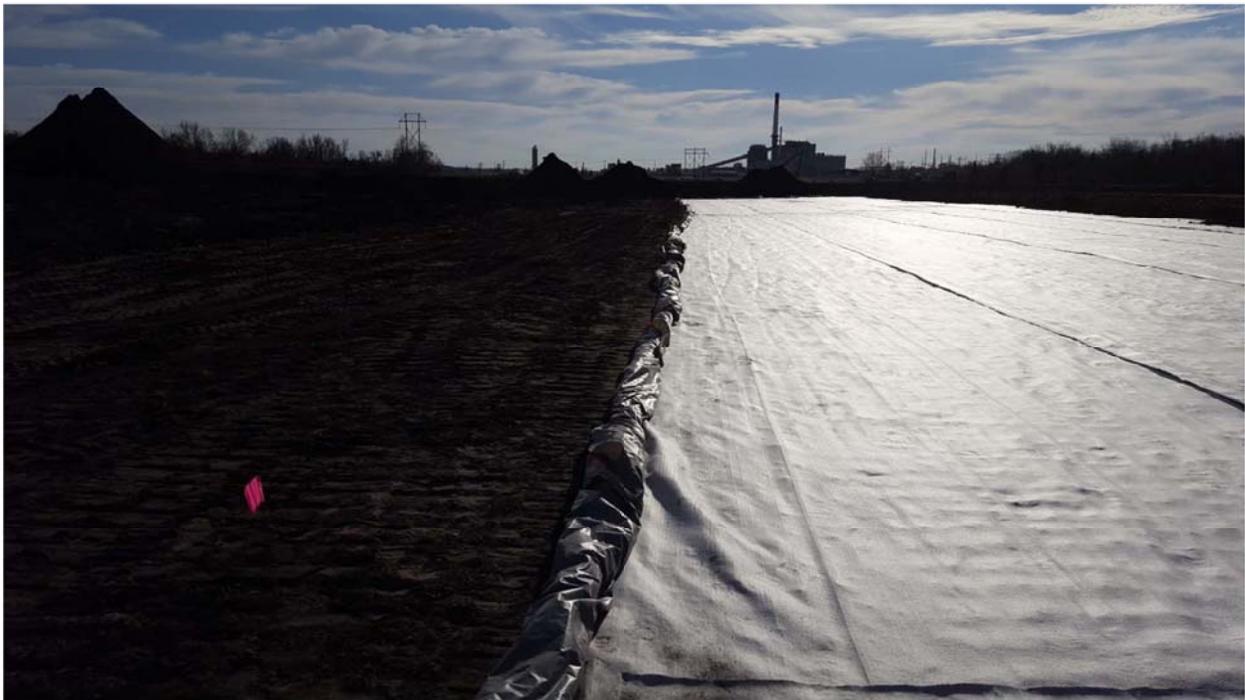
Figure 4: Ends of the GCL rolled over and covered with plastic to protect from weather  
(facing south)

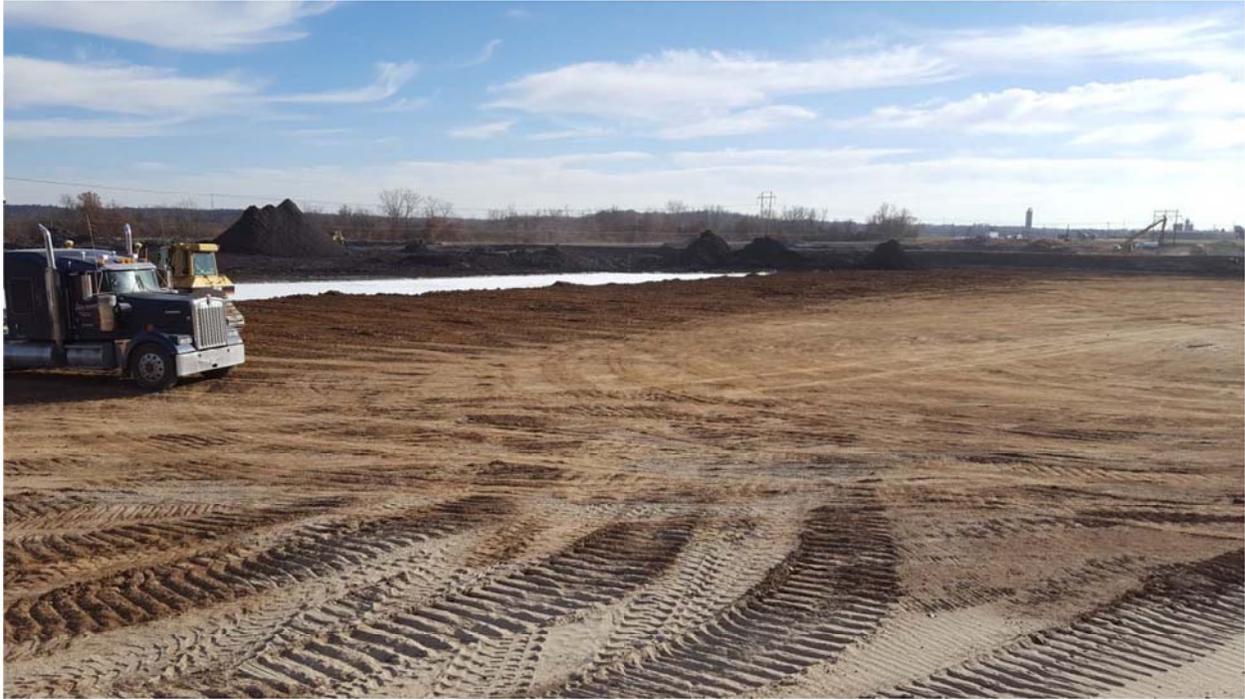
Figure 5: Dozer placing soil over the GCL panels installed in the morning  
(facing southeast)

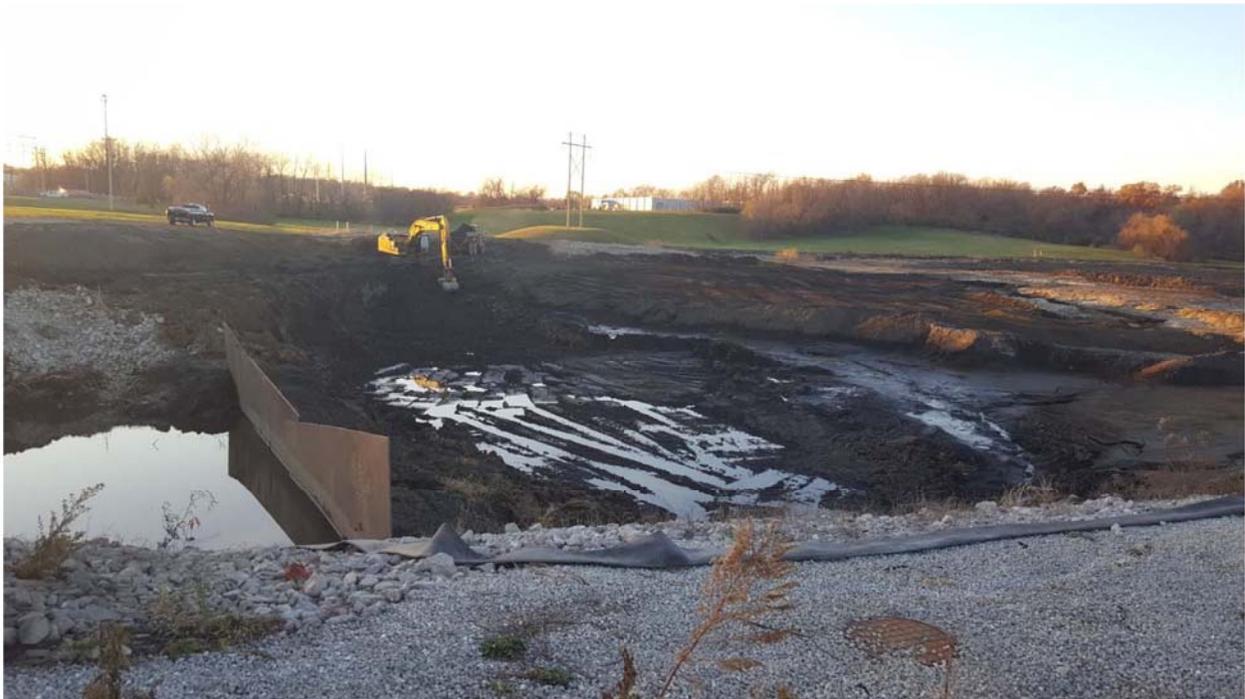
Figure 6: Excavating the saturated fly ash from the south side of the southwest fly ash pond  
down to the clay liner (facing west)

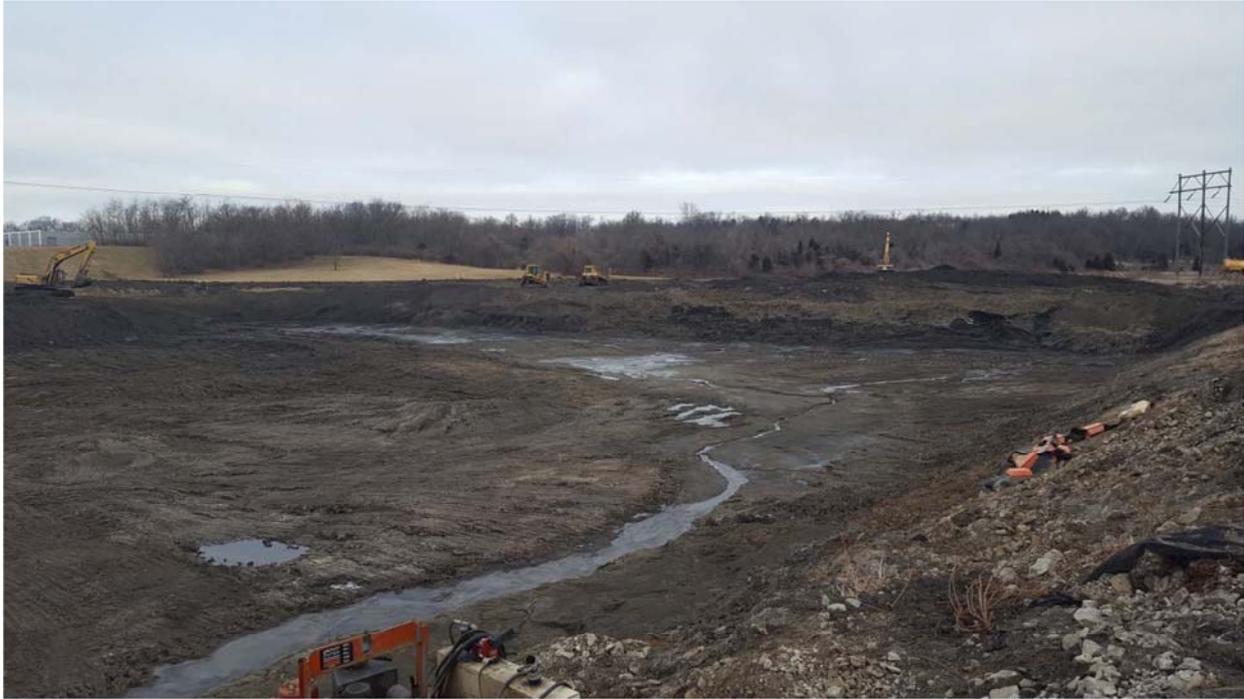
Figure 1: Overview of the southwest sediment pond (facing northwest)

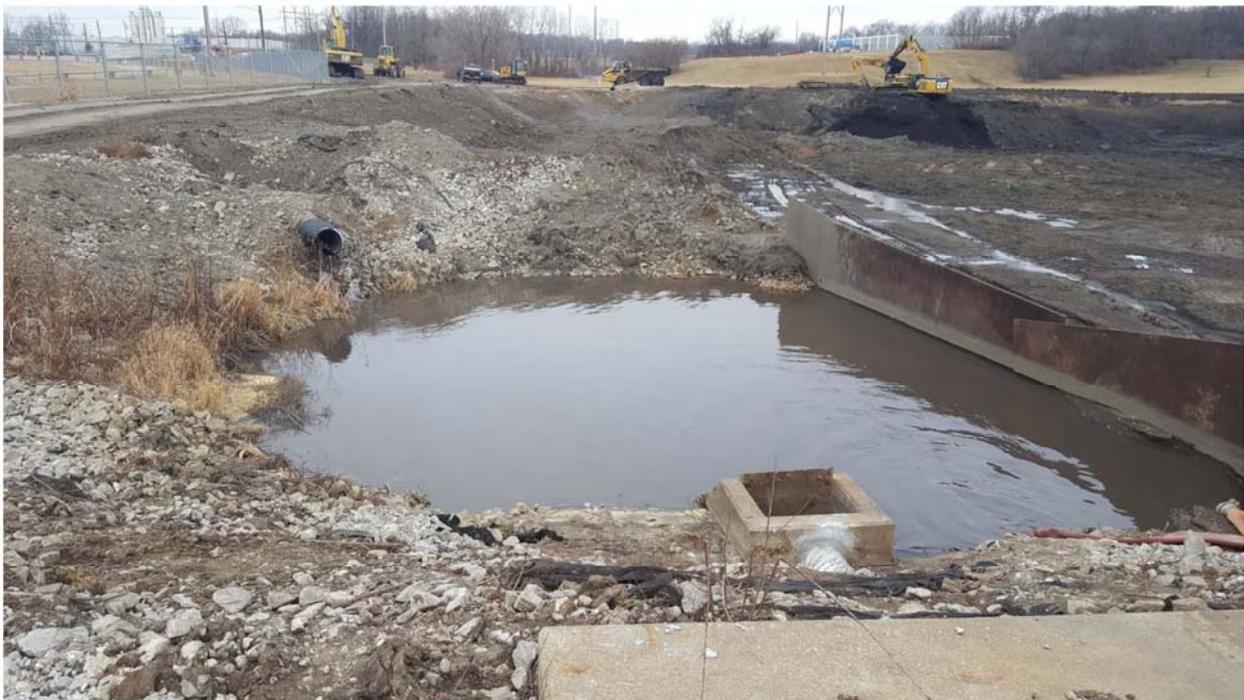
Figure 2: Pumping water from the south sediment pond into the basin for the LBVSD Outfall (facing west)

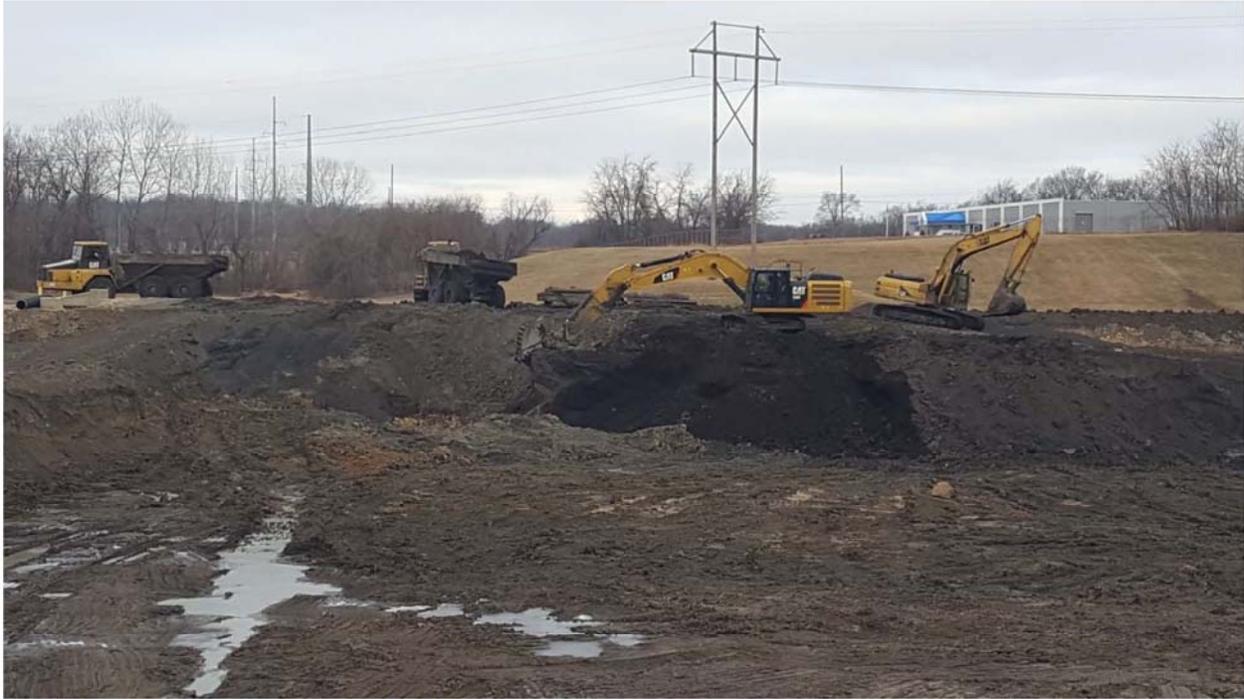
Figure 3: Excavating fly ash from the south half of the sediment pond (facing west)

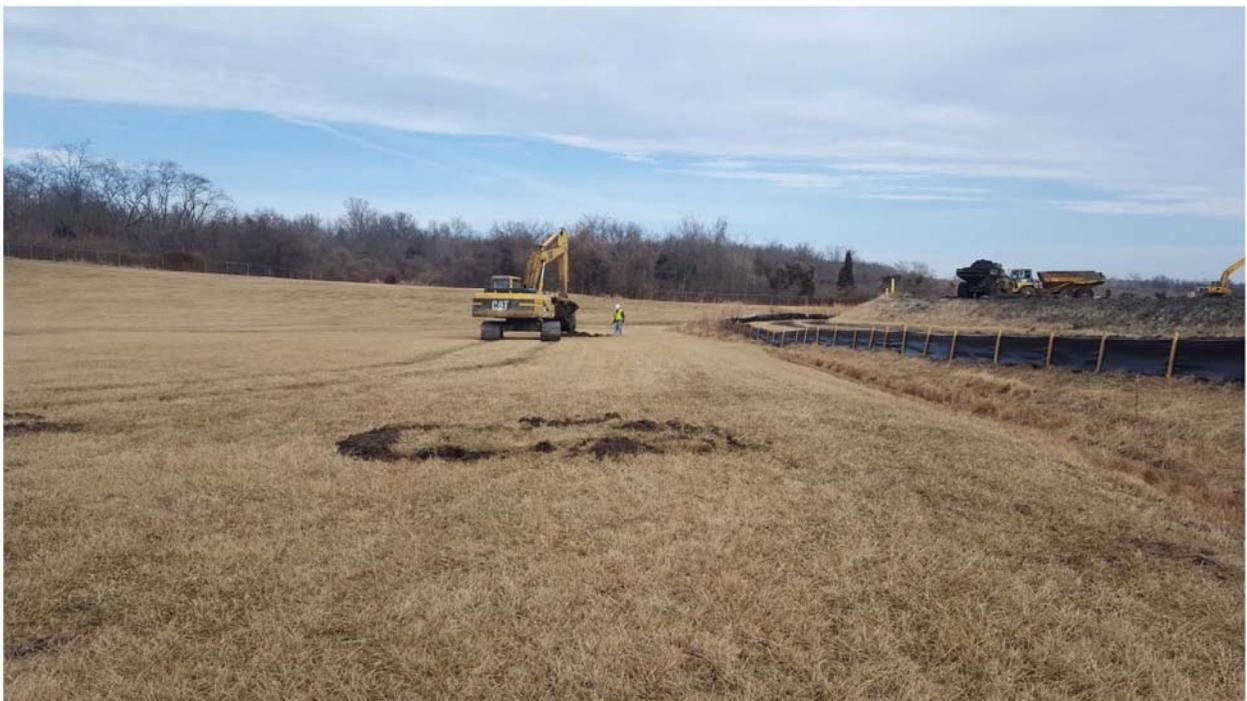
Figure 6: Excavating test pits to about 18 inches to get background soil samples (facing north)

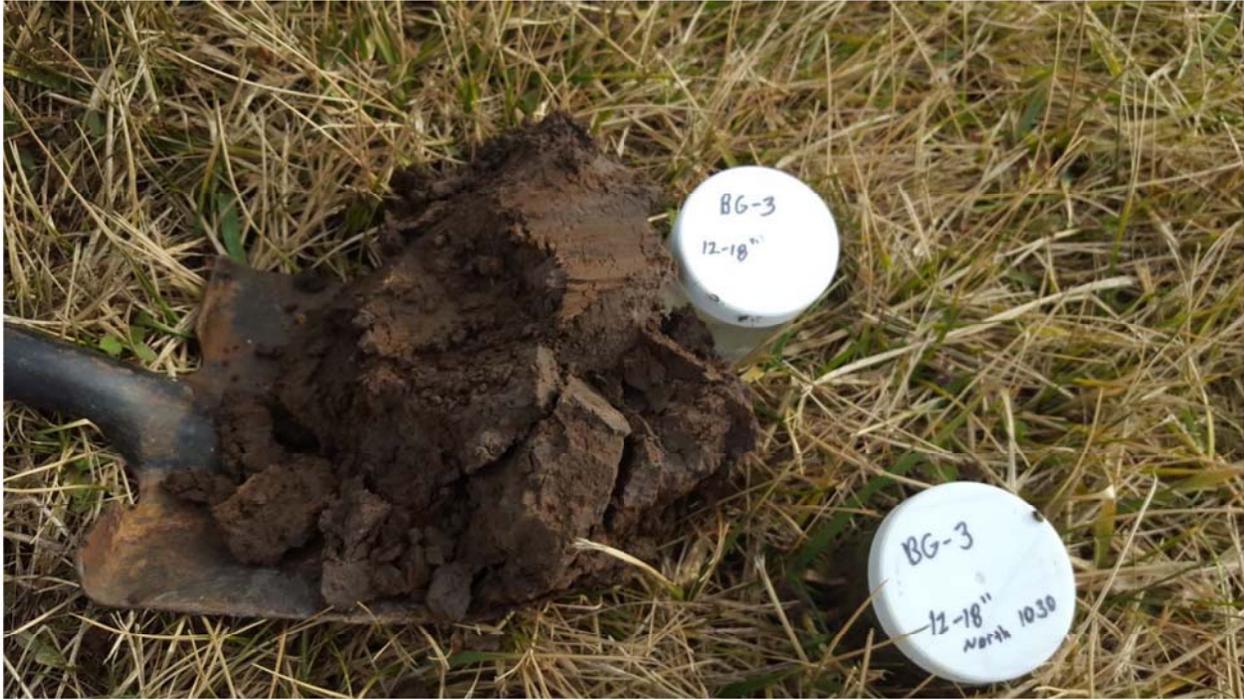
Figure 7: Clay soil encountered for the background sample (facing east)

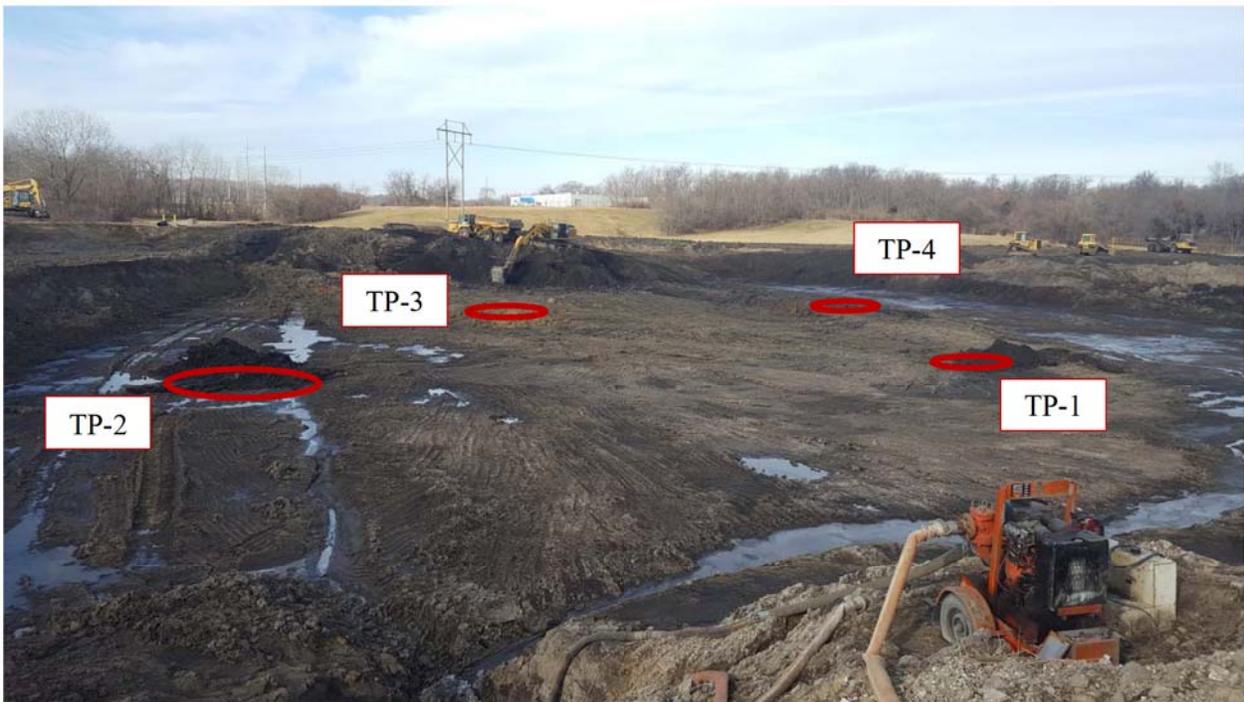
Figure 8: Overview of test pits in the southwest sediment pond (facing west)

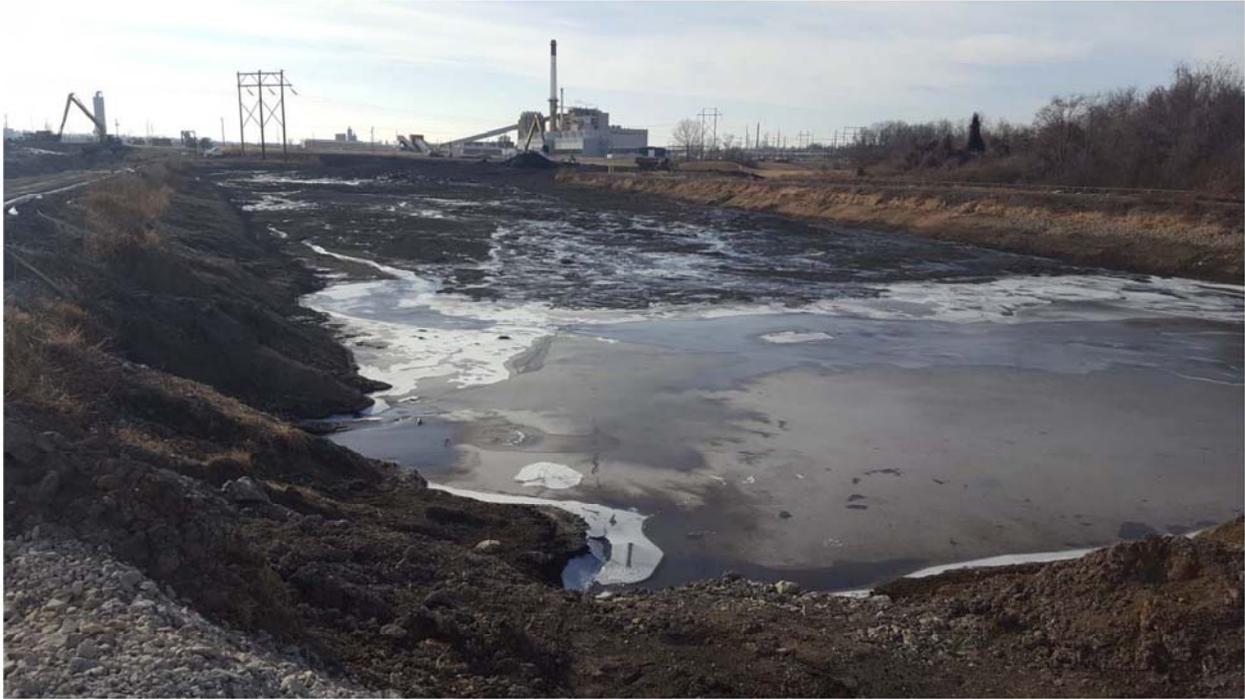
Figure 9: Southwest ash pond water pumped down (facing southwest)

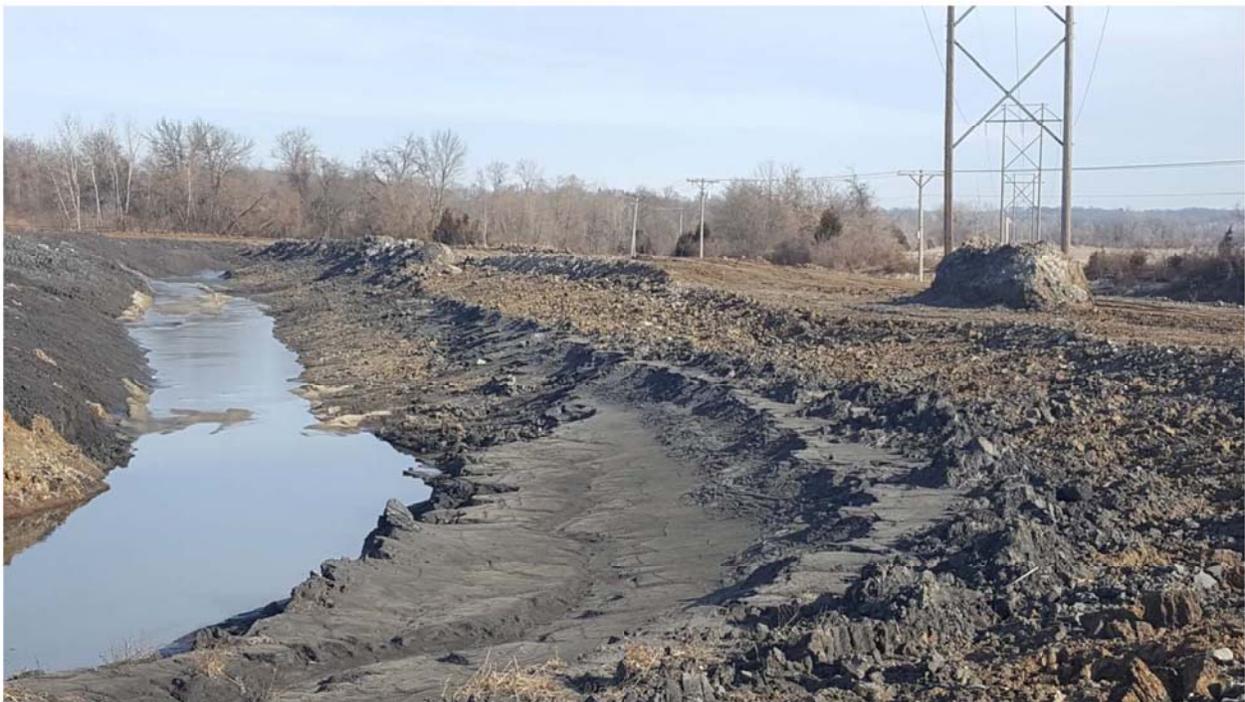
Figure 10: East berm graded down on the north fly ash pond (facing north)

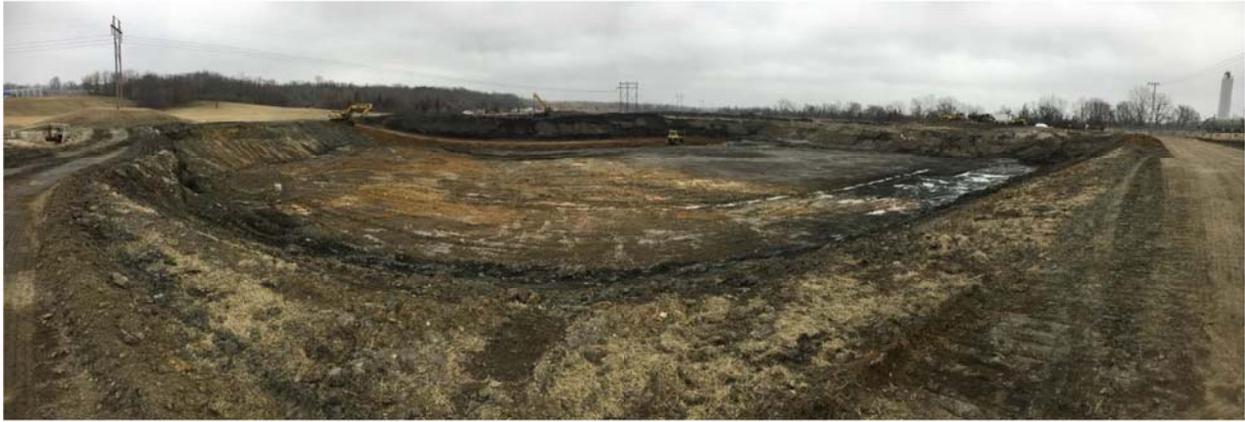
Figure 1: Overview of the sediment pond (facing northwest)

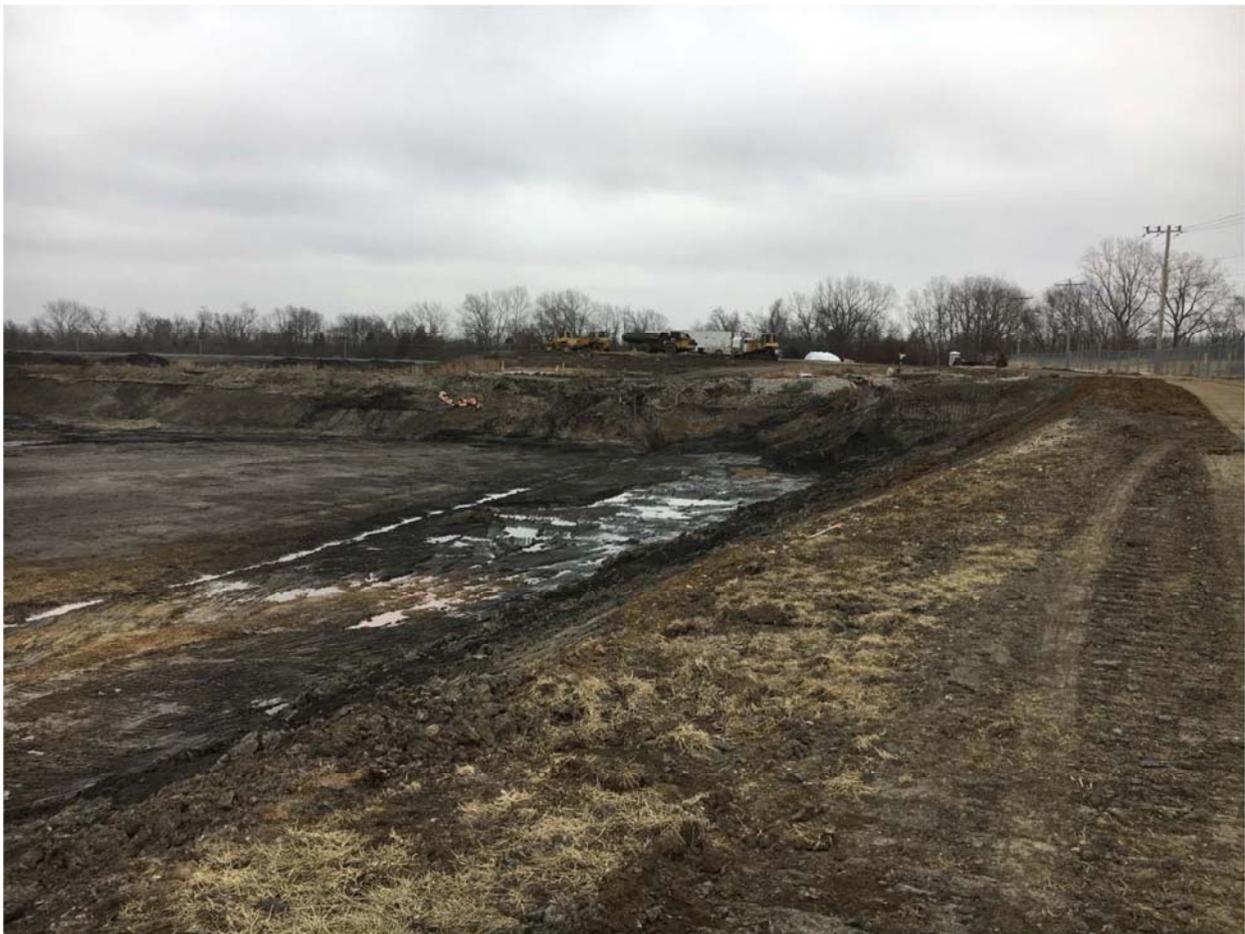
Figure 2: Southeast corner of sedimentation pond (facing east)

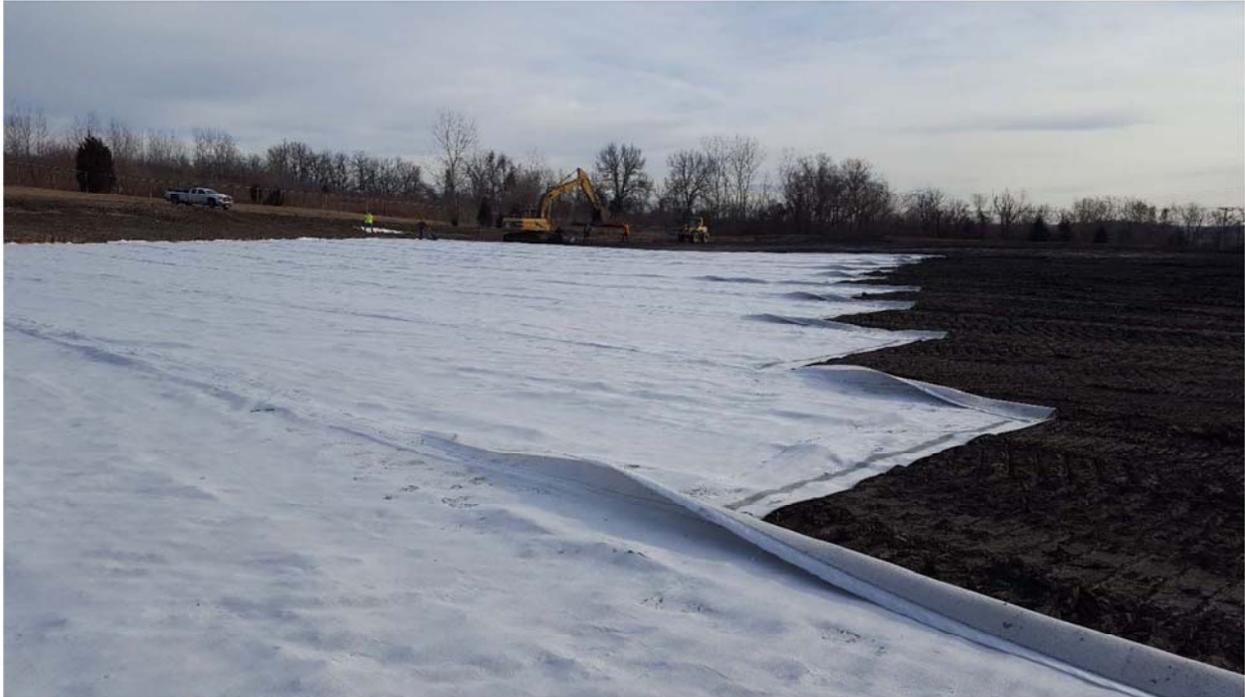
Figure 1: Placing BentoLiner GCL panels on the northeast fly ash pond (facing northeast)

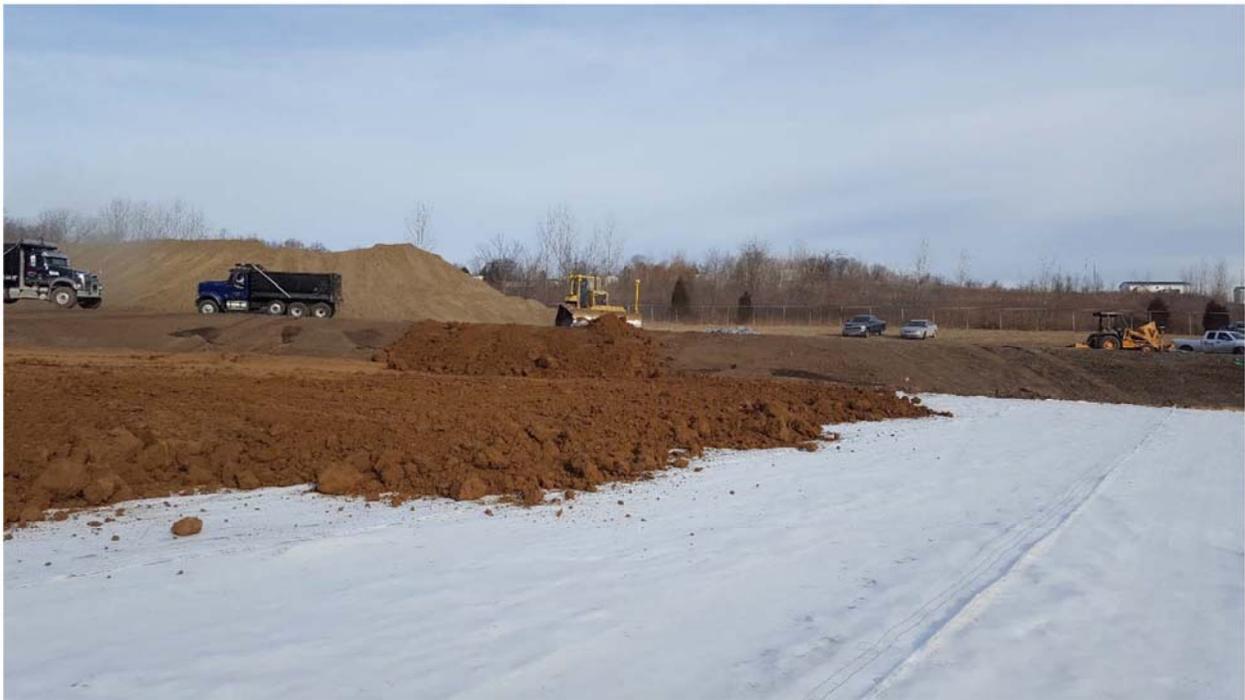
Figure 2: Dozer placing cover soil over the GCL panels in the north pond (facing northeast)

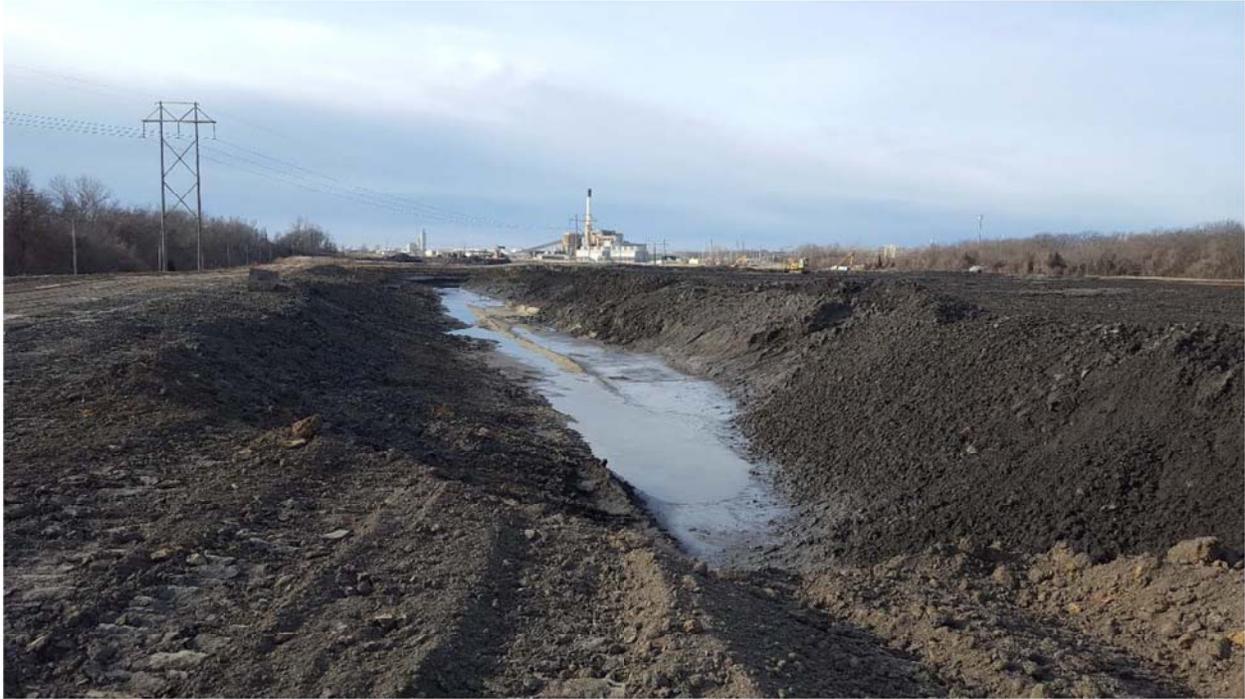
Figure 4: Fly ash graded out on the north pond (facing west)

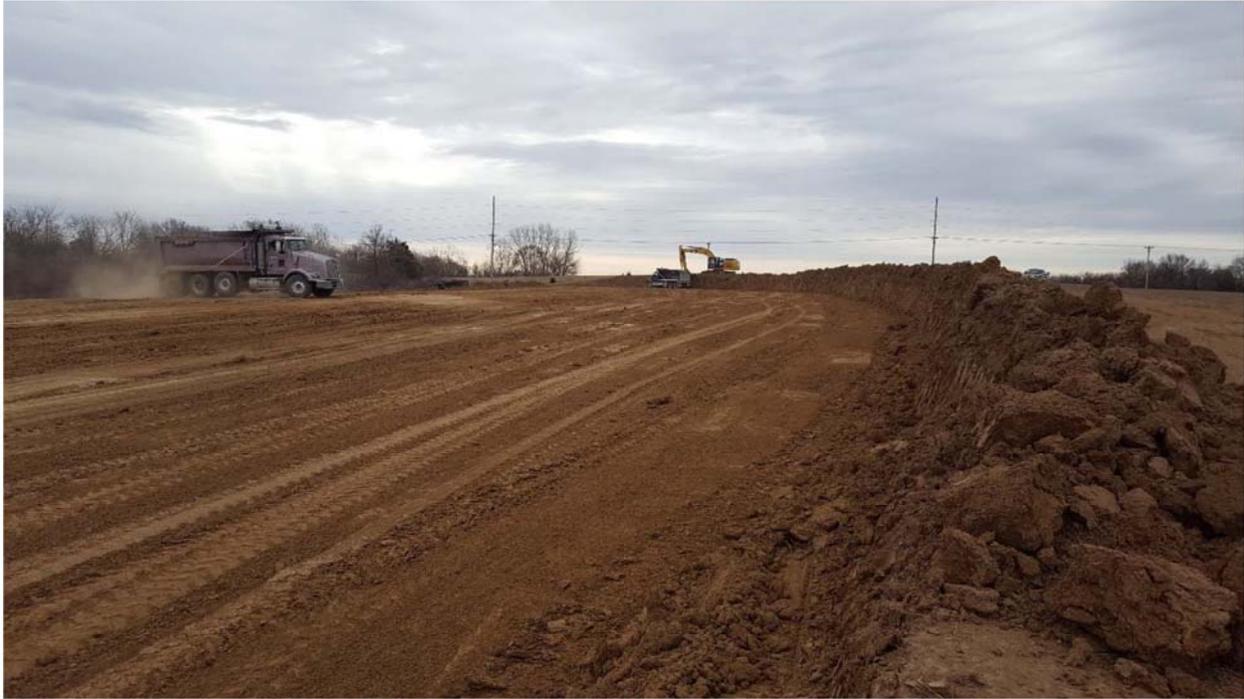
Figure 6: South area of the north fly ash pond still needing to be filled in and graded (facing west)

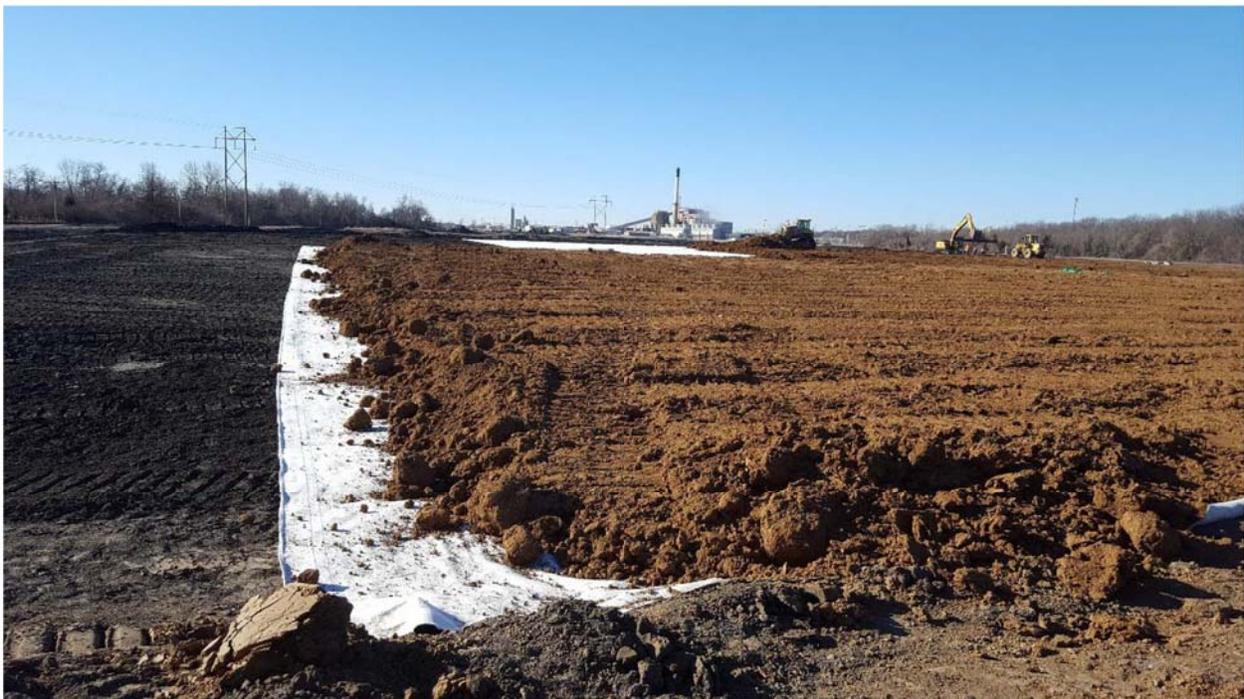
Figure 11: Placing bentonite powder between the long ends of the GCL panels (facing south)

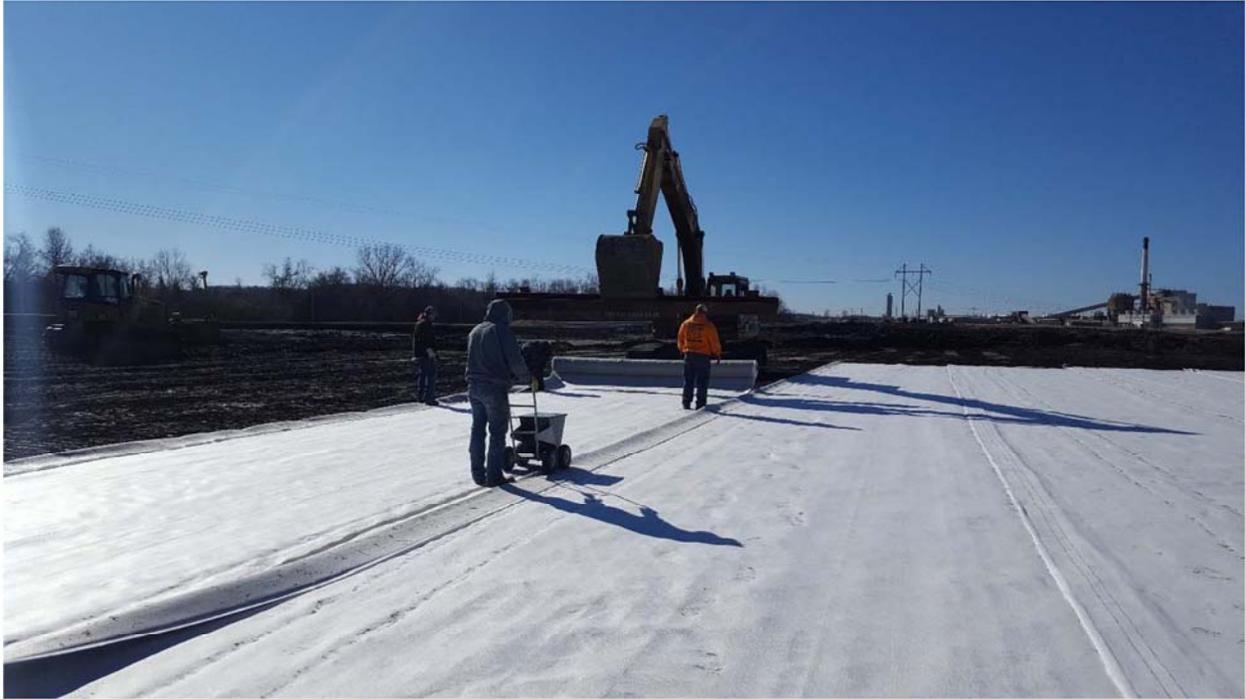
Figure 12: GCL panels placed on the north end of the north fly ash pond (facing southwest)
