## **Ash Impoundment Closure Report**

Independence Power & Light  
Blue Valley Power Station  
21500 East Truman Road  
Independence, Missouri 64056

**SCS ENGINEERS**  
7311 West 130th Street, Suite 100  
Overland Park, Kansas 66213  
(913) 681-0030

April 2018  
Revised June 2018  
File No. 27215142.00

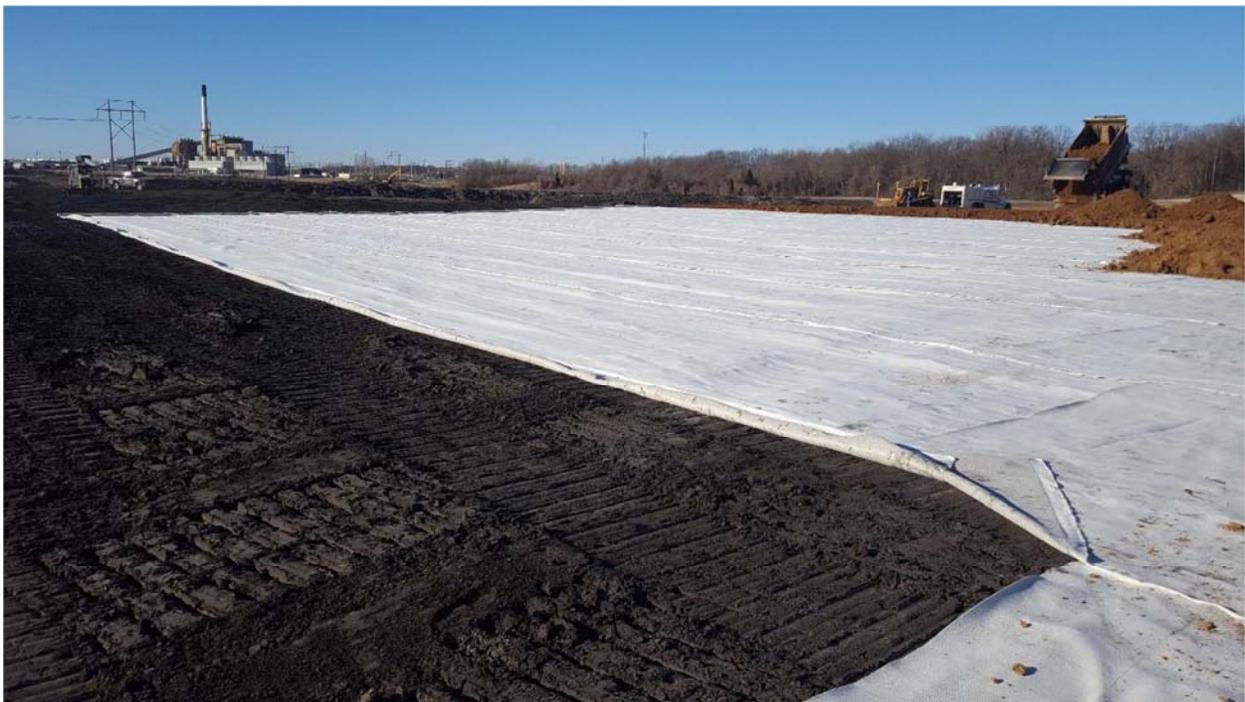
Figure 13: Deploying GCL rolls on the middle-east side of the north fly ash pond (facing south)

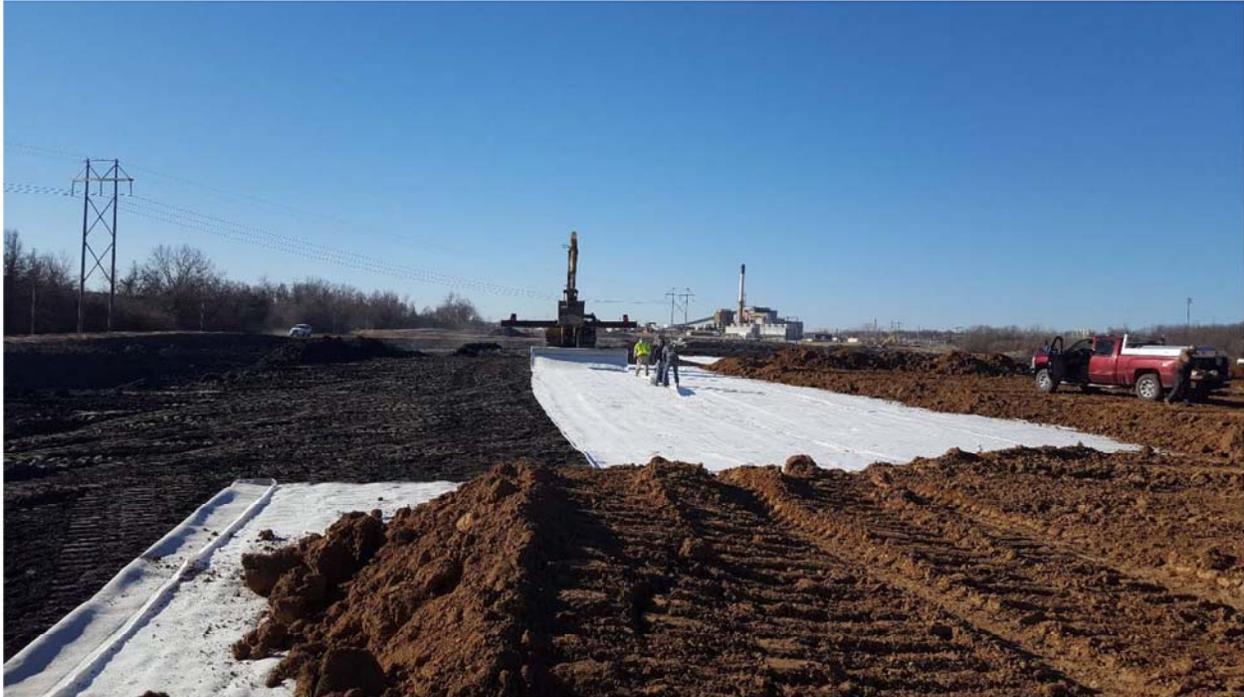
Figure 1: Overview of bottom sedimentation pond before clay liner installation (facing east)

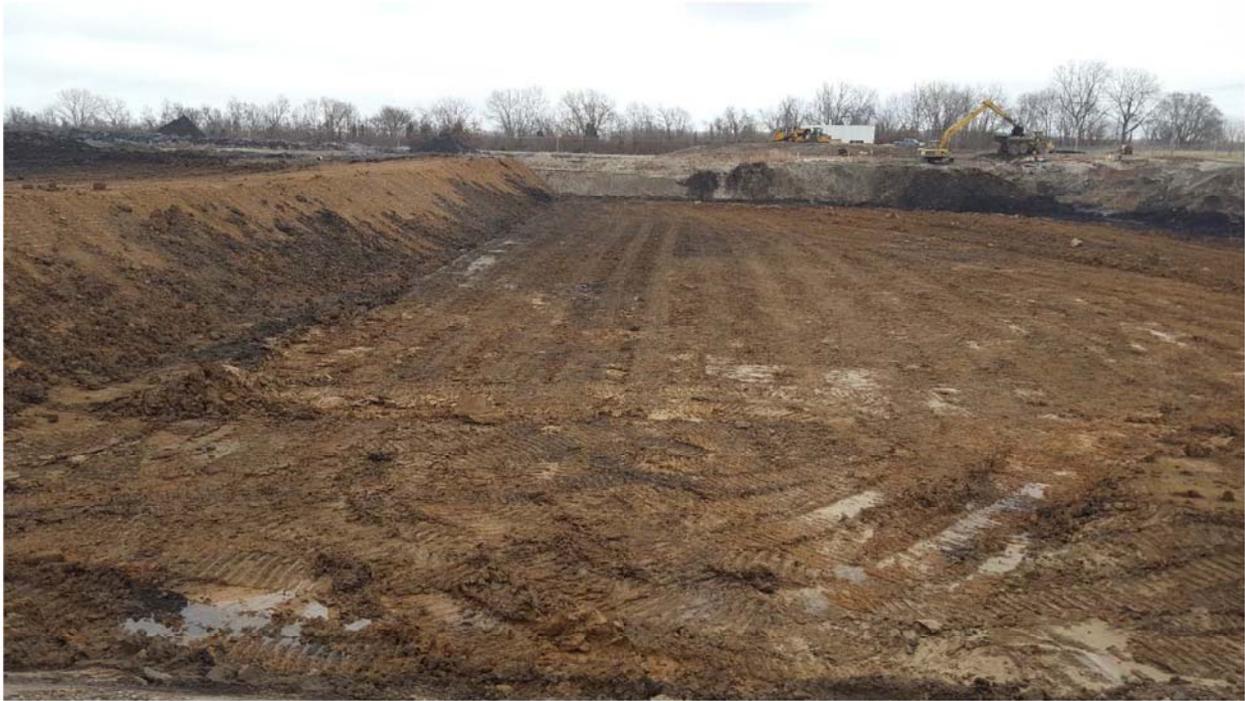
Figure 2: Excavating impacted soils from the southeast corner of the sedimentation pond (facing south)

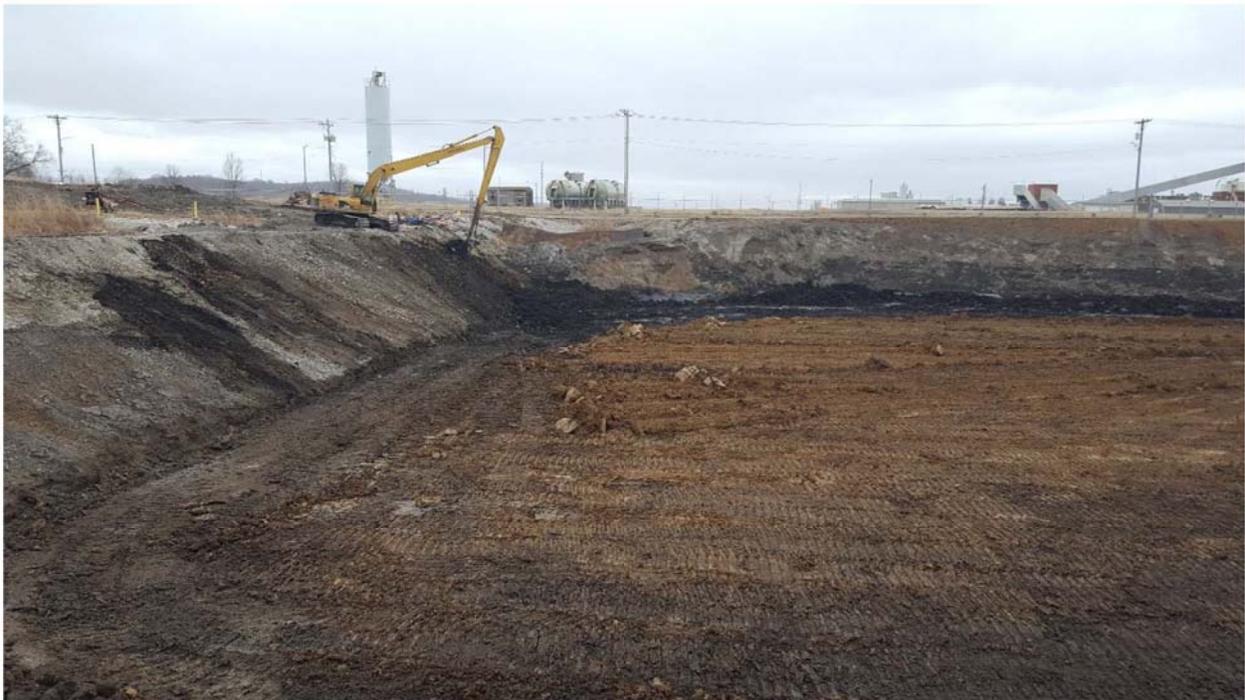
Figure 3: Impacted soils hauled to the north side of the north of the sedimentation pond berm in the bottom ash pond (facing northwest)

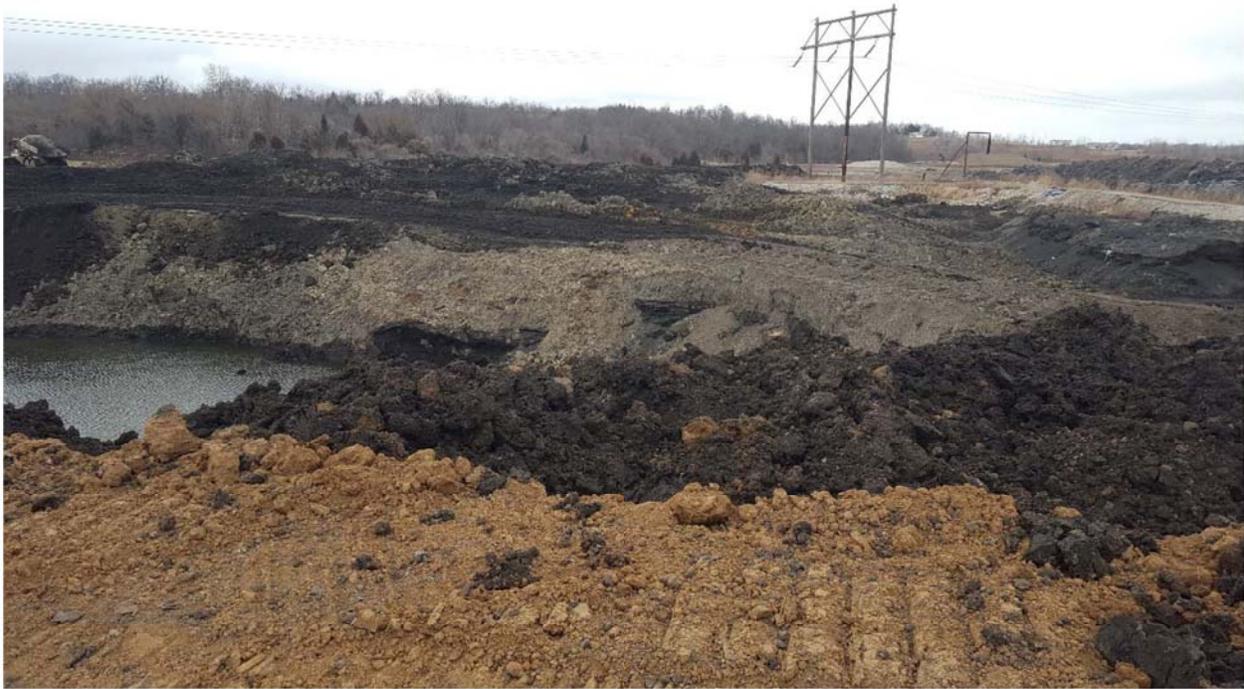
Figure 4: Dozer pushing clean brown clay to fill in excavated east area (facing southwest)

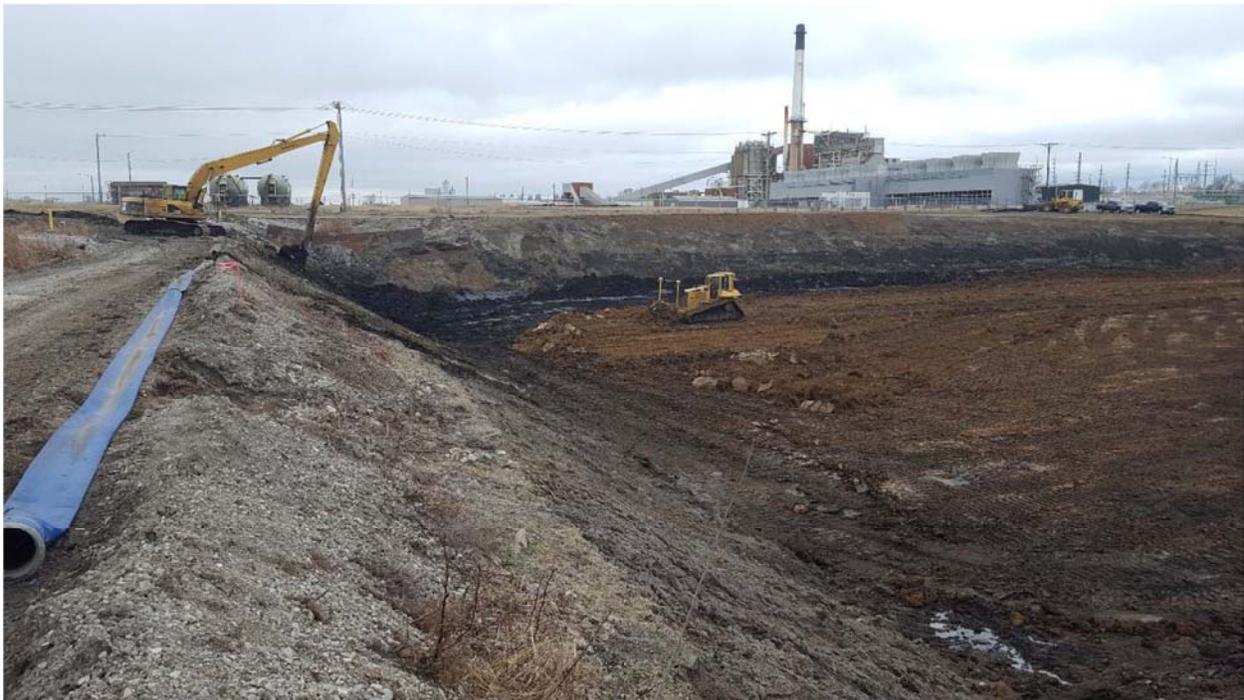
Figure 5: Placing clay to fill in the east trench of the north fly ash pond (facing north)

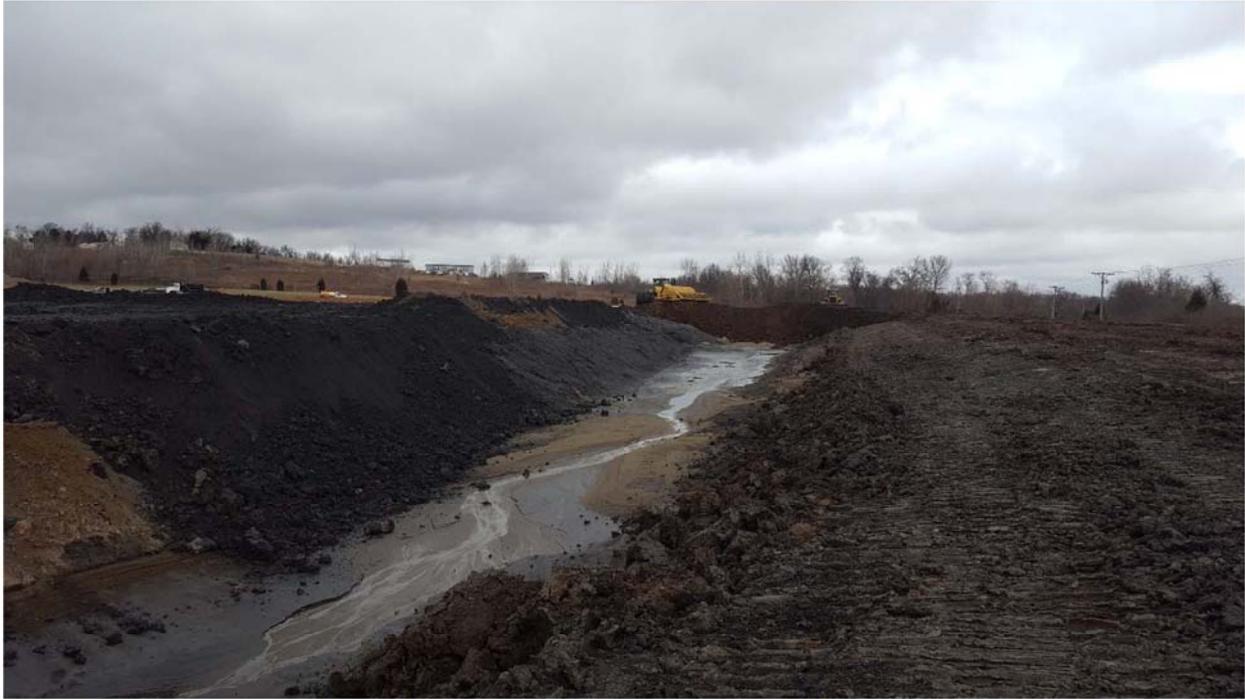
Figure 6: Hauling clay from the offsite borrow property to place compacted clay liner in bottom of sedimentation pond (facing northwest)

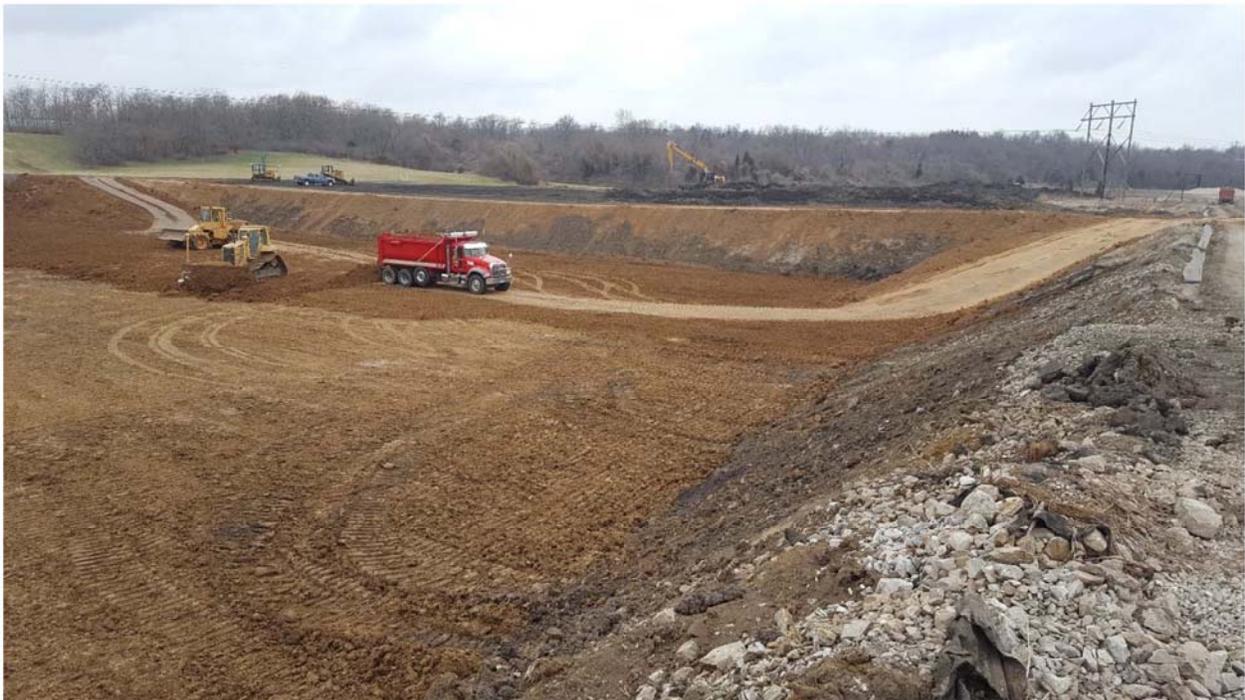
Figure 7: Compacting the clay liner lifts with a CAT 815B sheepsfoot compactor (facing southeast)

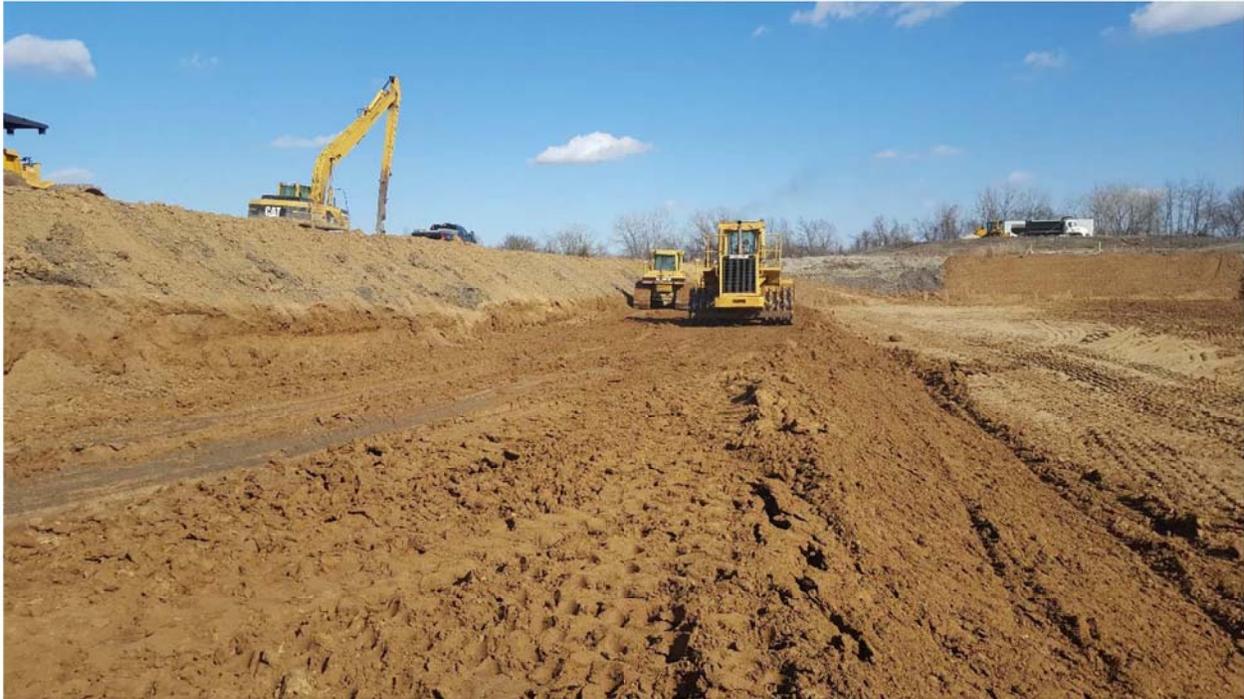
Figure 14: Overview of the clay liner on the bottom of the sedimentation pond (facing west)

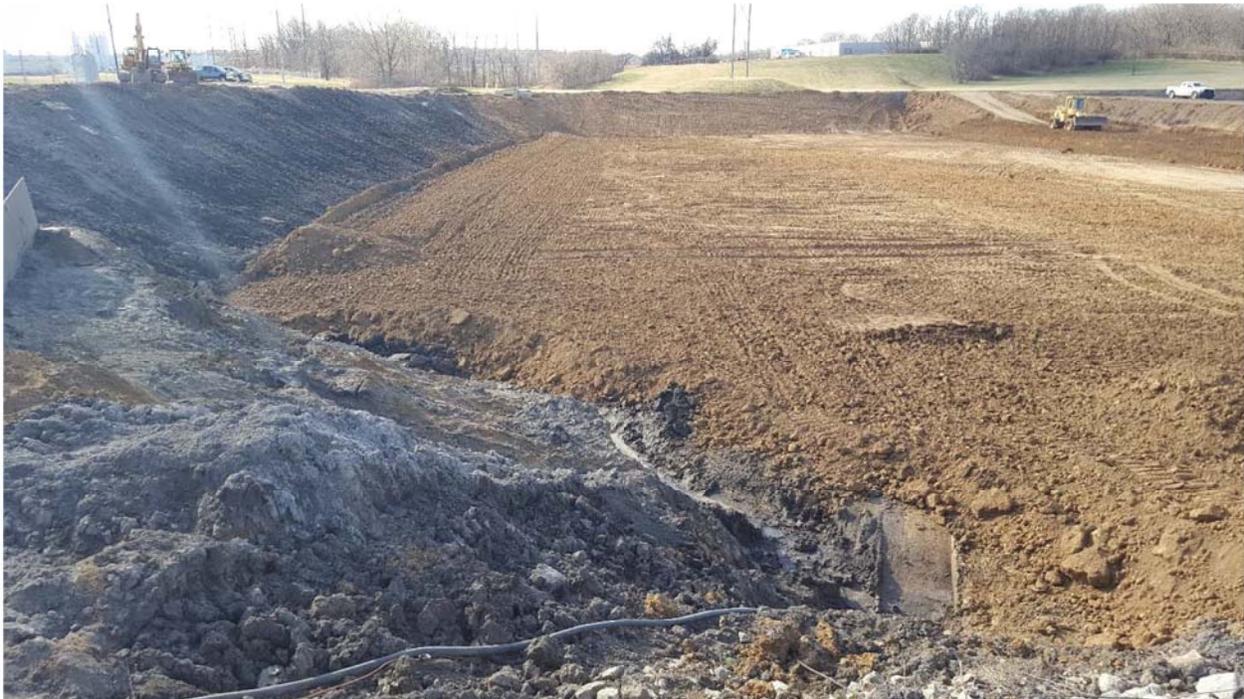
Figure 15: Overview of the construction of the south half of the north soil berm in the sedimentation pond (facing northwest)

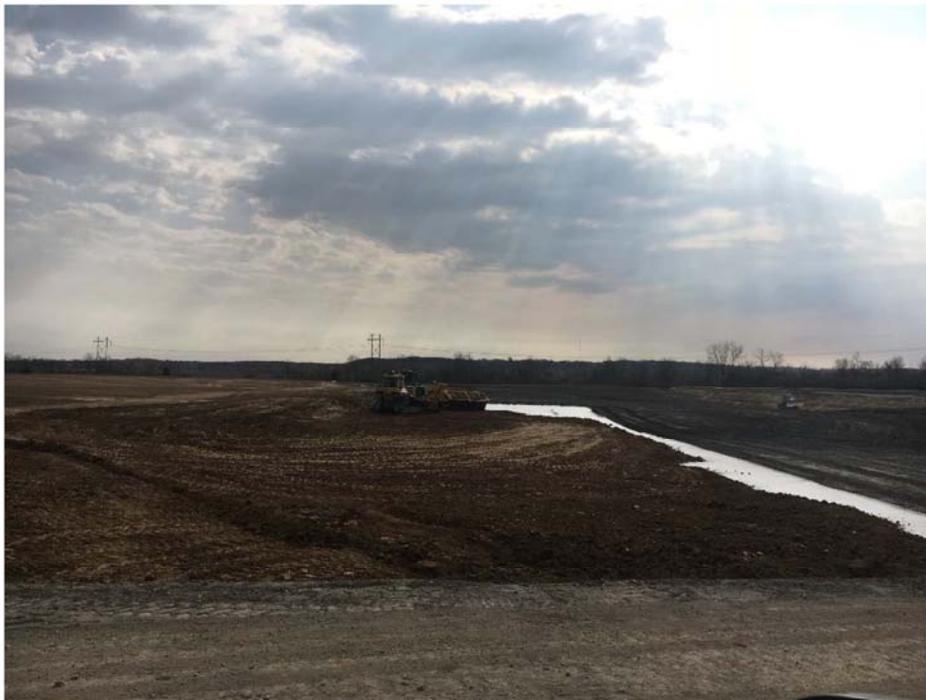
Figure 5: Deploying additional GCL in North Pond and placing bentonite between panel overlaps (facing east)

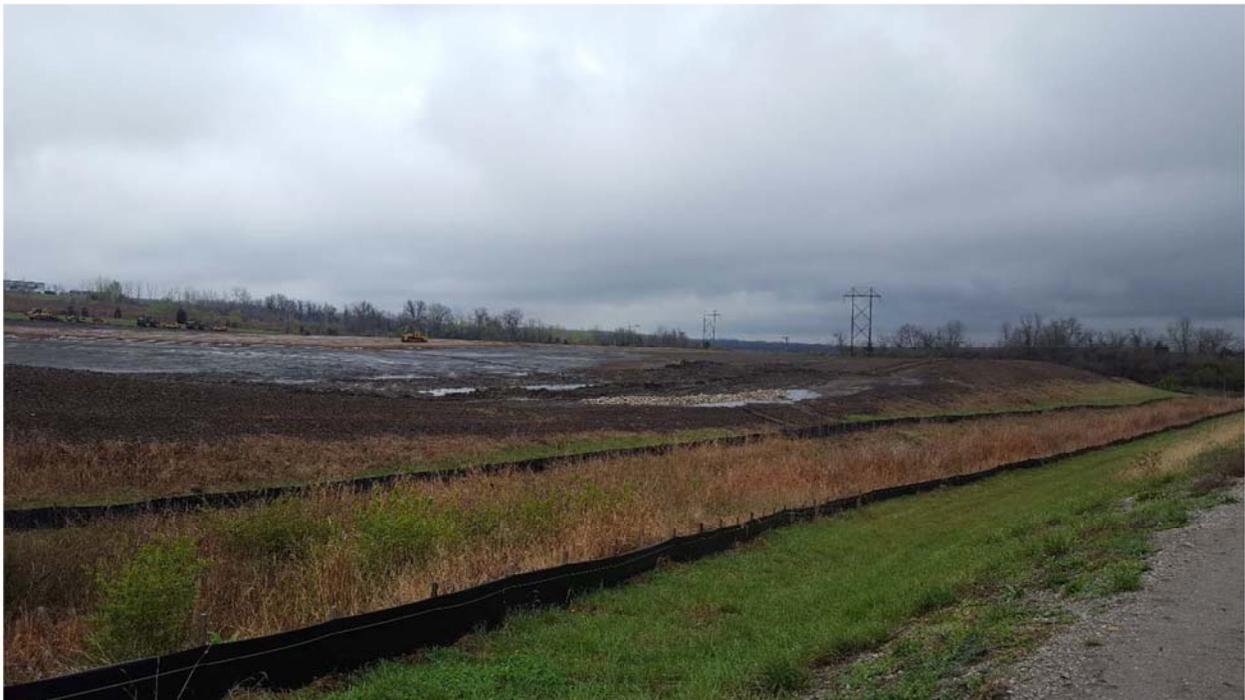
Figure 2: Overview of the south side of the north fly ash pond (facing east)

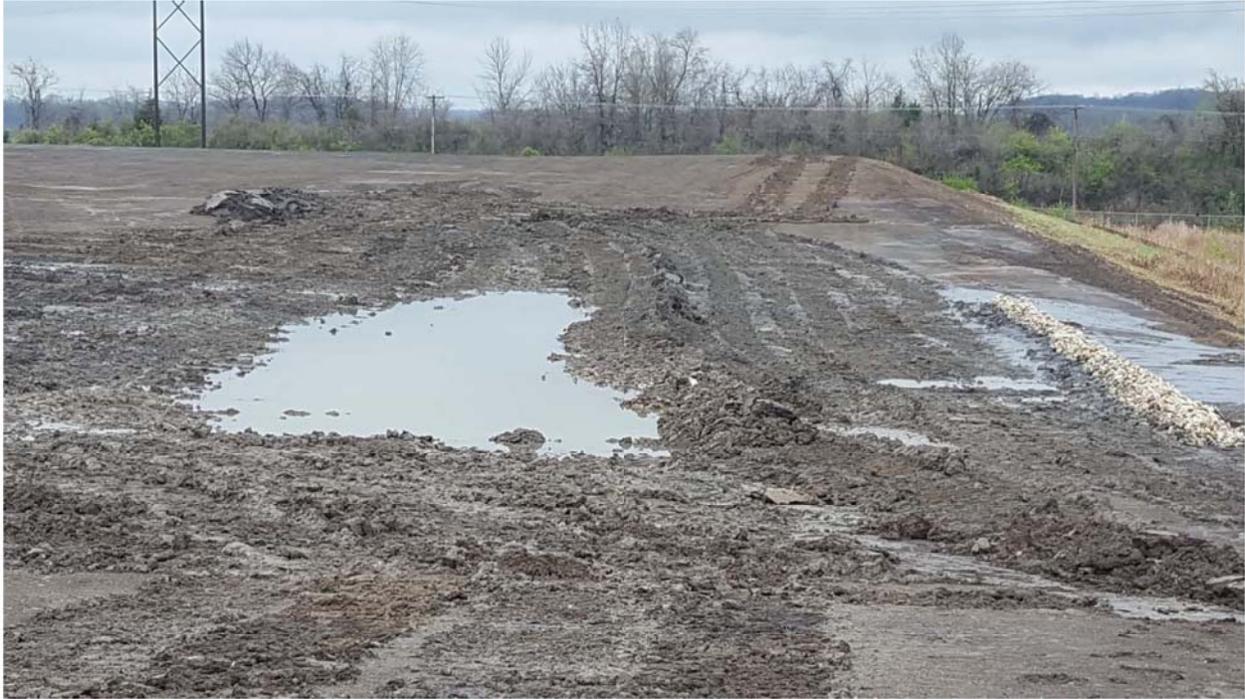
Figure 3: Temporary soil and rock berms put in place to prevent ash/silt run-off (facing east)

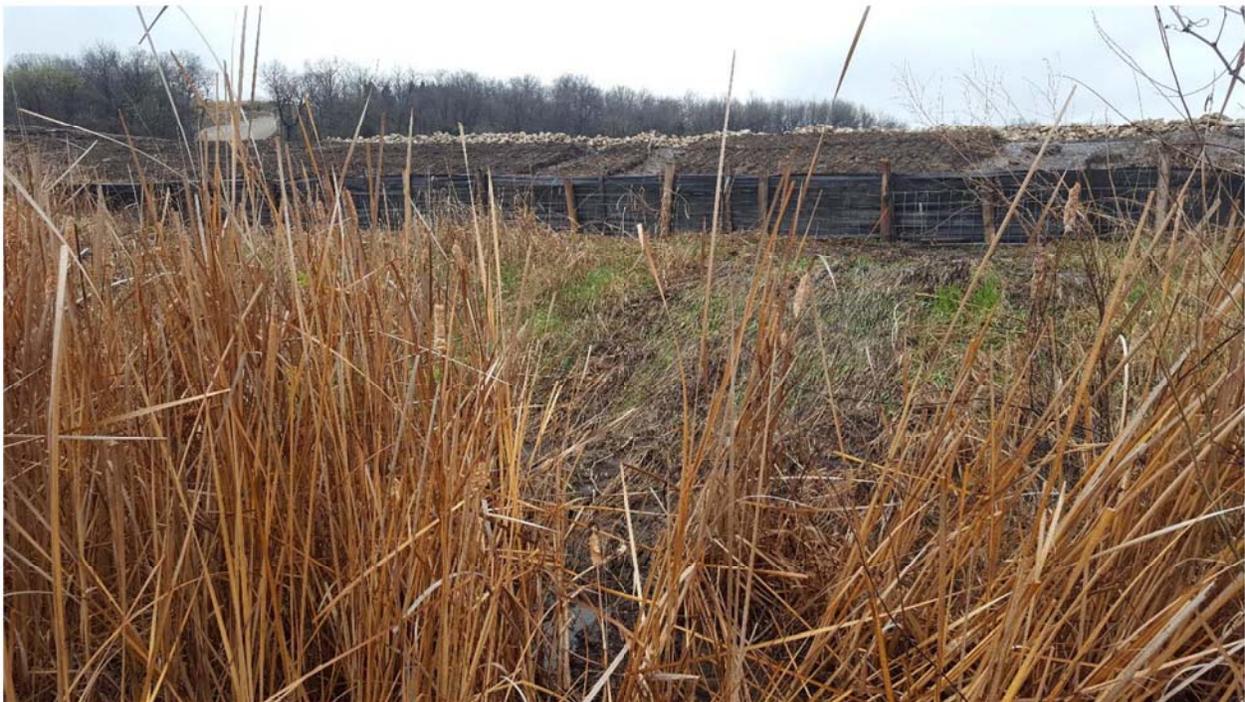
Figure 4: Silt fencing in-place on the south side of the north fly ash pond (facing northwest)

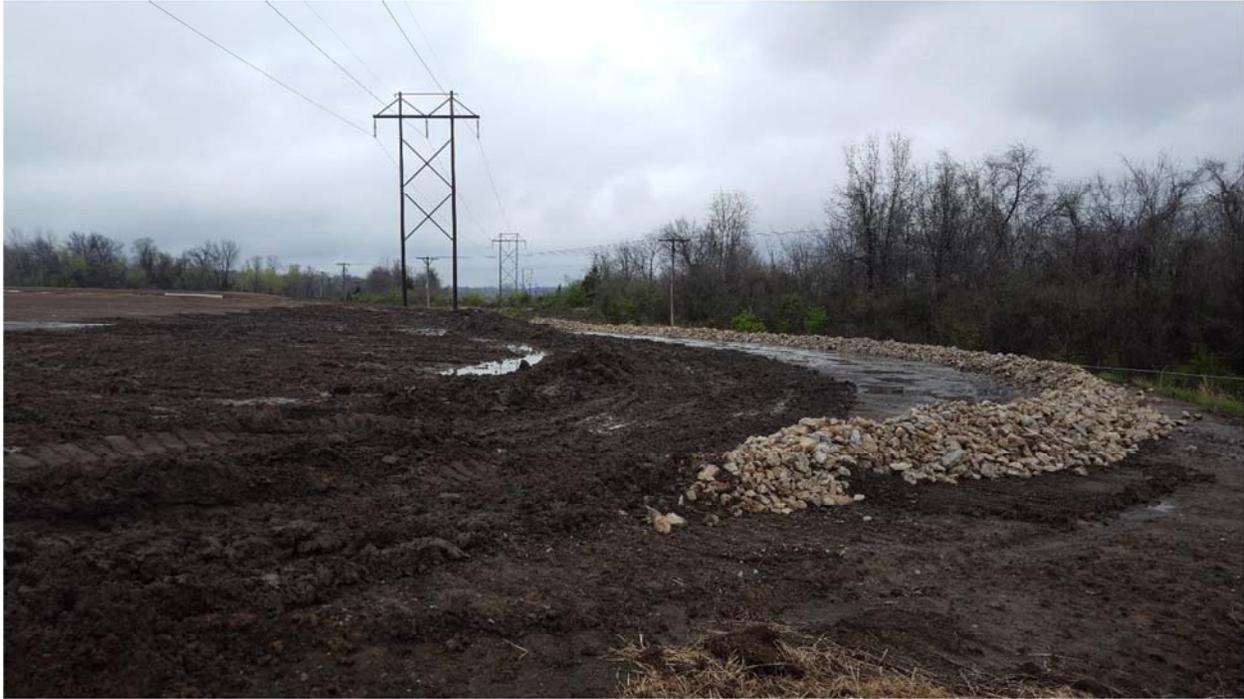
Figure 5: Soil and rock berms installed in the southeast corner of the north ash pond (facing northeast)

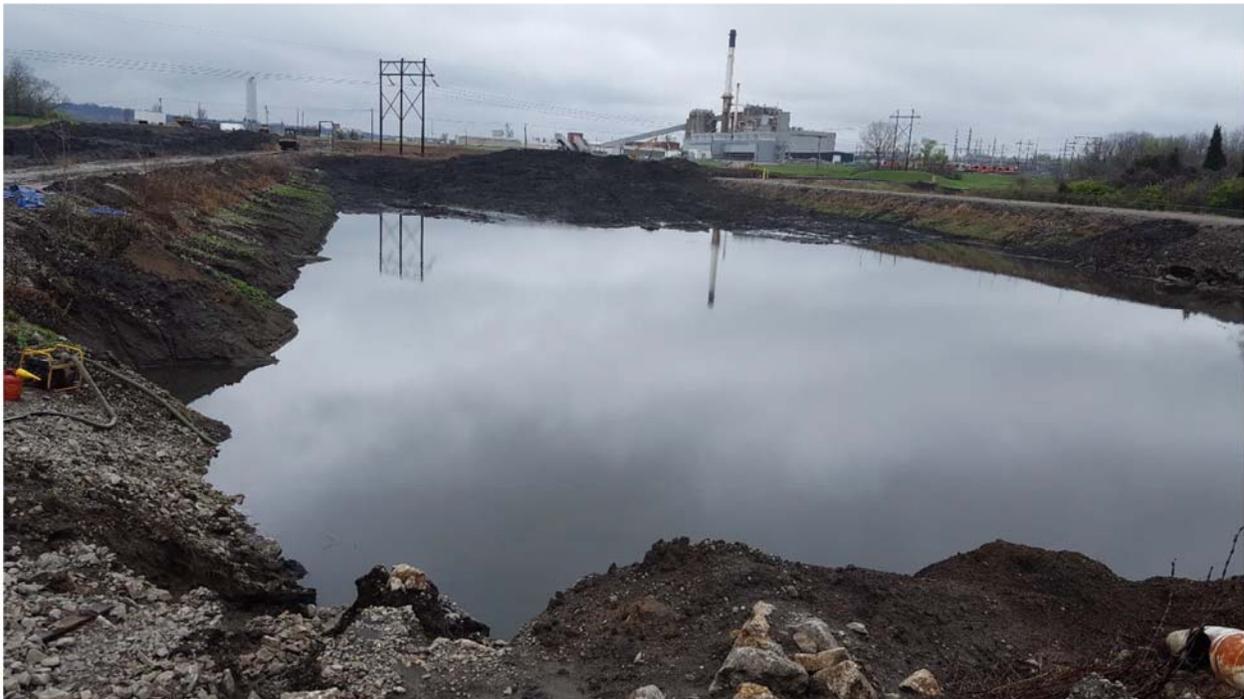
Figure 6: Southwest bottom ash pond with accumulated standing water (facing south)

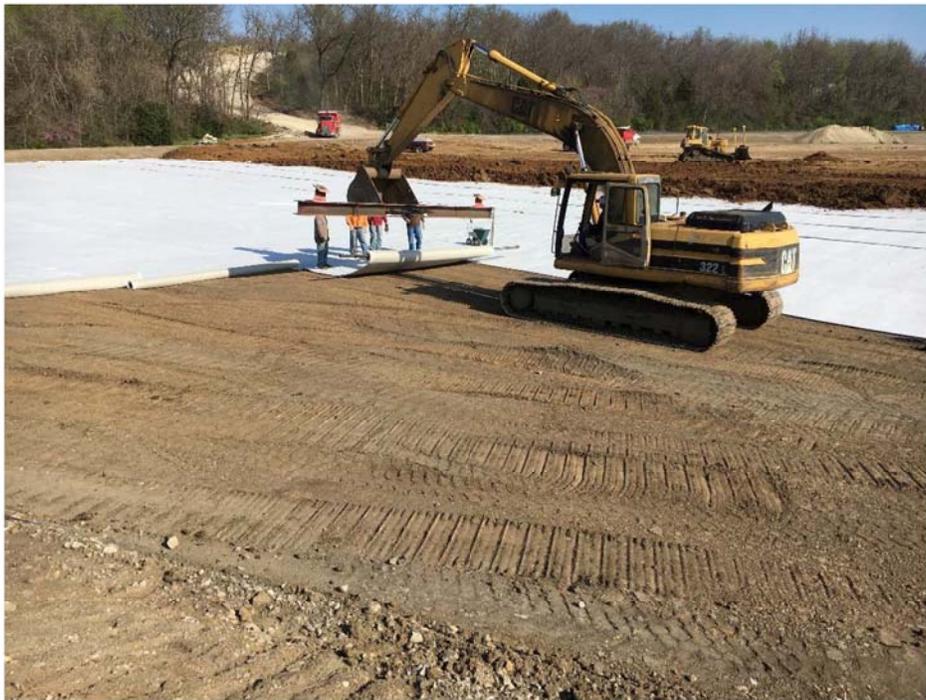
Figure 1: GCL panels being deployed in southwest corner of north fly ash pond (facing northwest)

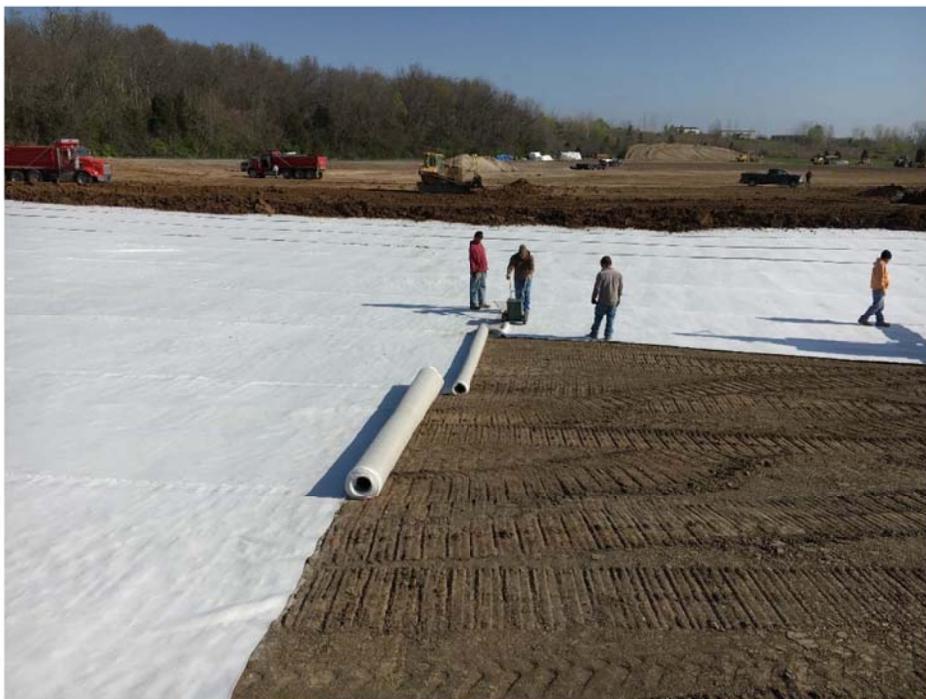
Figure 2: Granular bentonite placement between GCL overlap

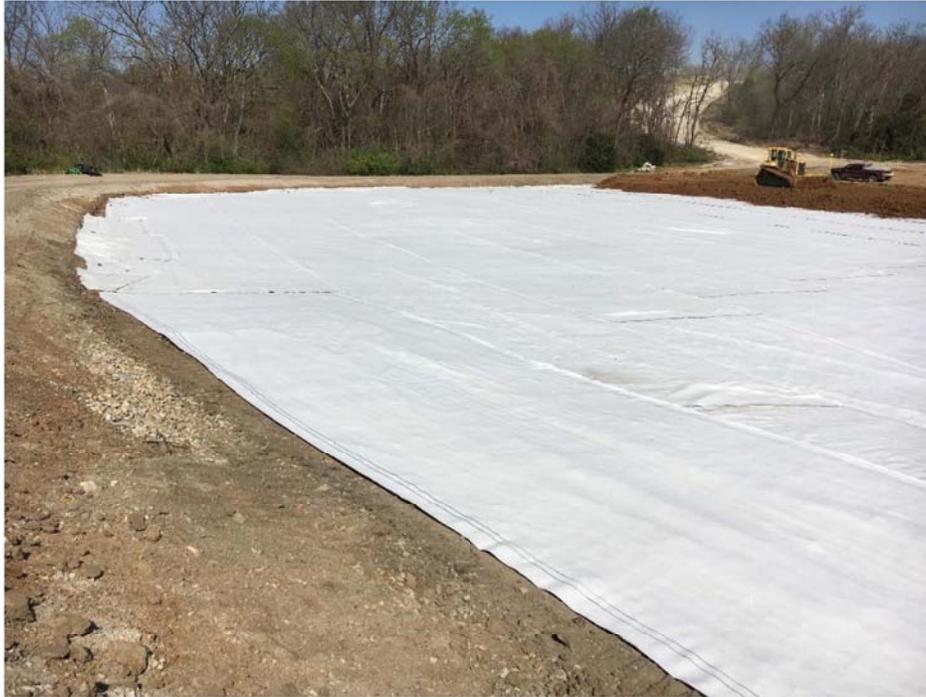
Figure 3: GCL deployed in the southwest corner of the north ash pond and Dozer placing 1 foot minimum soil over GCL (facing northwest)

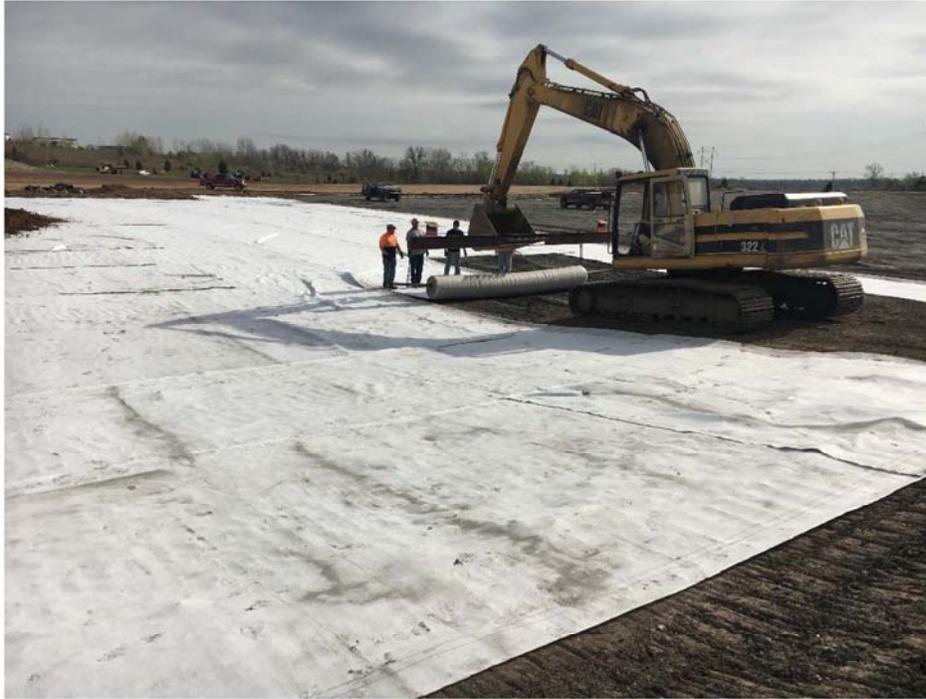
Figure 5: Deploying additional GCL in North Pond up to the boundary of the CAR GCL (facing northeast)

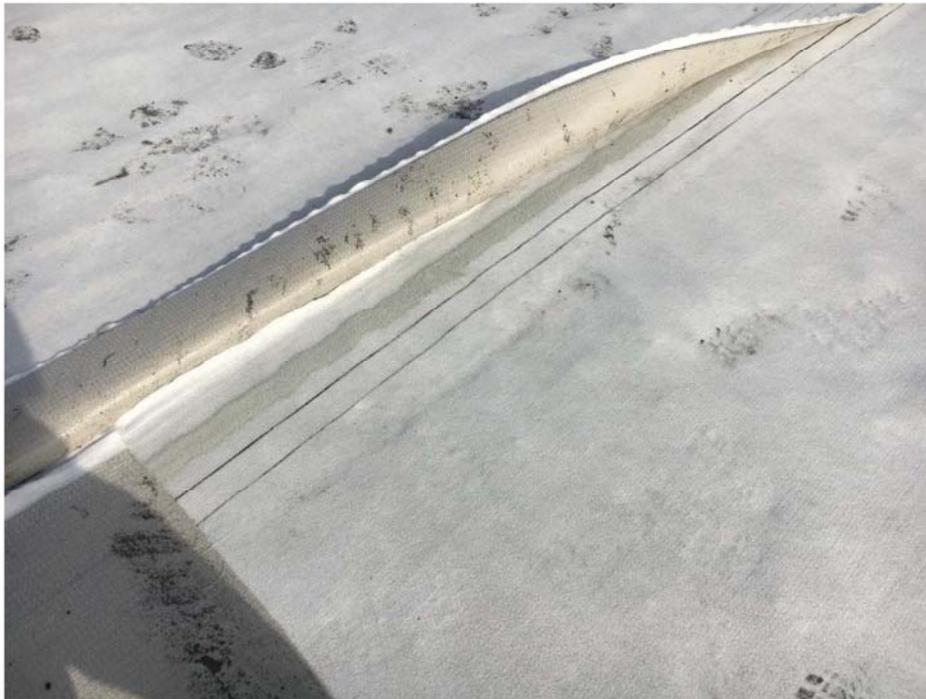
Figure 6: Granular bentonite placed between GCL panel overlap.

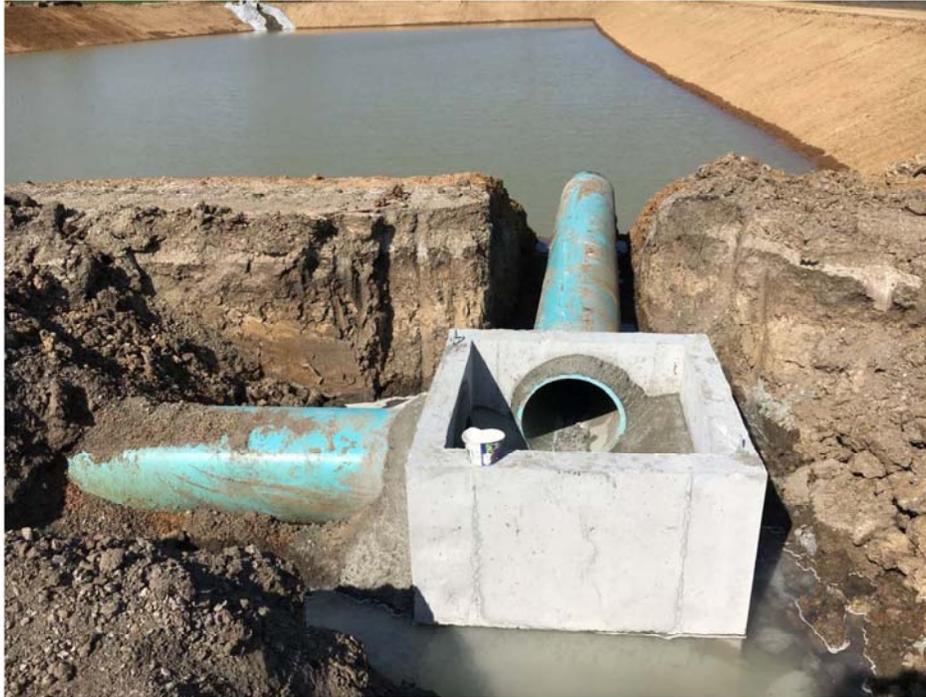
Figure 7: Discharge pipe and manhole near the northeast corner of the sedimentation basin.  
(facing west – 4/11/2017)

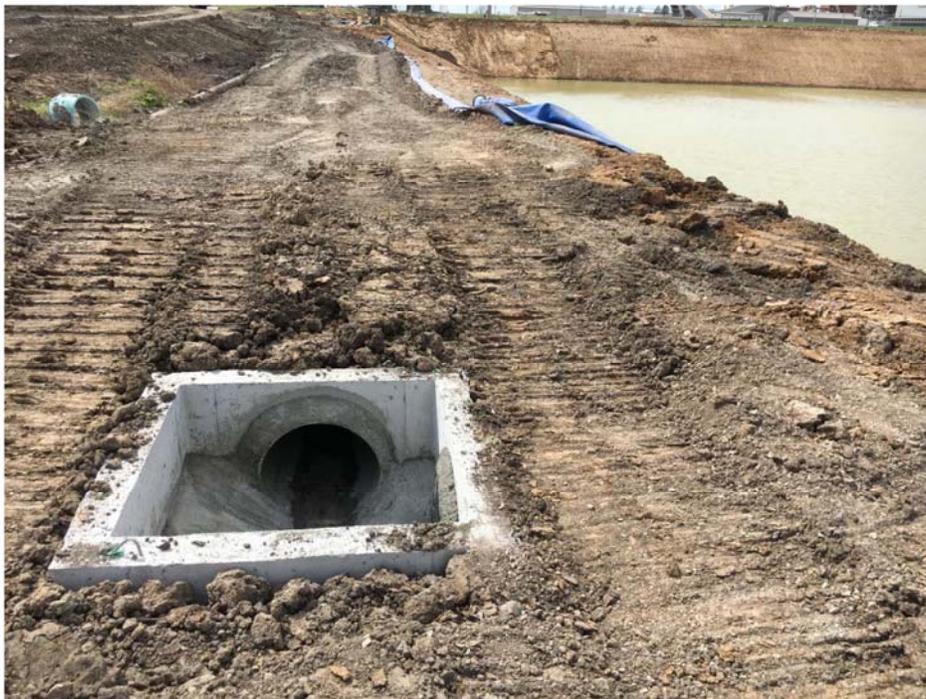
Figure 8: Backfilled around manhole of sedimentation basin discharge pipe.  
(facing south – 4/12/2017)

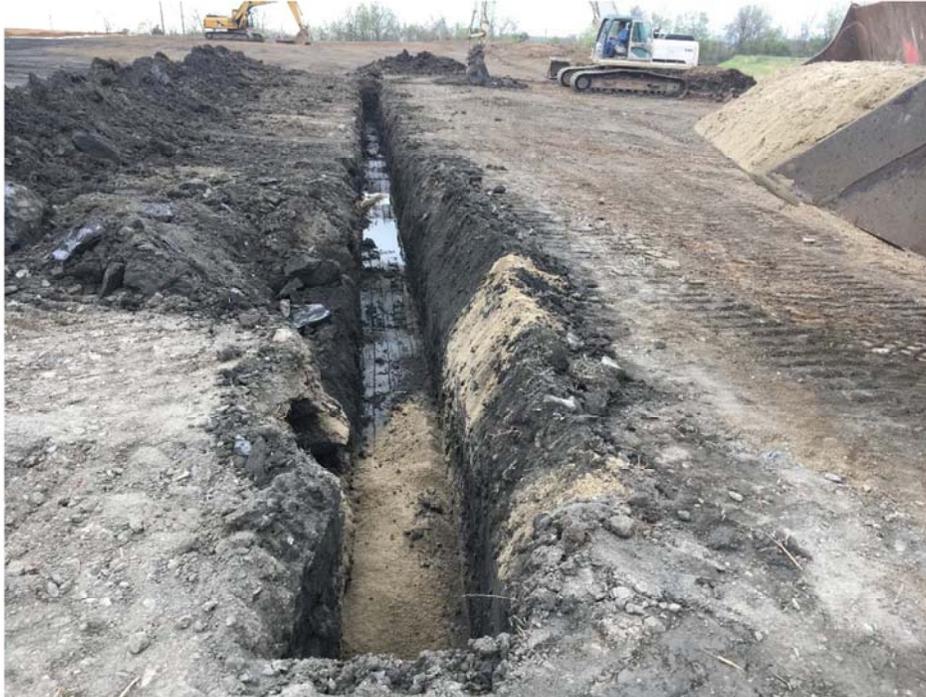
Figure 1: Excavation of pressure relief pipe trench in the North Pond south discharge area. (facing east)

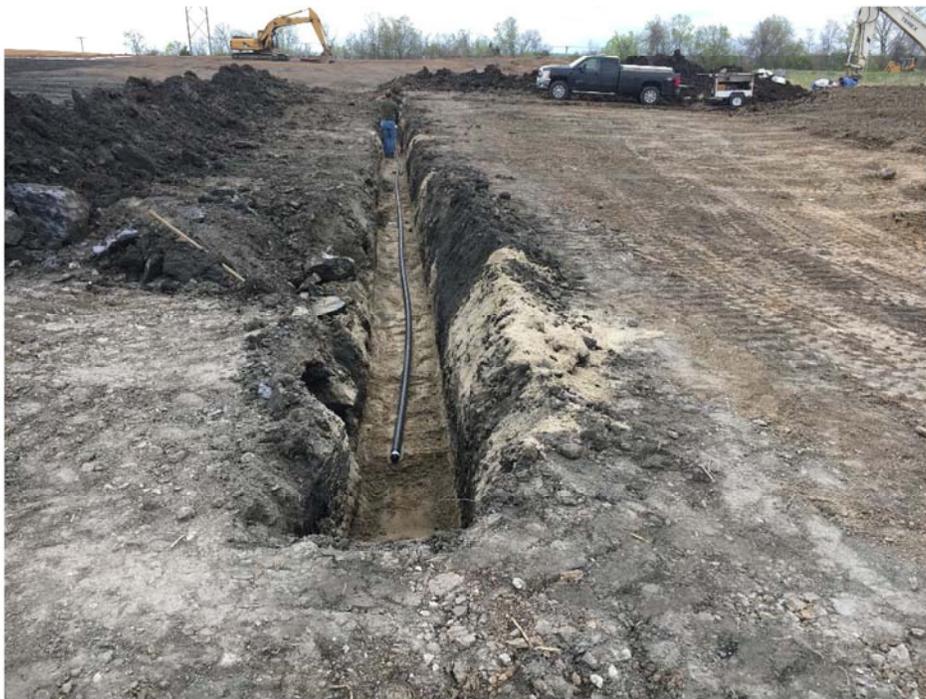
Figure 2: Slotted SDR 11 HDPE pipe installed on top of sand bedding in the North Pond south discharge area trench. (facing east)

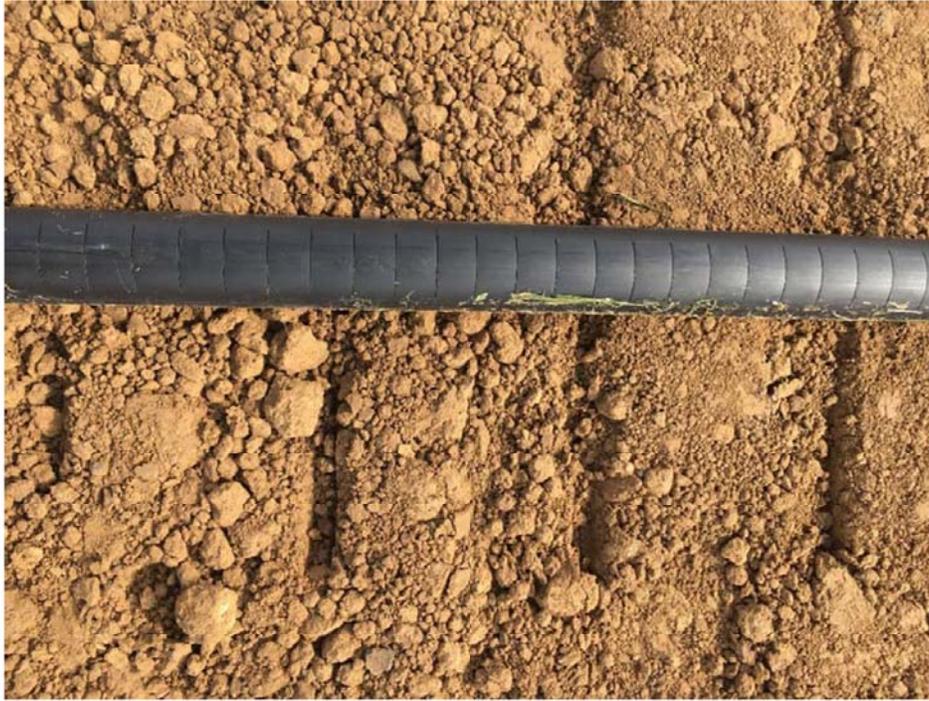
Figure 3: Slotted SDR 11 HDPE pipe.

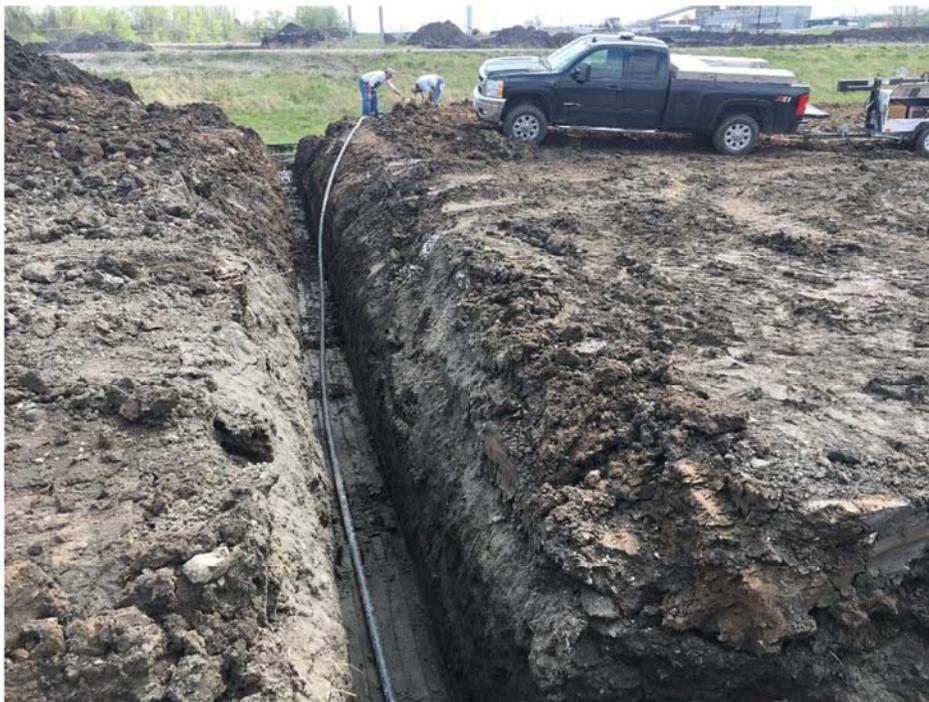
Figure 4: Installing solid HDPE SDR pipe through the North Pond south berm. (facing south)

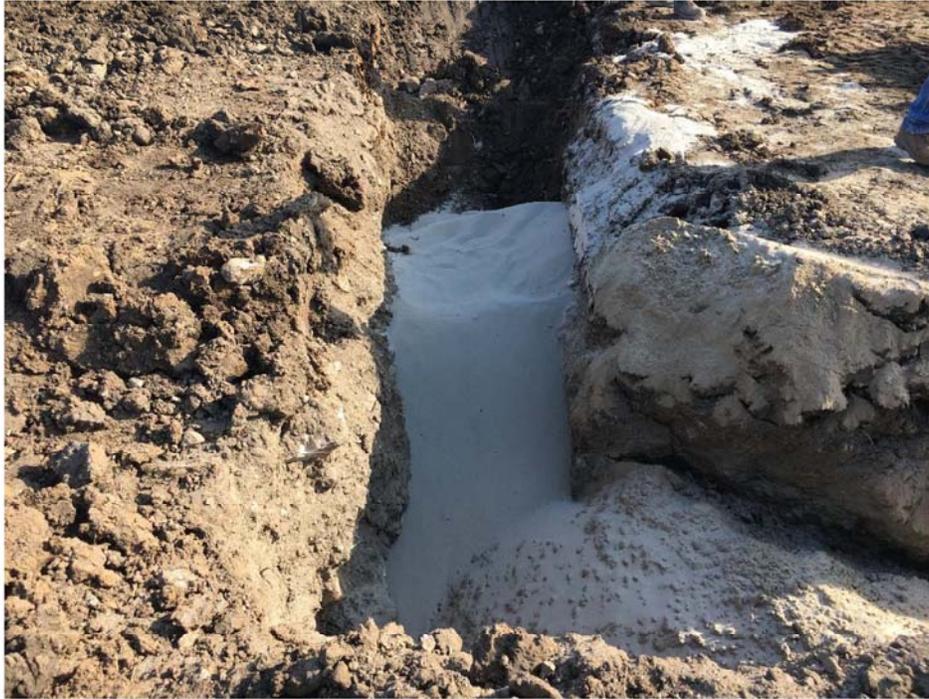
Figure 5: Bentonite plug at solid pipe transition. (facing south)

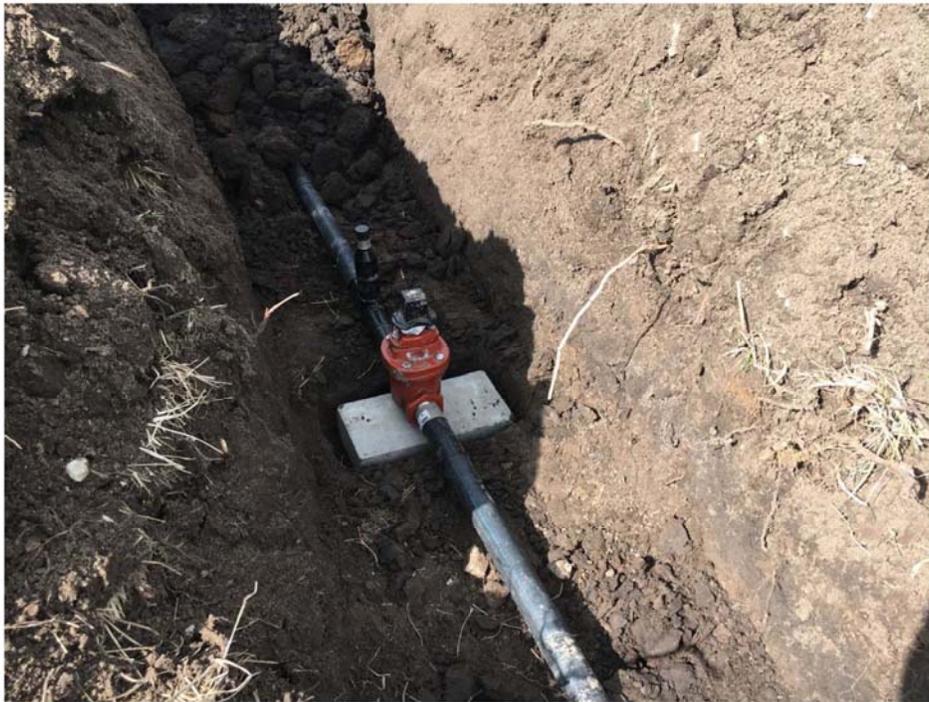
Figure 6: Valve located on solid pipe located near where the pipe daylights through the embankment 1" pressure release port located before valve. (facing north)
