## **Ash Impoundment Closure Report**

Independence Power & Light  
Blue Valley Power Station  
21500 East Truman Road  
Independence, Missouri 64056

**SCS ENGINEERS**  
7311 West 130th Street, Suite 100  
Overland Park, Kansas 66213  
(913) 681-0030

April 2018  
Revised June 2018  
File No. 27215142.00

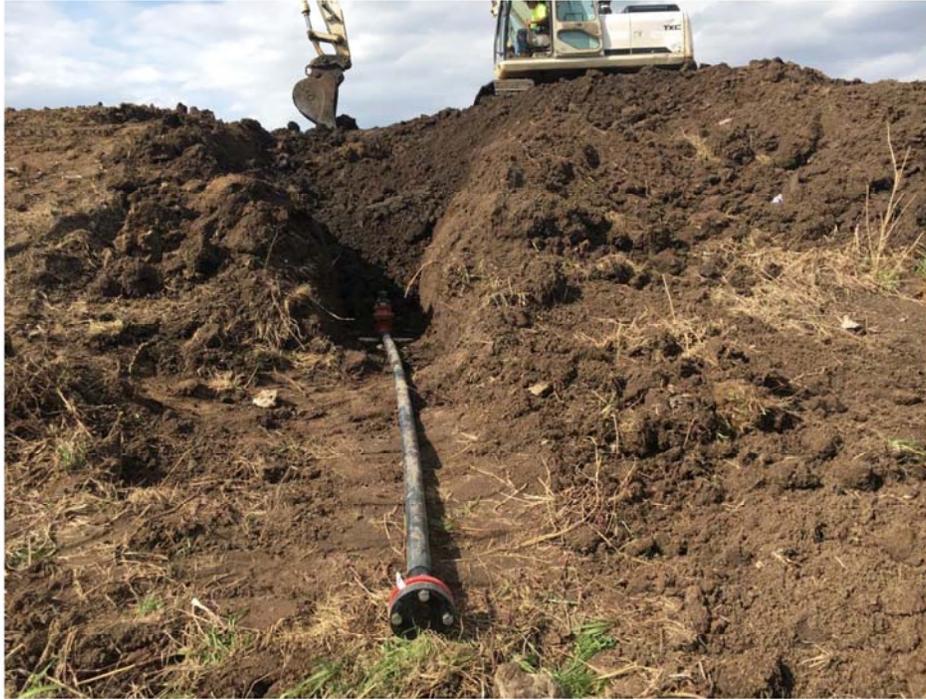
Figure 7: Flange location of solid pipe. (facing north)

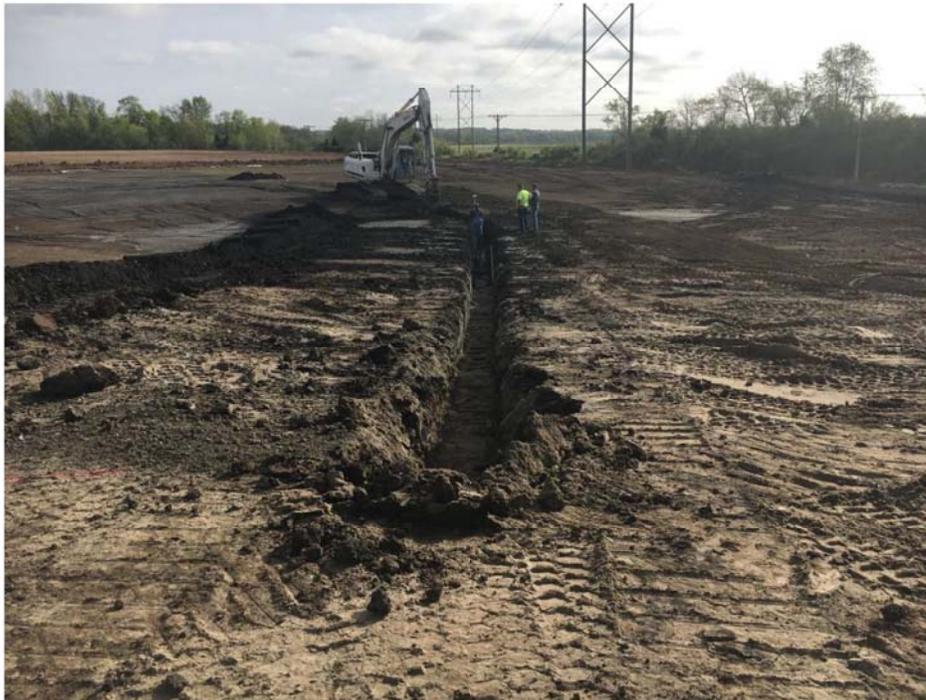
Figure 8: Excavation of the North Pond's southeast discharge area pressure relief pipe trench.  
(facing northeast)

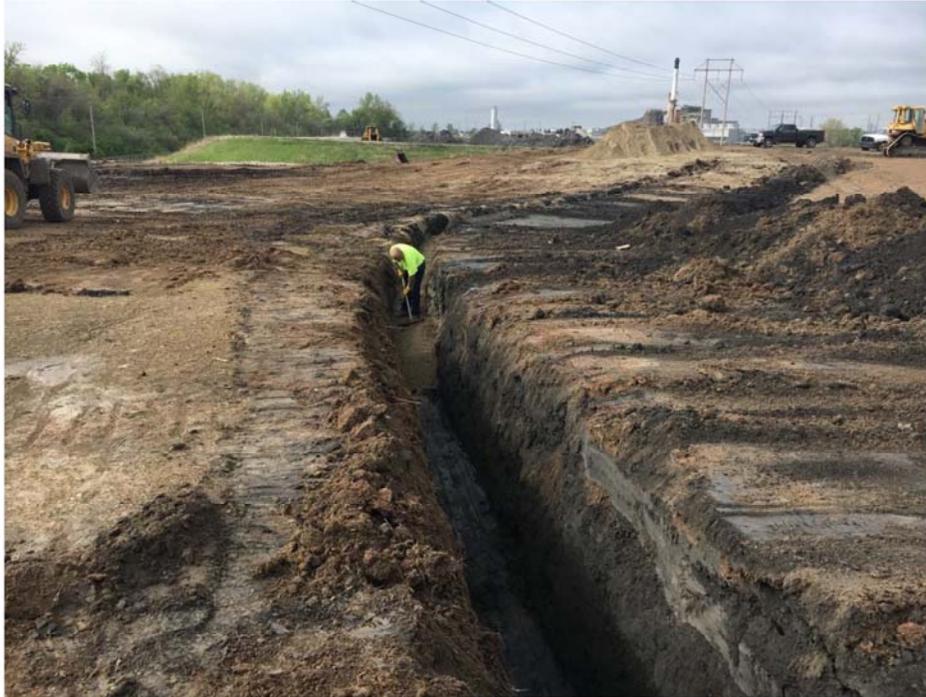
Figure 9: Placement of sand bedding in the North Pond's southeast discharge area pressure relief system pipe trench. (facing south)

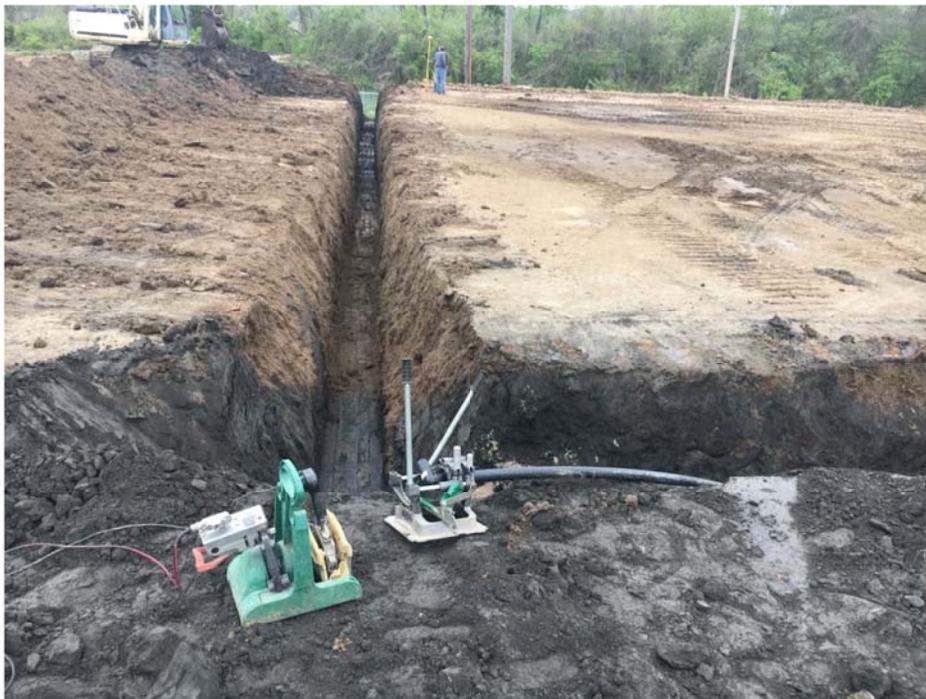
Figure 10: North Pond's southeast discharge area, solid pipe trench extending through the east embankment. Fusion welding elbow to connect solid pipe to slotted pipe. (facing north)

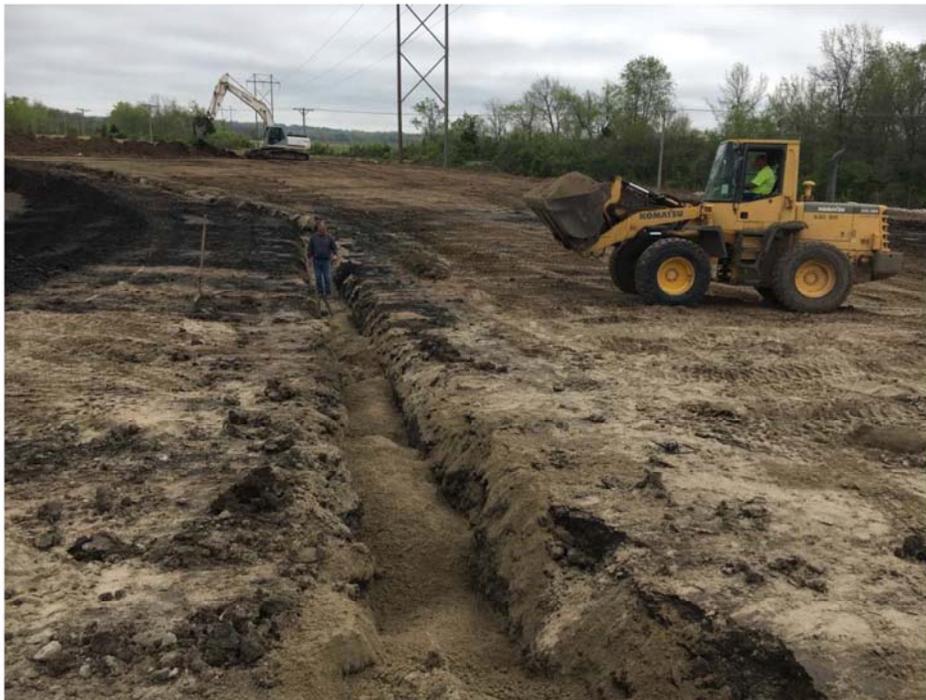
Figure 11: Placement of sand bedding over the top of the slotted pipe. (facing northeast)

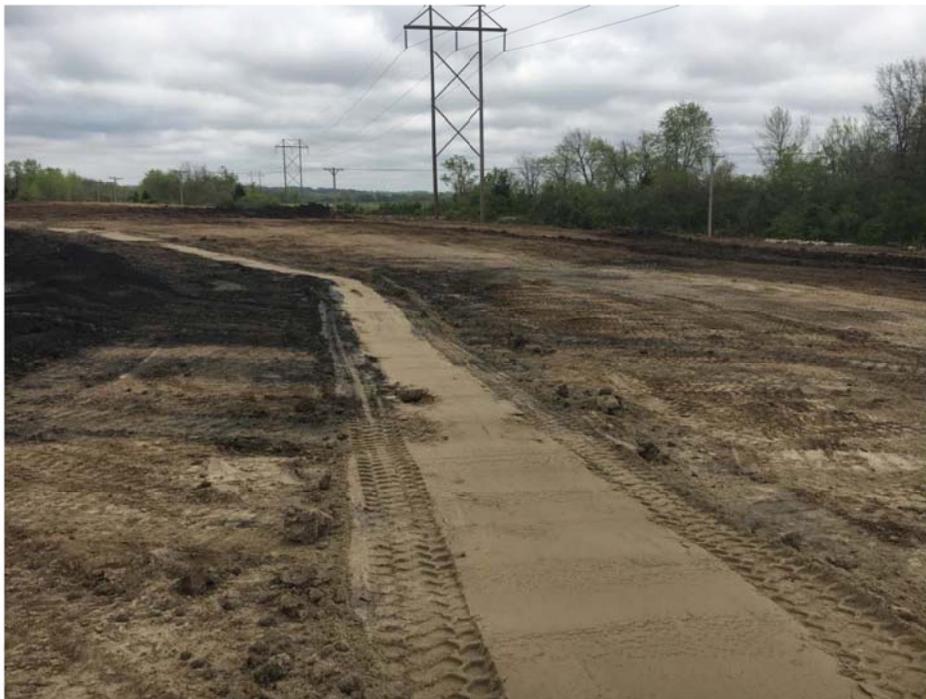
Figure 12: Slotted pipe trench backfilled with sand. (facing northeast)

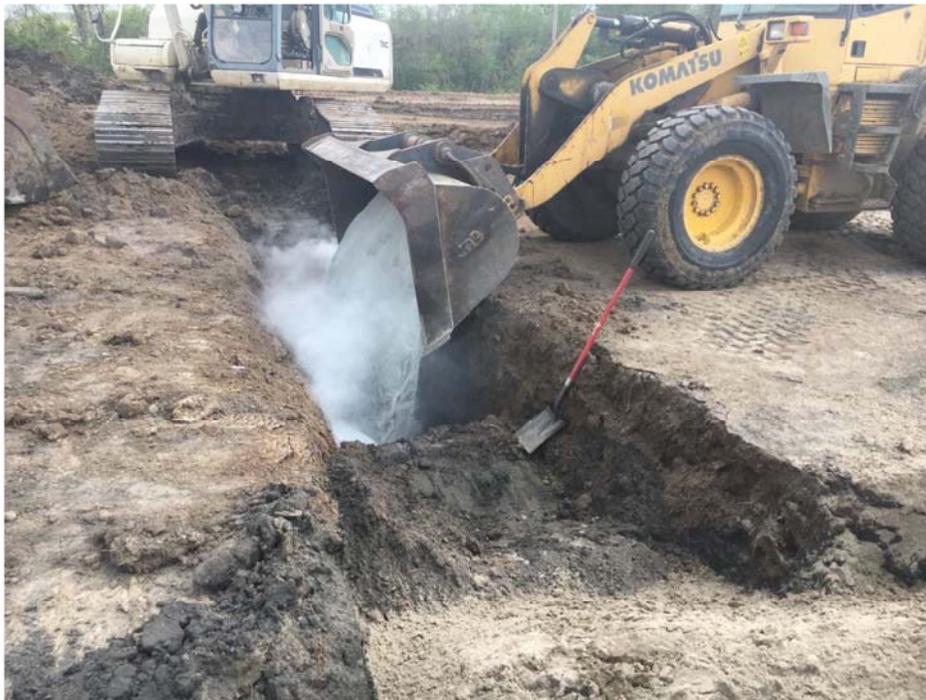
Figure 13: Placement of bentonite plug near solid pipe transition. (facing east)

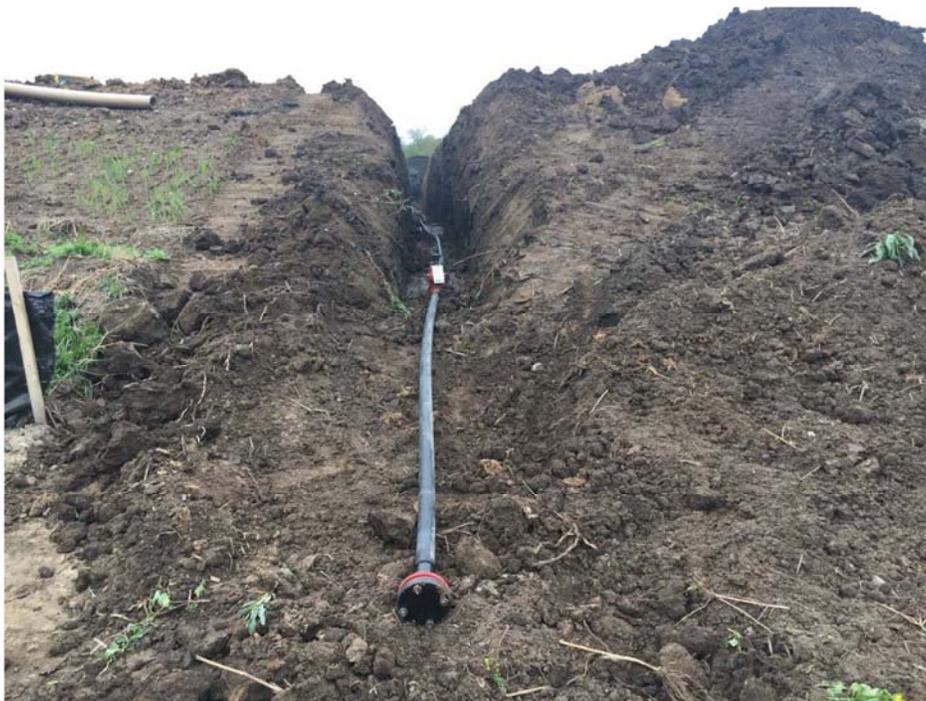
Figure 14: Solid pipe daylight location with valve and flange cap. (facing west)

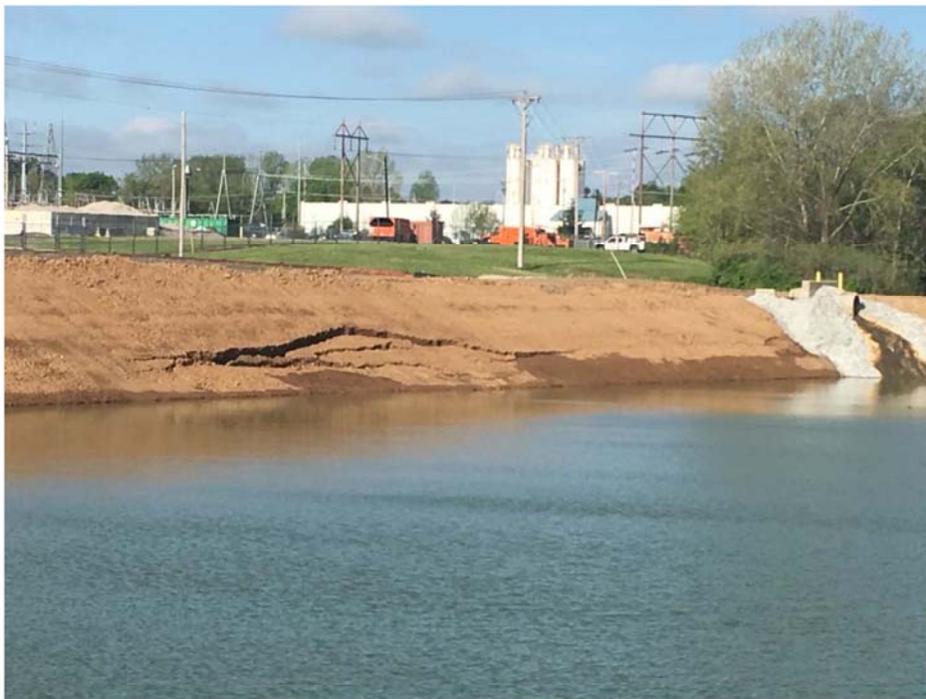
Figure 16: View of south berm of the sedimentation basin. (facing southwest – 4/18/2017)

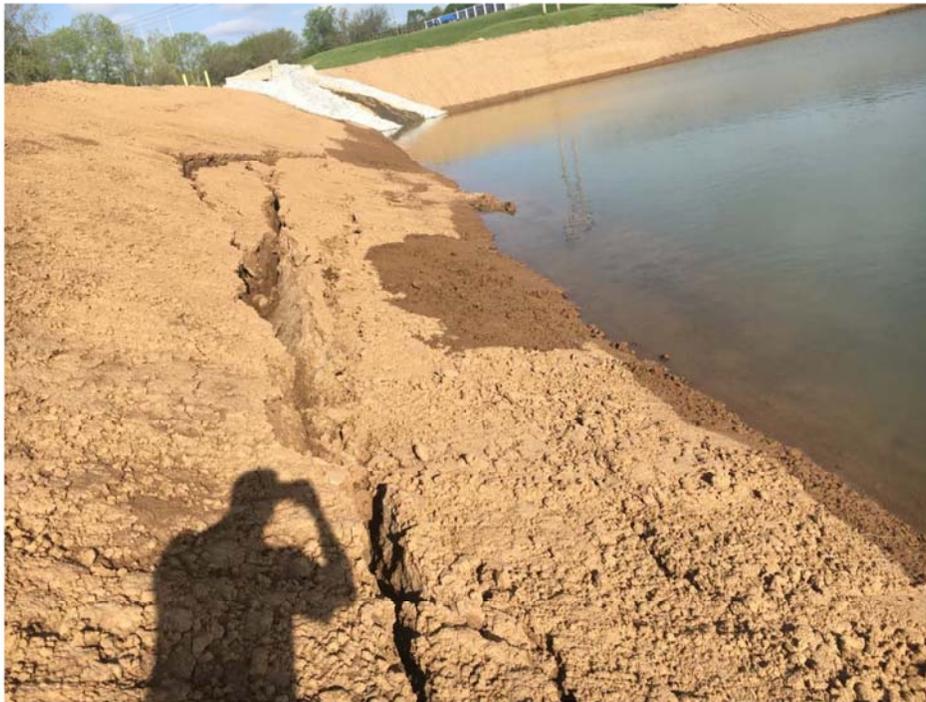
Figure 17: View of the south berm of the sedimentation basin. (facing west – 4/18/2017)

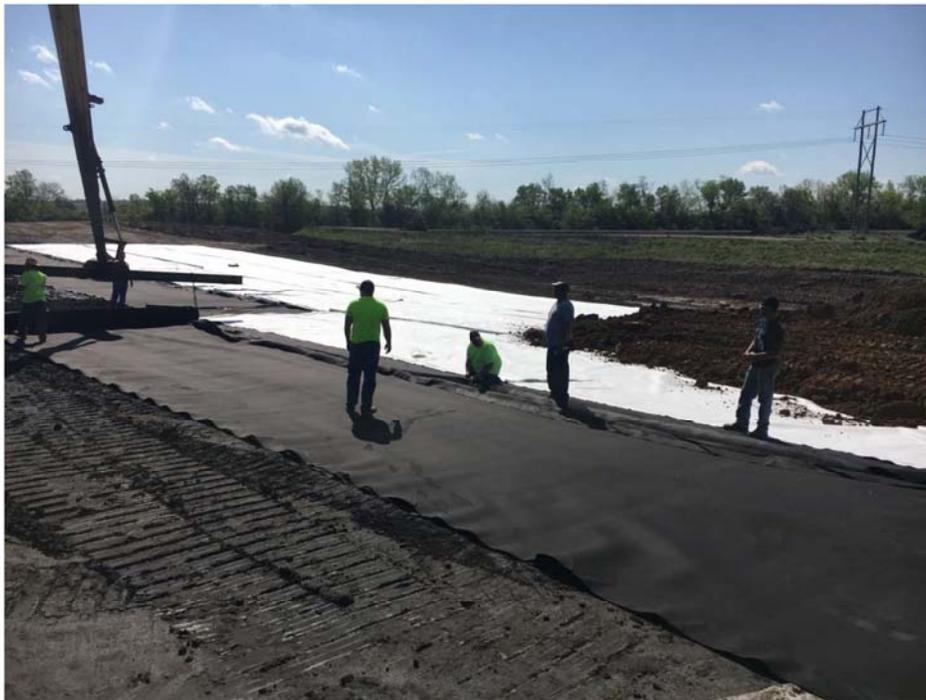
Figure 1: Deploying geocomposite over the North Pond's south pressure relief drainage area.  
(facing southeast)

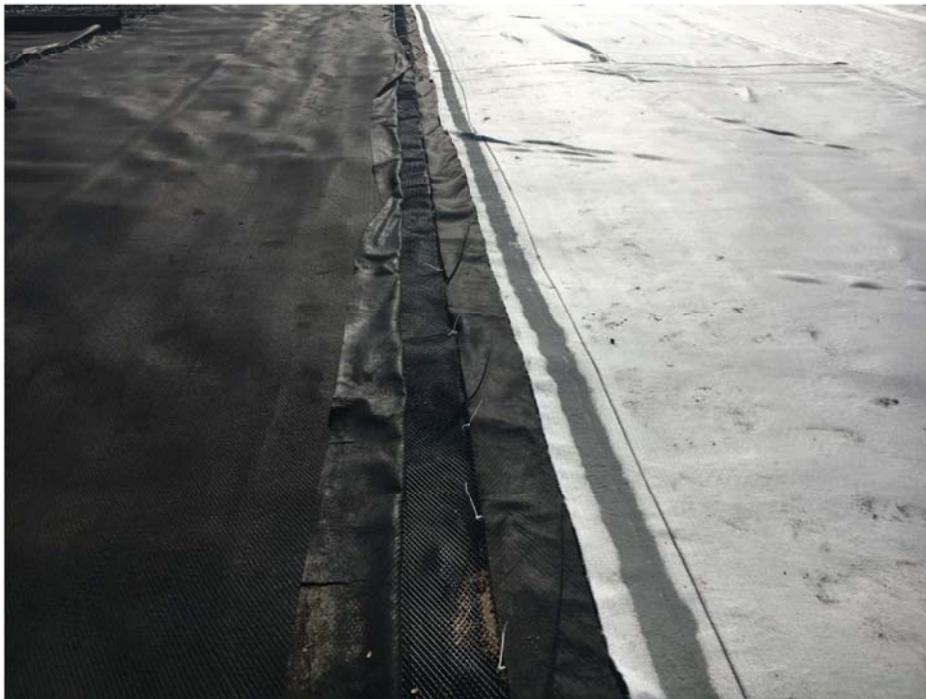
Figure 2: Zip tied geonet on geocomposite panels and granular bentonite on overlap of CAR  
GCL overlap. (East)

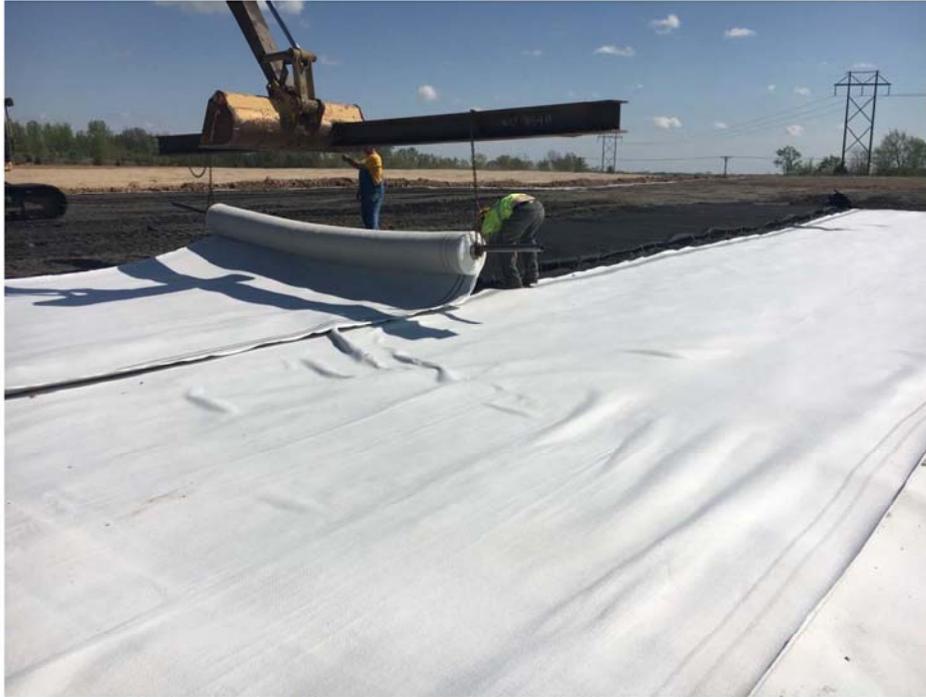
Figure 3: Deployment of CAR GCL over geocomposite. (facing northeast)

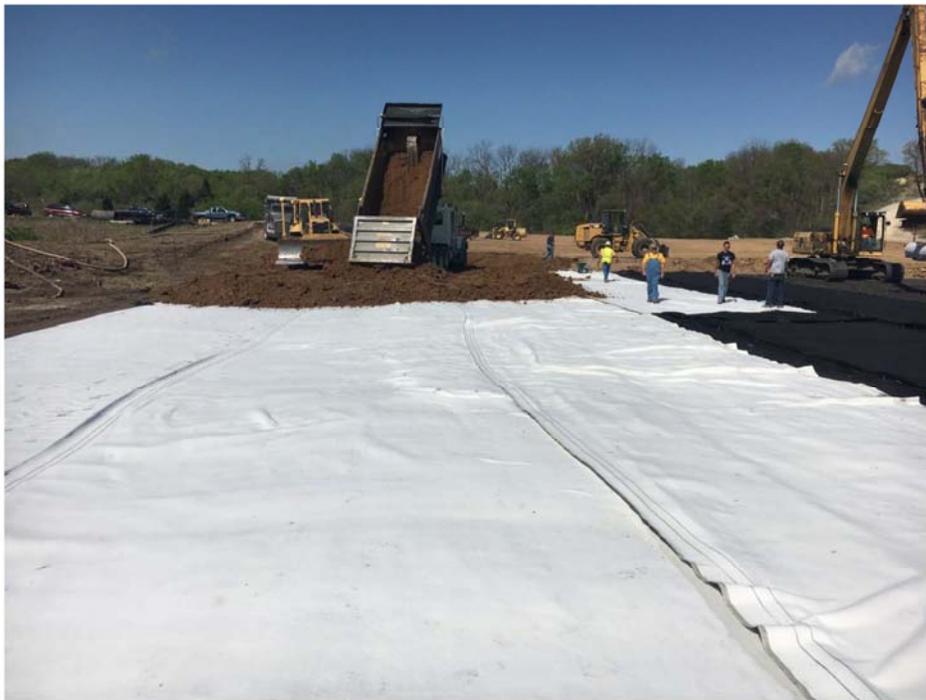
Figure 4: Placement of soil over top of CAR GCL and geocomposite in south discharge area. (facing west)

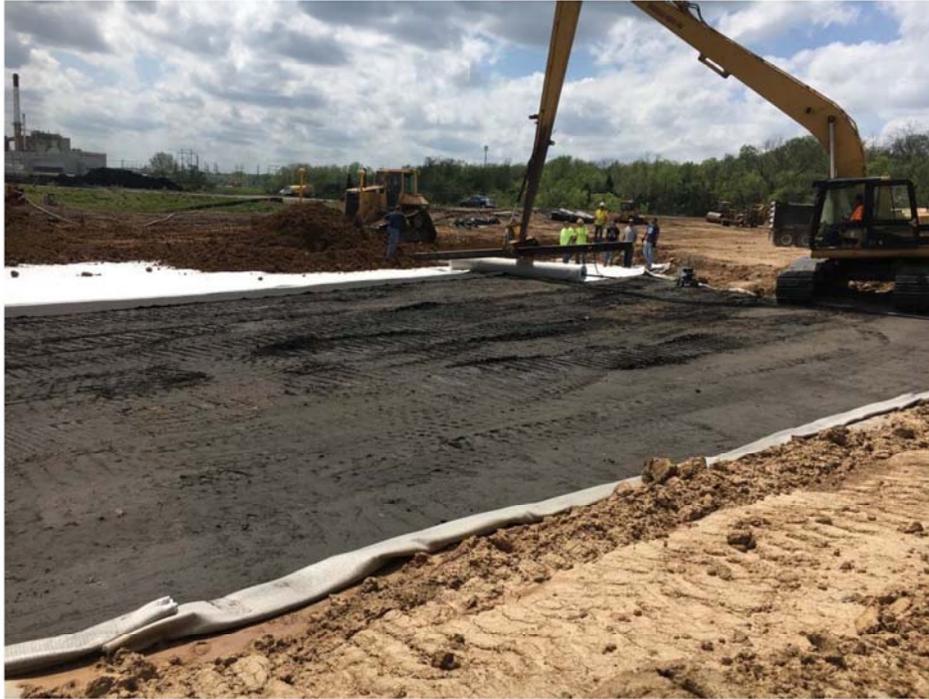
Figure 5: Deploying CAR GCL over the north edge of the geocomposite. (facing south)

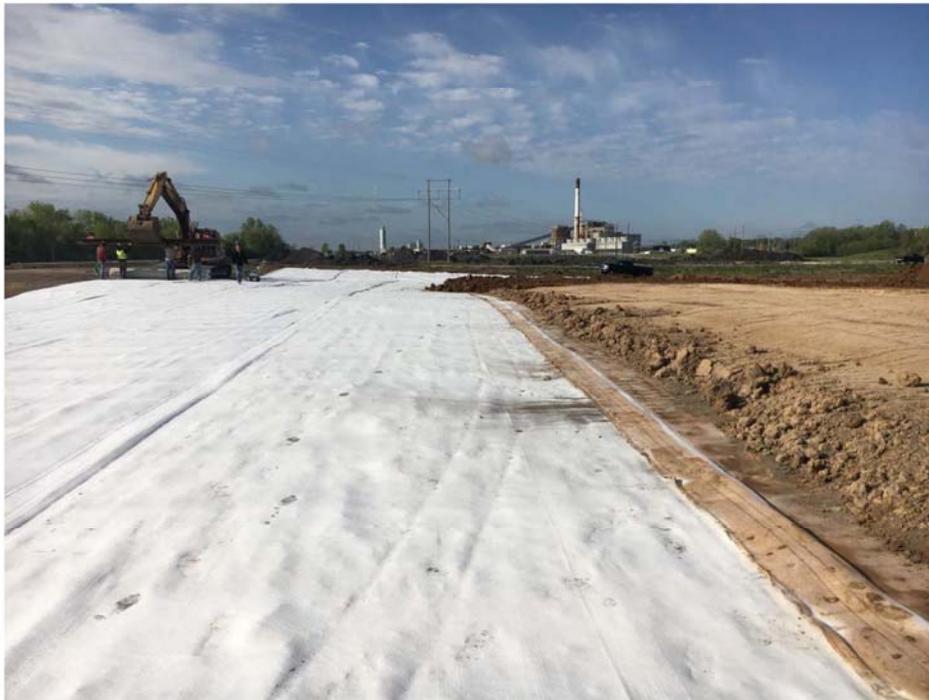
Figure 6: Deploying regular GCL to the west of the southeast discharge area (facing south).

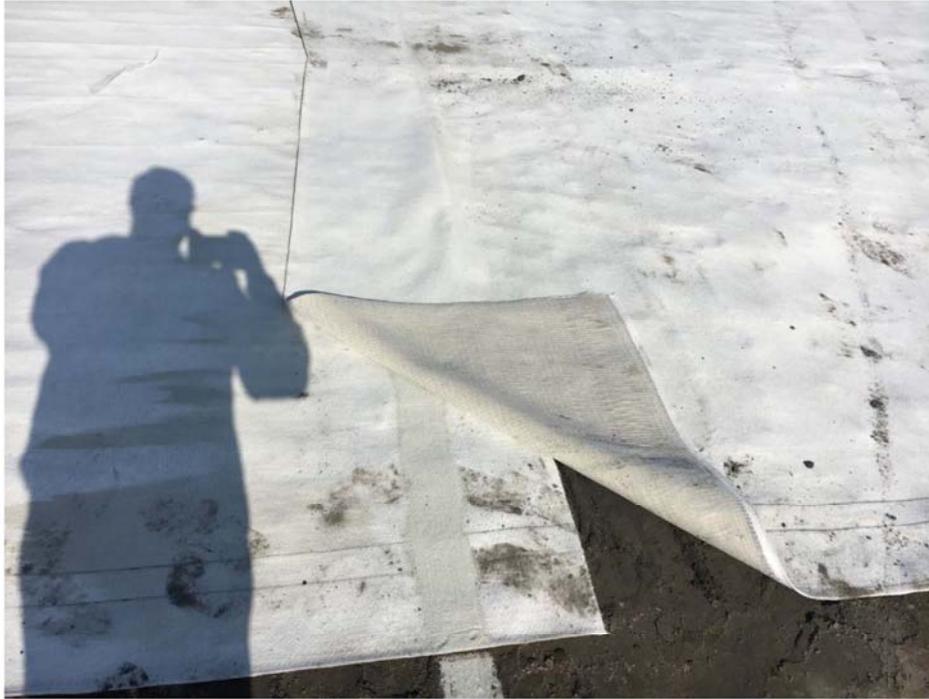
Figure 7: Granular bentonite placed between overlaps of GCL. (facing south)

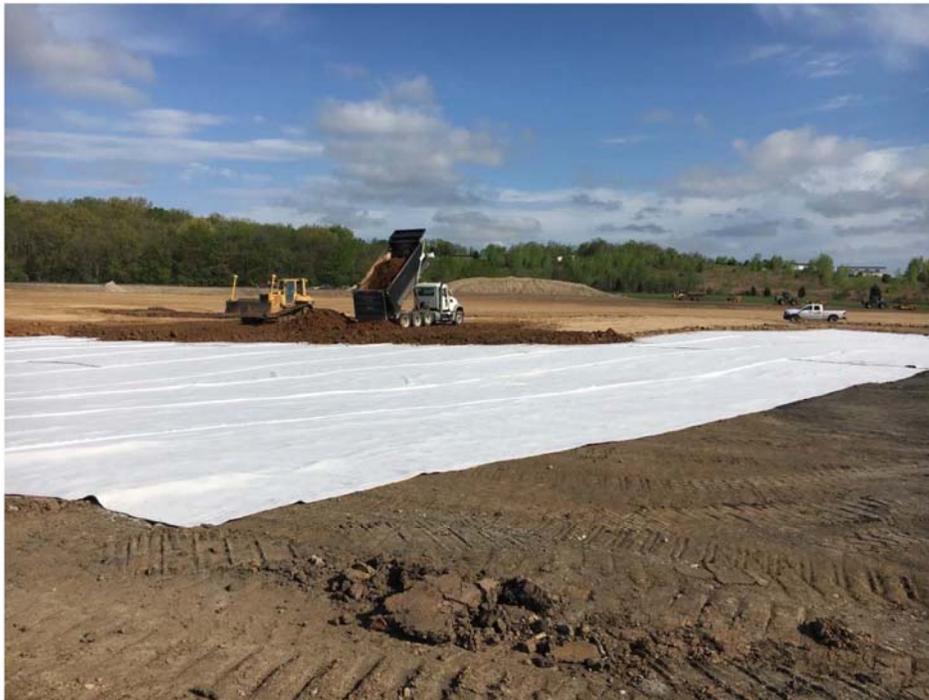
Figure 8: Placement of soil over GCL panels (facing northwest).

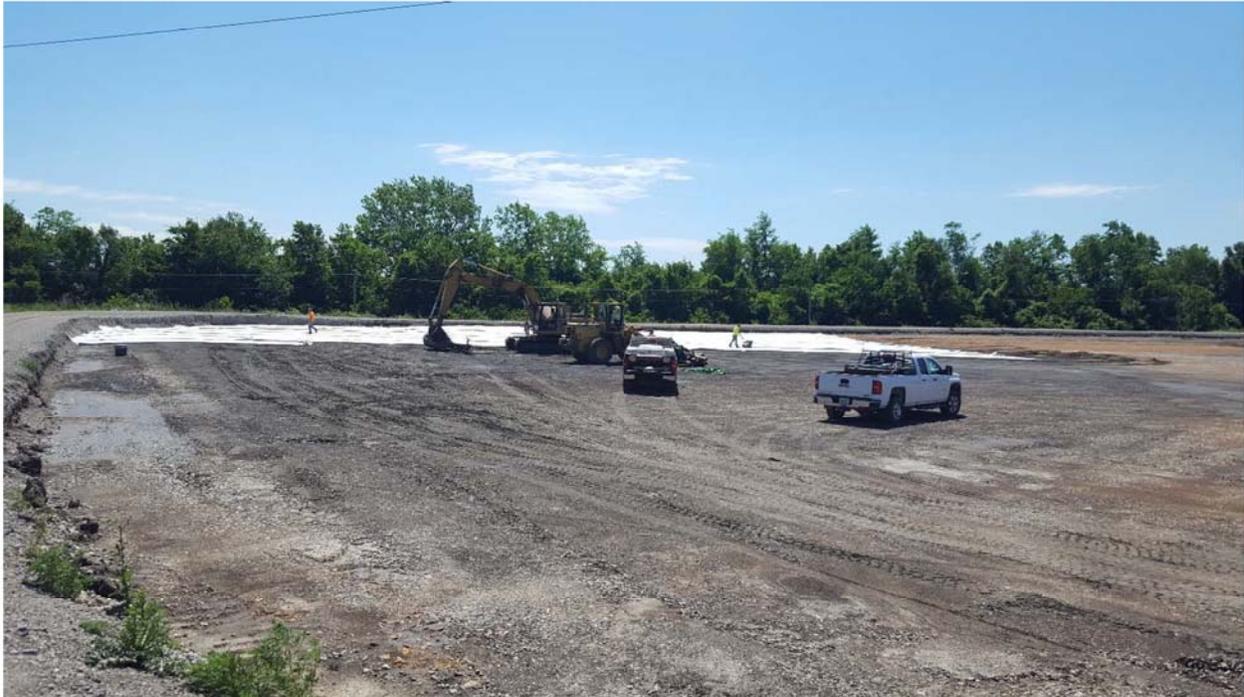
Figure 1: 6-19-17 GCL panels being deployed in the northeast corner of southeast fly ash pond (facing east)

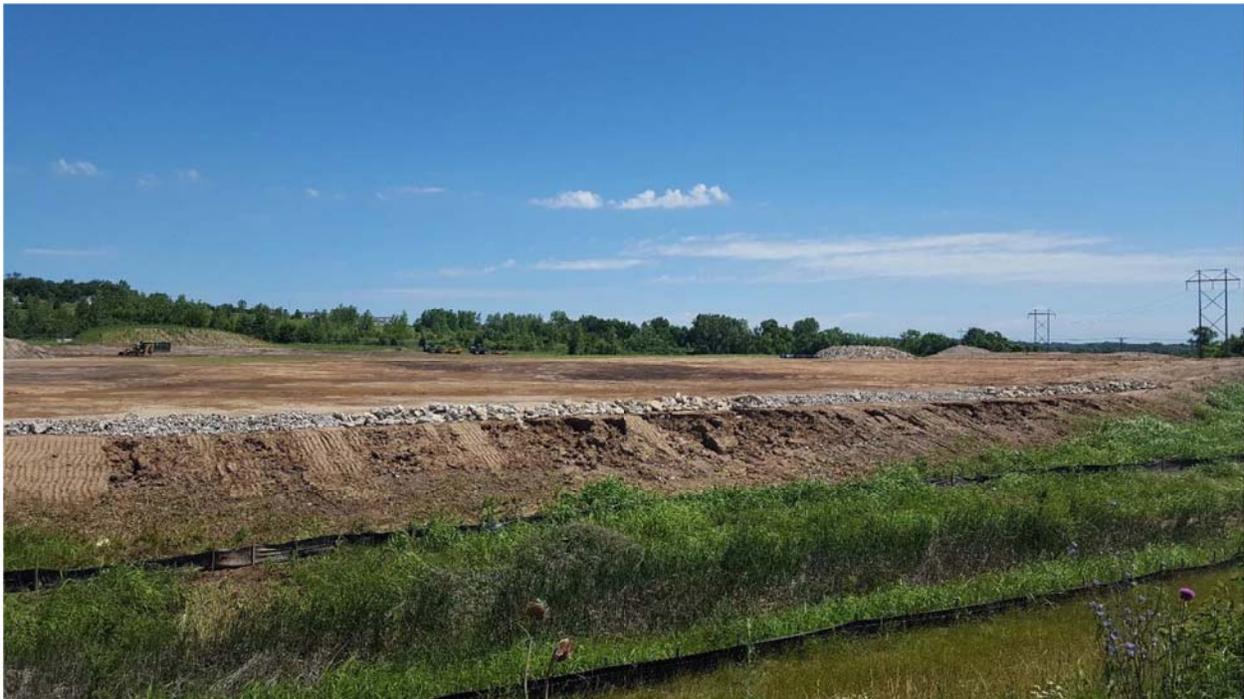
Figure 2: 6-19-17 Erosion from surface rain water on the south slope of the north fly ash pond (facing north)

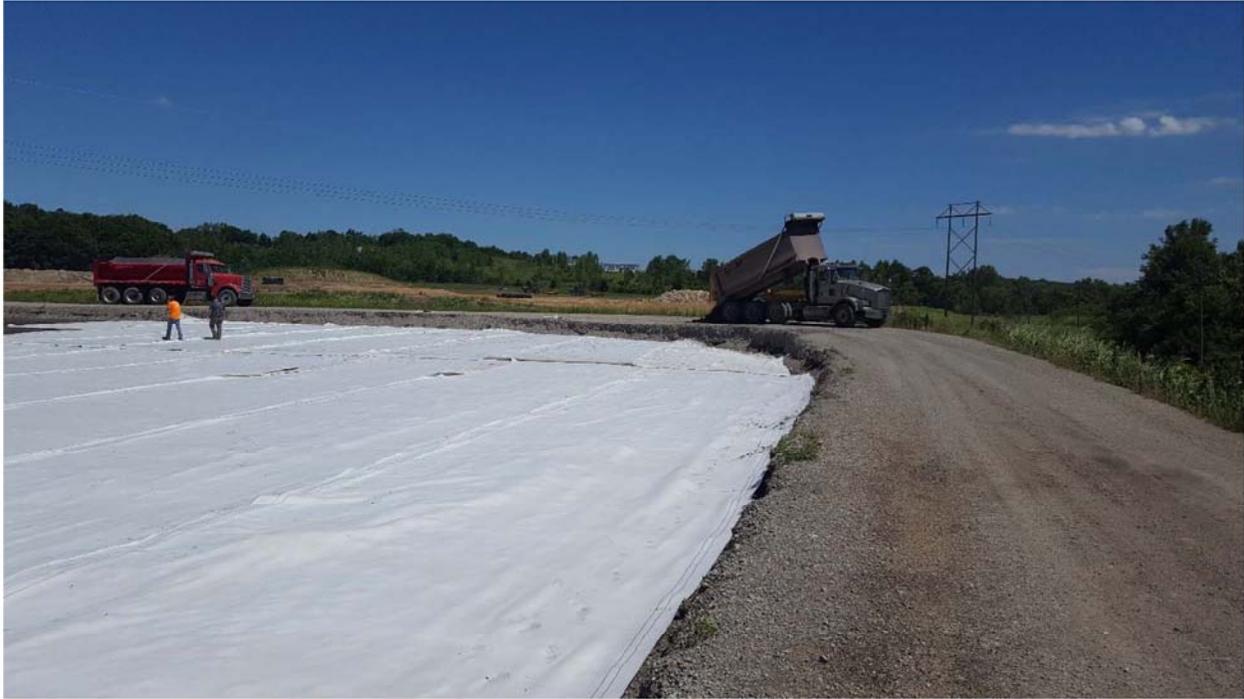
Figure 3: 6-19-17 Haul trucks began bringing soil to build the ramp into the southeast fly ash pond (facing north)

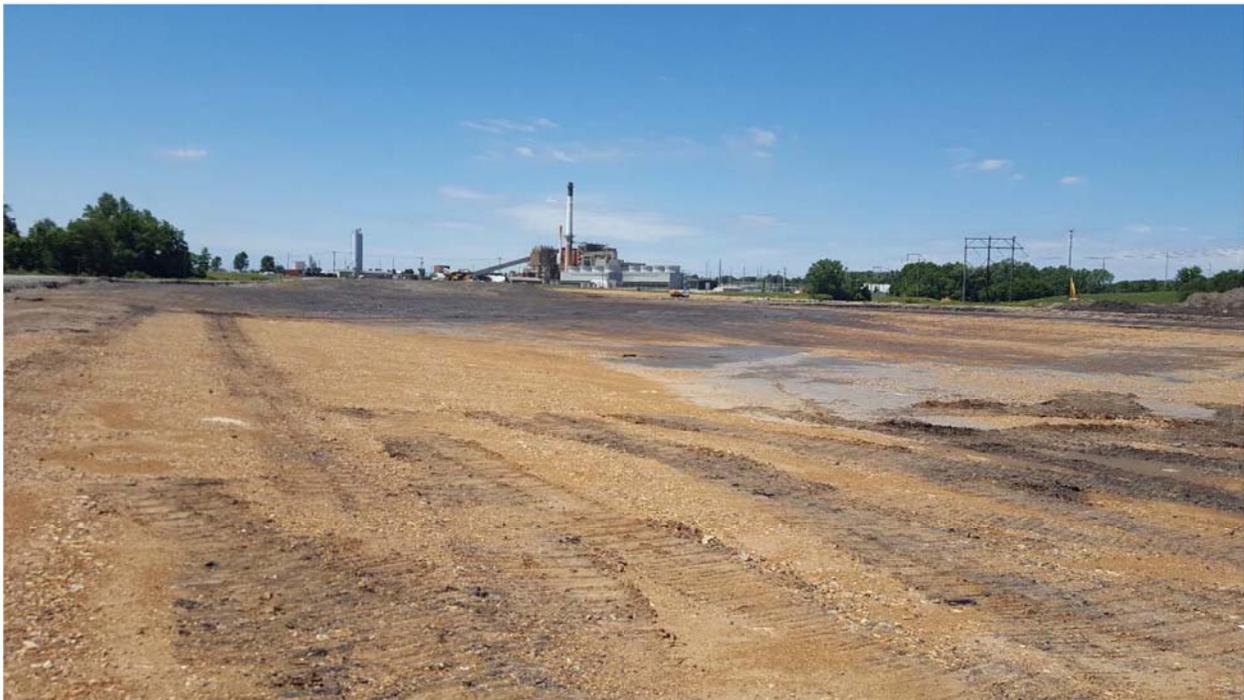
Figure 4: 6-19-17 Overview of the southeast fly ash pond graded out and ready for GCL covering (facing southwest)

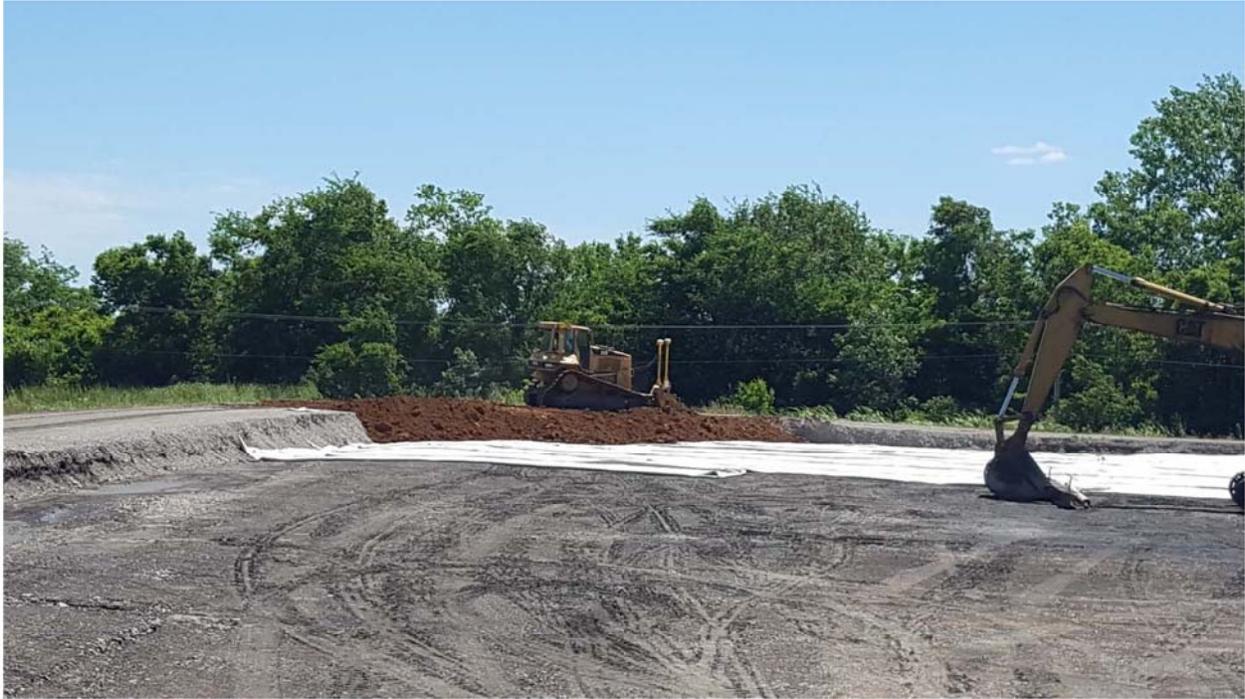
Figure 5: 6-19-17 A D6 dozer pushing soil out over the GCL to build the ramp into the pond (facing east)

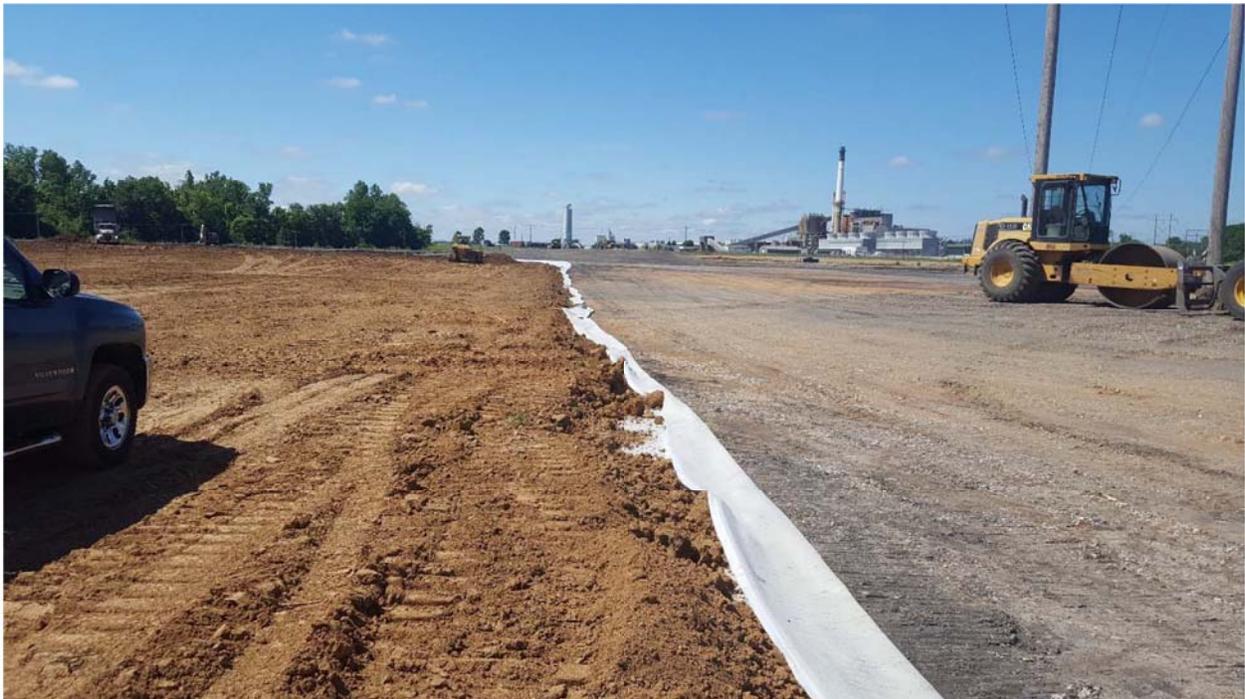
Figure 6: 6-22-17 A D6 dozer placing the soil over the deployed regular GCL (facing south)

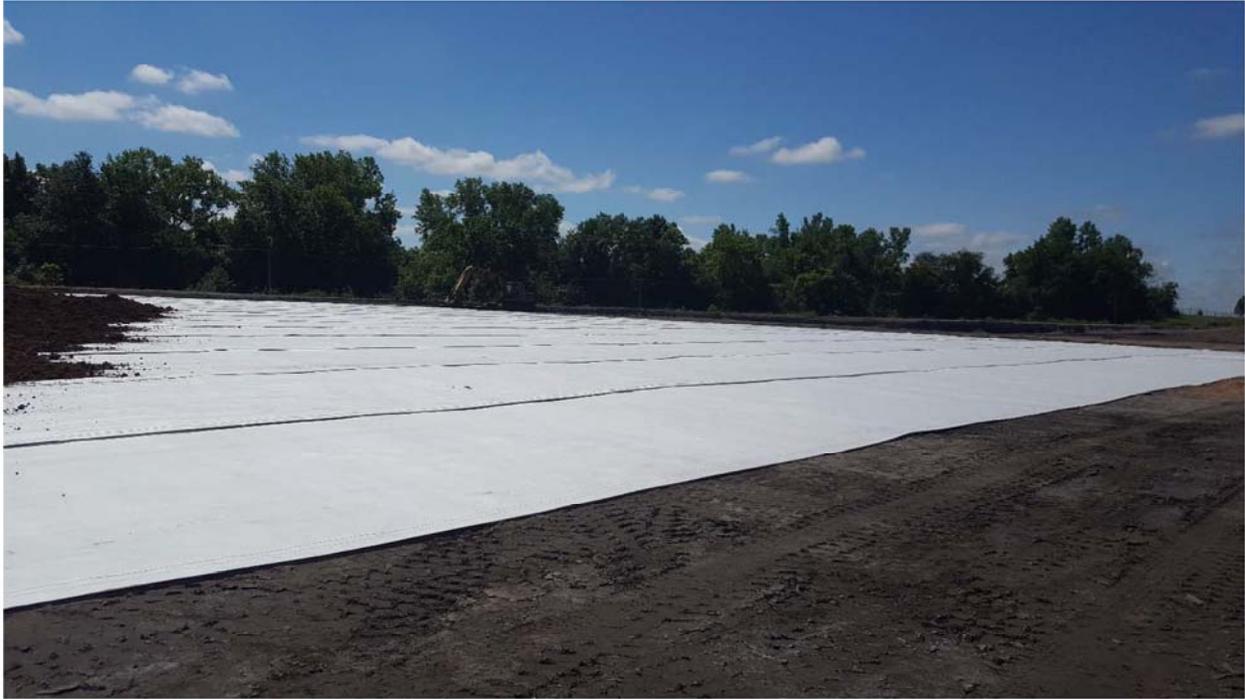
Figure 7: 6-22-17 Panels of regular GCL deployed in the northeast corner of the southeast fly ash pond (facing southeast )

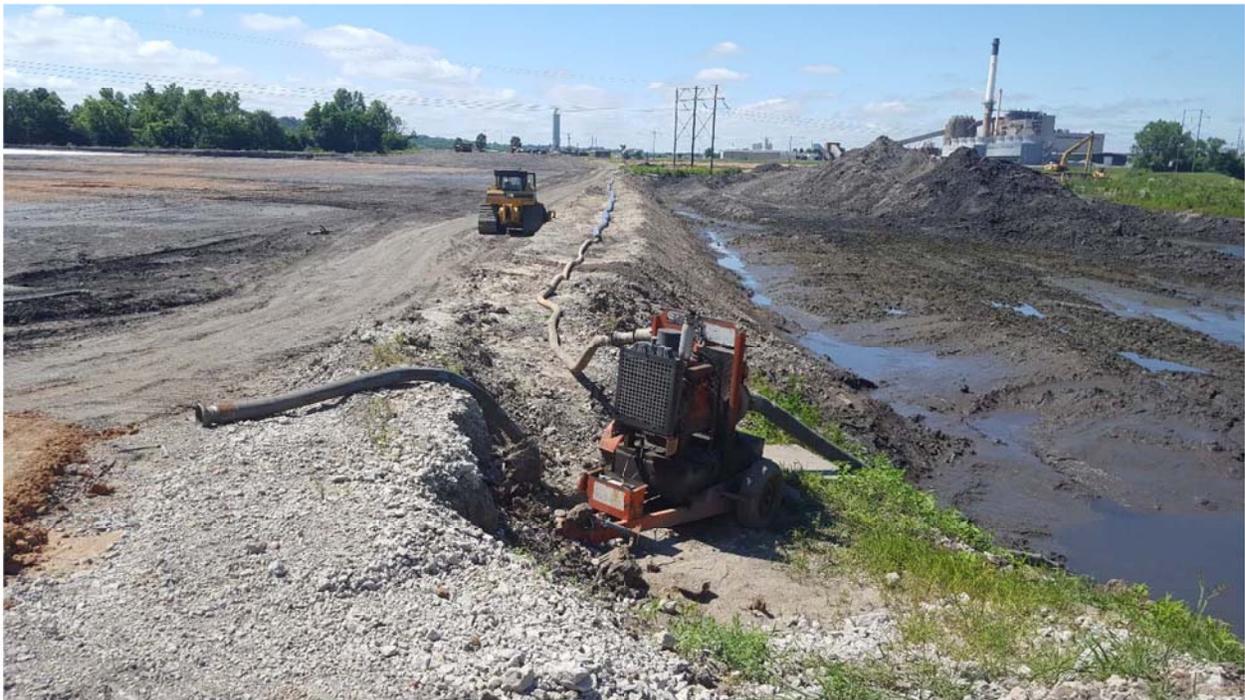
Figure 8: 6-22-17 Pumping water from the southwest fly ash pond to the sediment pond (facing south)

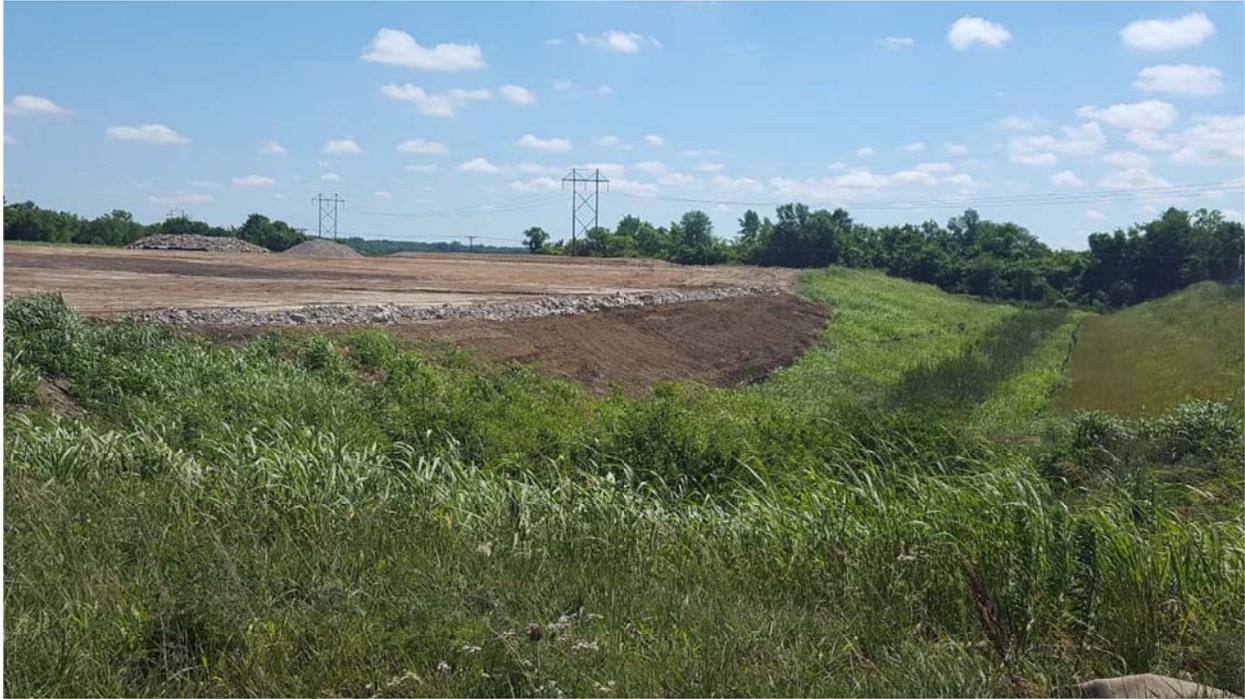
Figure 9: 6-22-17 South slope of the north pond regraded to fix the washed out areas (facing east)

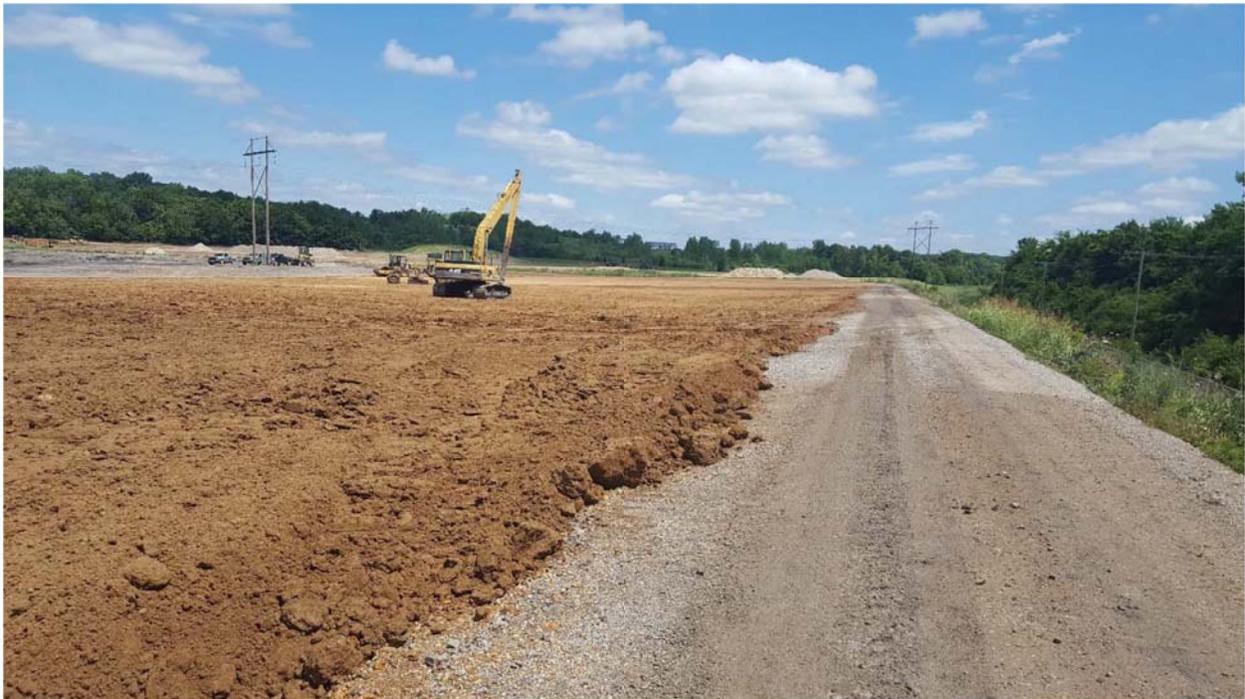
Figure 10: 6-22-17 Soil was placed up to grade at a foot thick and the same elevation as the access road on the east side of the southeast pond (facing north)

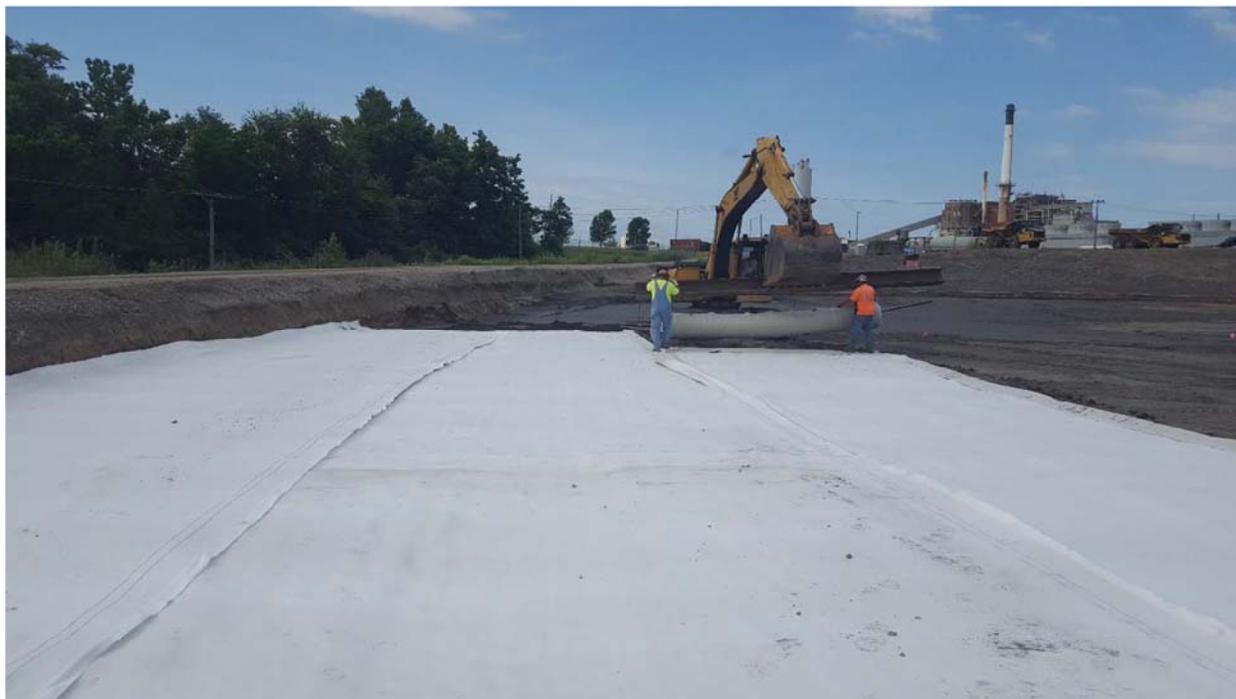
Figure 11: 6-23-17 Radmacher personnel deploying regular GCL panels on the middle section of the southeast fly ash pond (facing south)

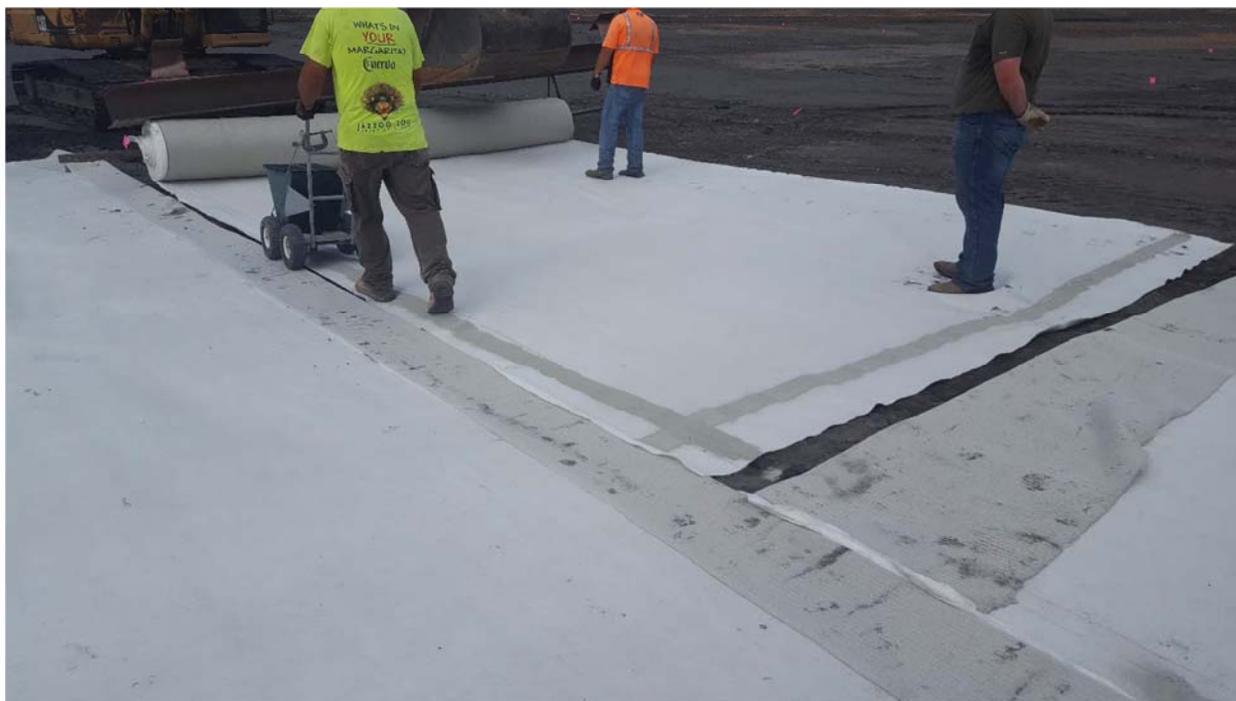
Figure 12: 6-23-17 Placing bentonite powder between the overlapped sections of the GCL panels (facing southwest)
