## **Ash Impoundment Closure Report**

Independence Power & Light  
Blue Valley Power Station  
21500 East Truman Road  
Independence, Missouri 64056

**SCS ENGINEERS**  
7311 West 130th Street, Suite 100  
Overland Park, Kansas 66213  
(913) 681-0030

April 2018  
Revised June 2018  
File No. 27215142.00

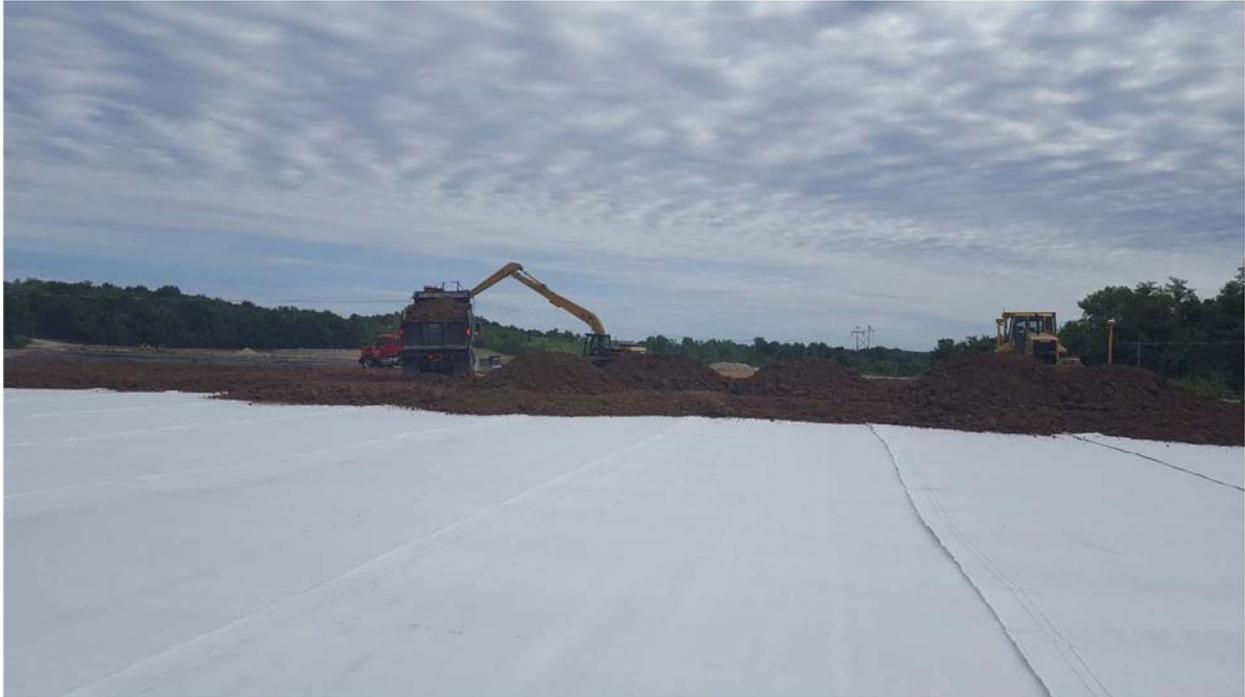
Figure 13: 6-23-17 Haul trucks dumping soil from the borrow source and a D6 dozer placing soil 1 foot thick over the GCL panels (facing north)

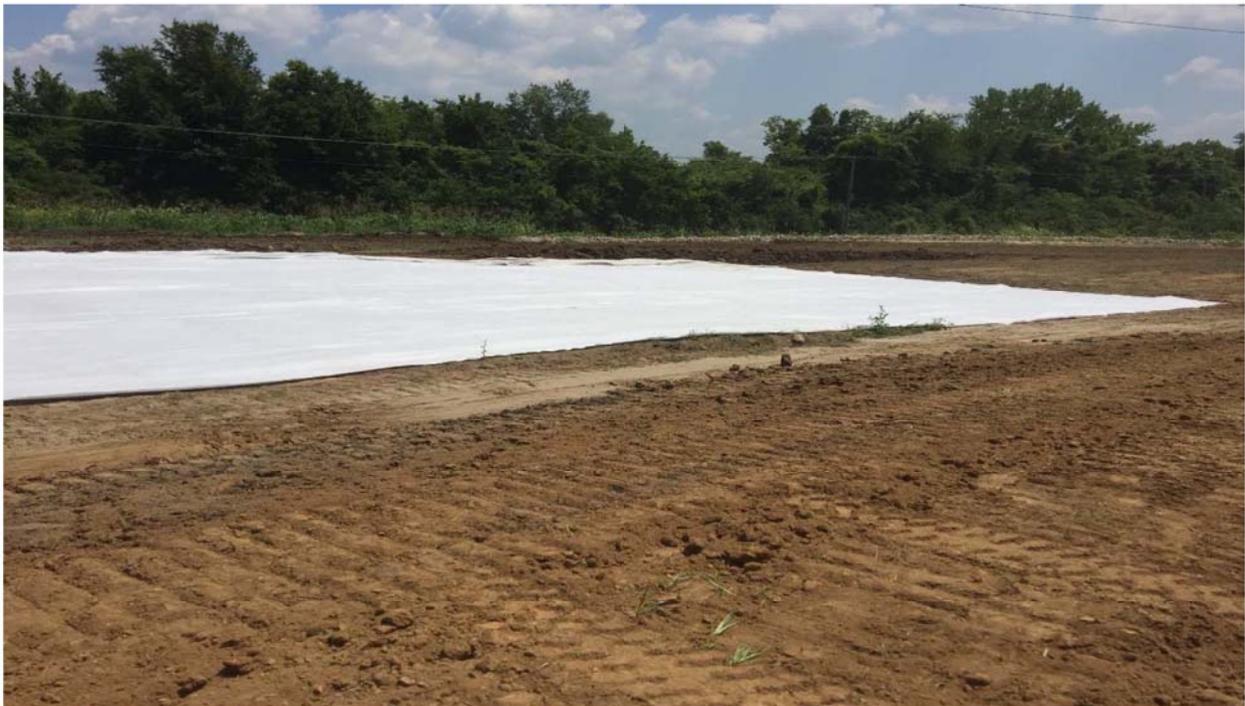
Figure 1: GCL installed in the southeast corner of the North pond (facing southeast)

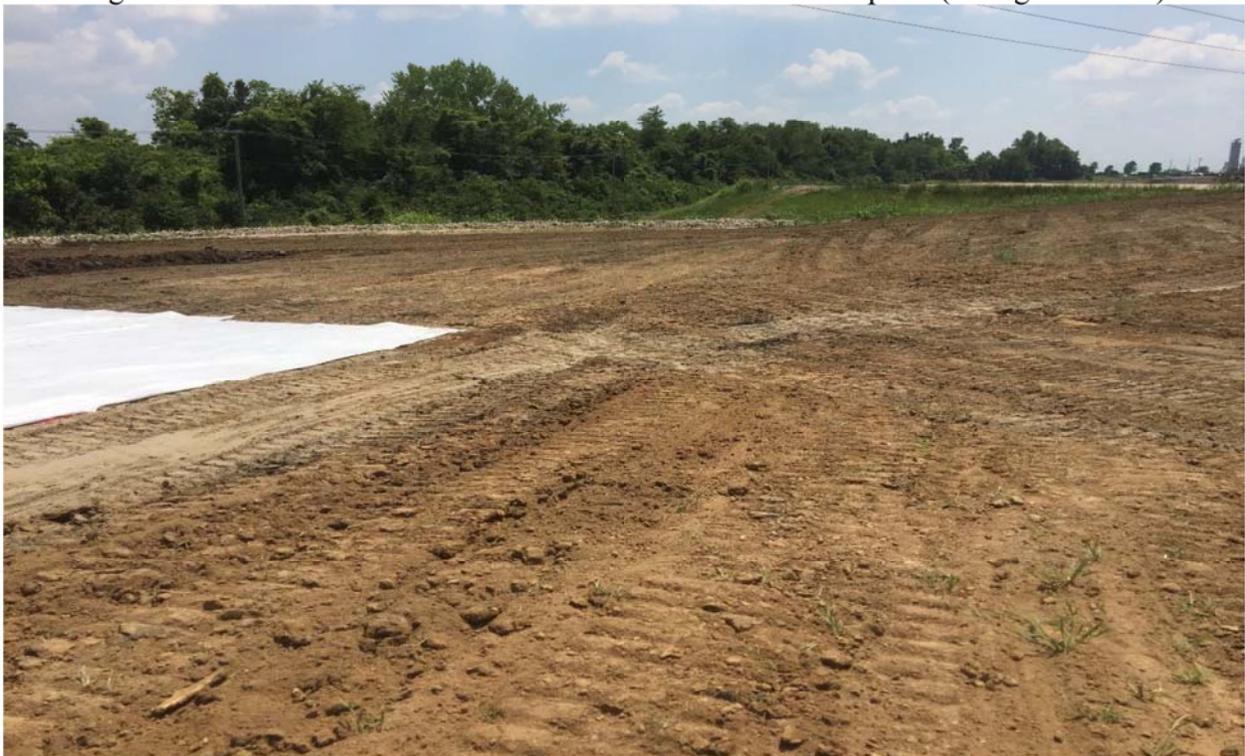
Figure 2: Overview of the southeast side of the north fly ash pond (facing southeast)

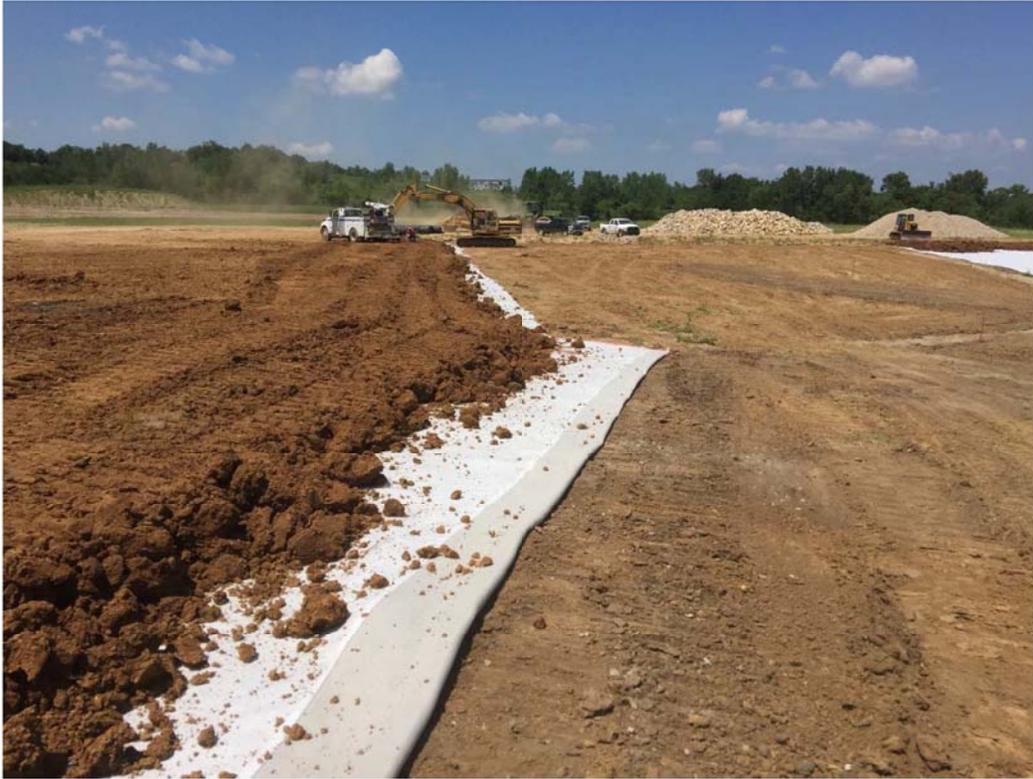
Figure 3: Cover soil placed over the GCL that was installed in the morning (facing northwest)

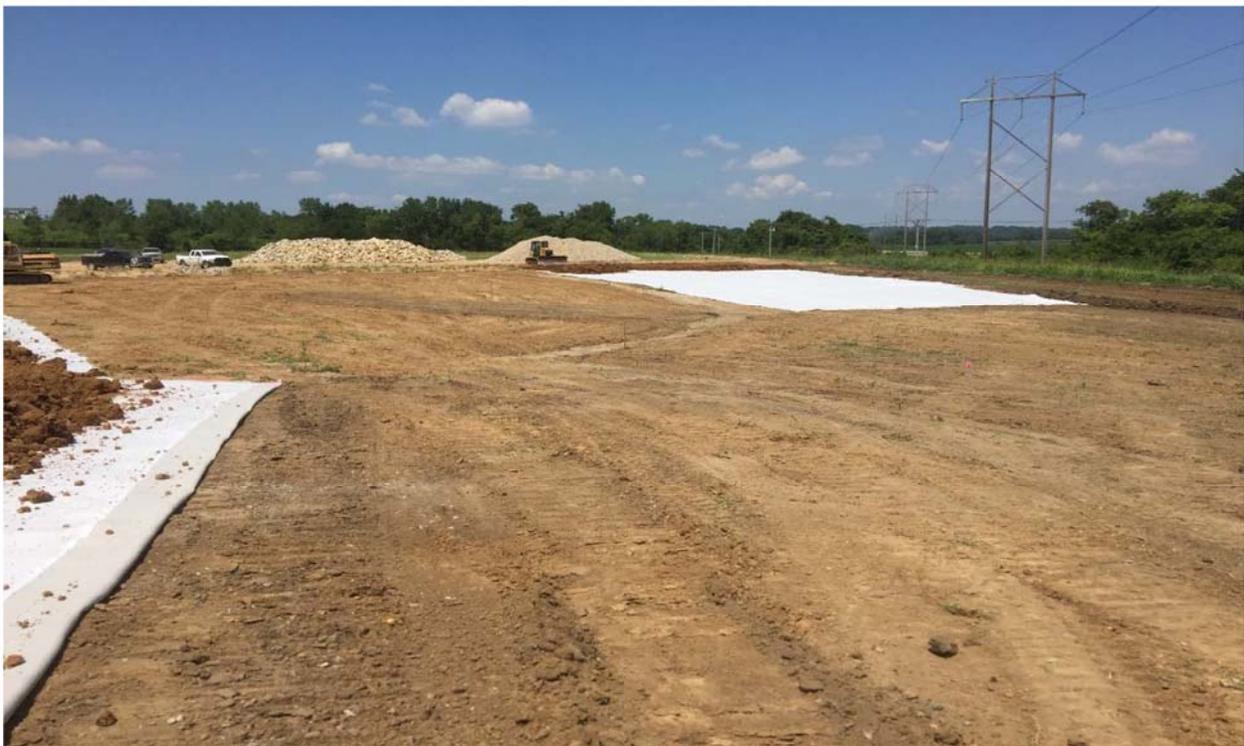
Figure 5: Dozer placing nearby soil over the GCL liner in the North fly ash pond (facing north)

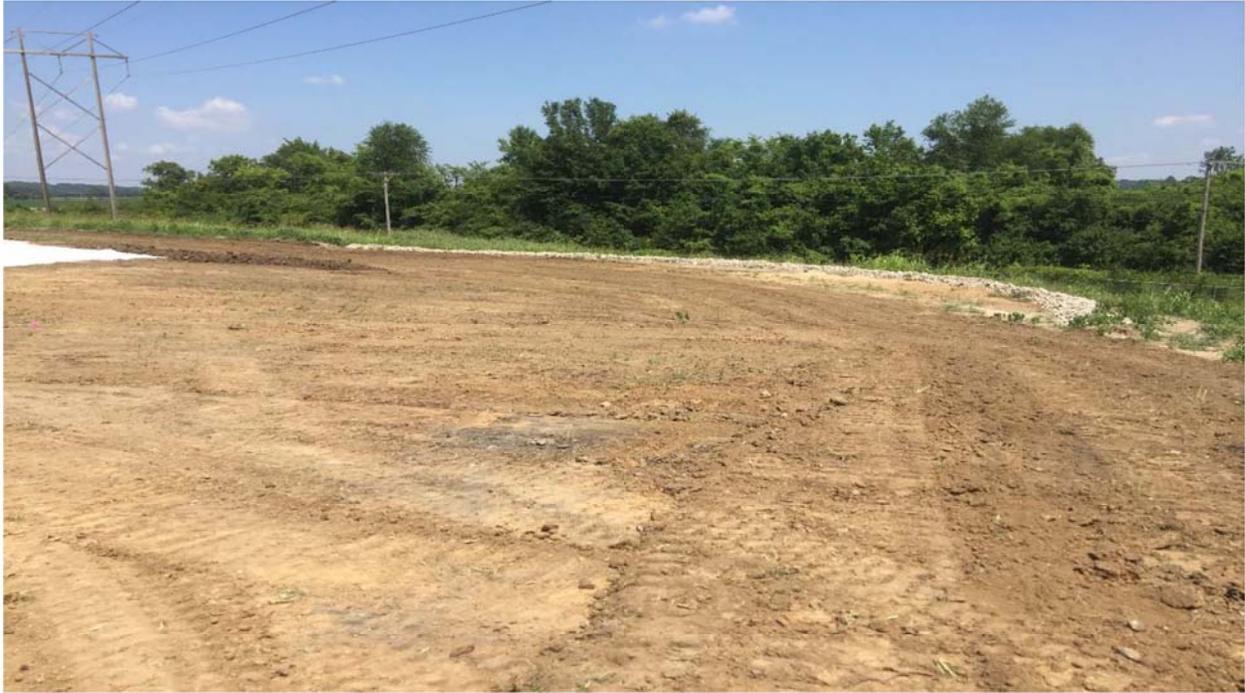
Figure 6: Southeast corner of the north pond with vegetation removed and ready for drainage GCL and Geocomposite. (facing east)

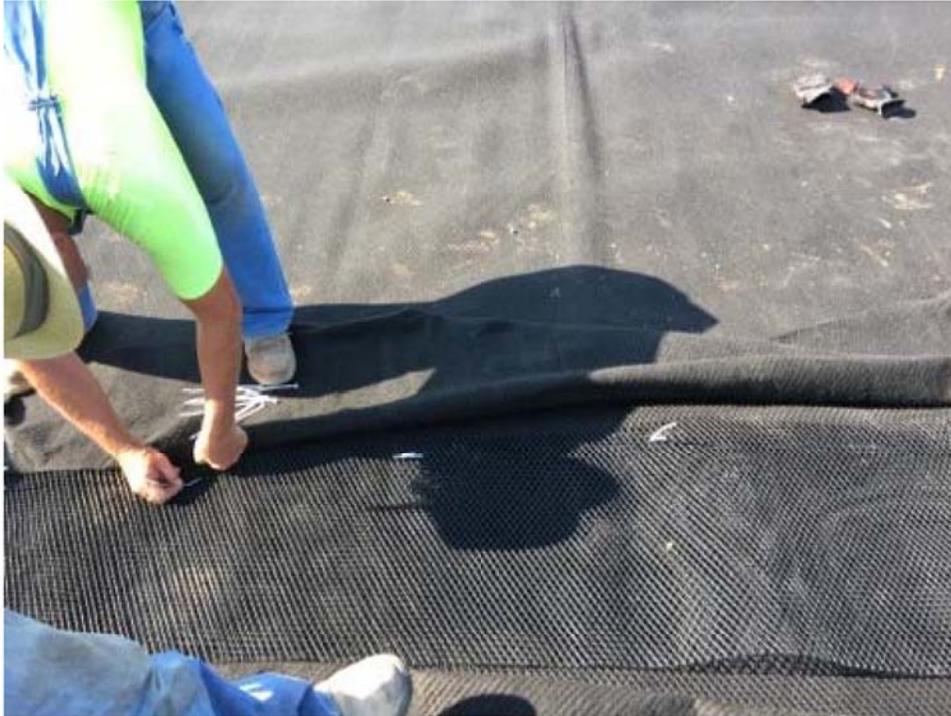
Figure 1: Zip-tying Geonet panels of the Geocomposite together about every foot in the southeast corner of the North pond (facing west)

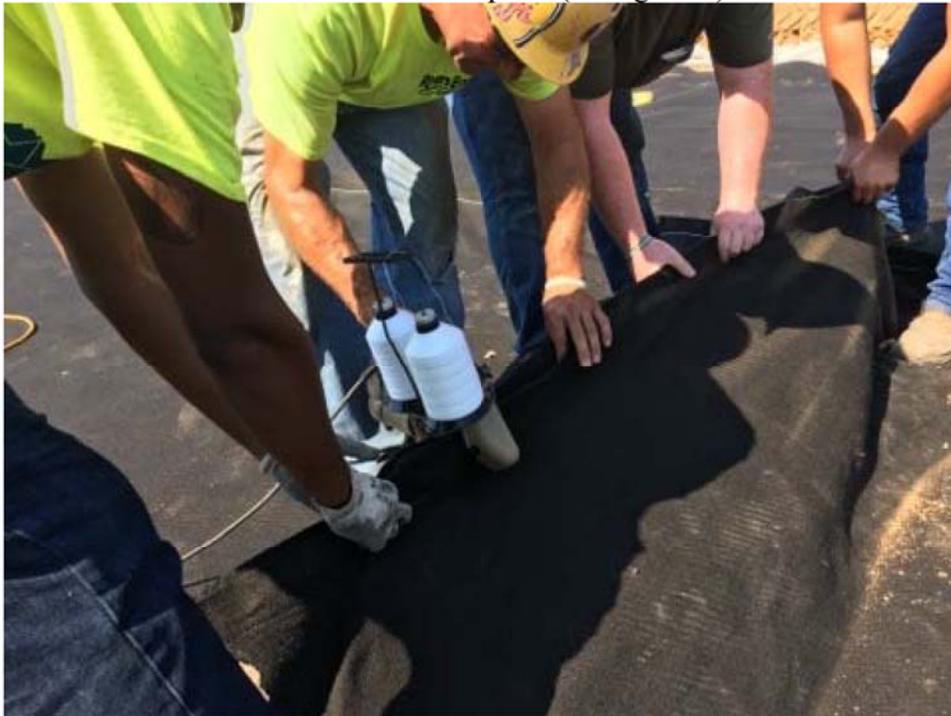
Figure 2: Sewing the Geotextile ends together using a sewing gun in southeast drainage area of the north pond (facing southeast)

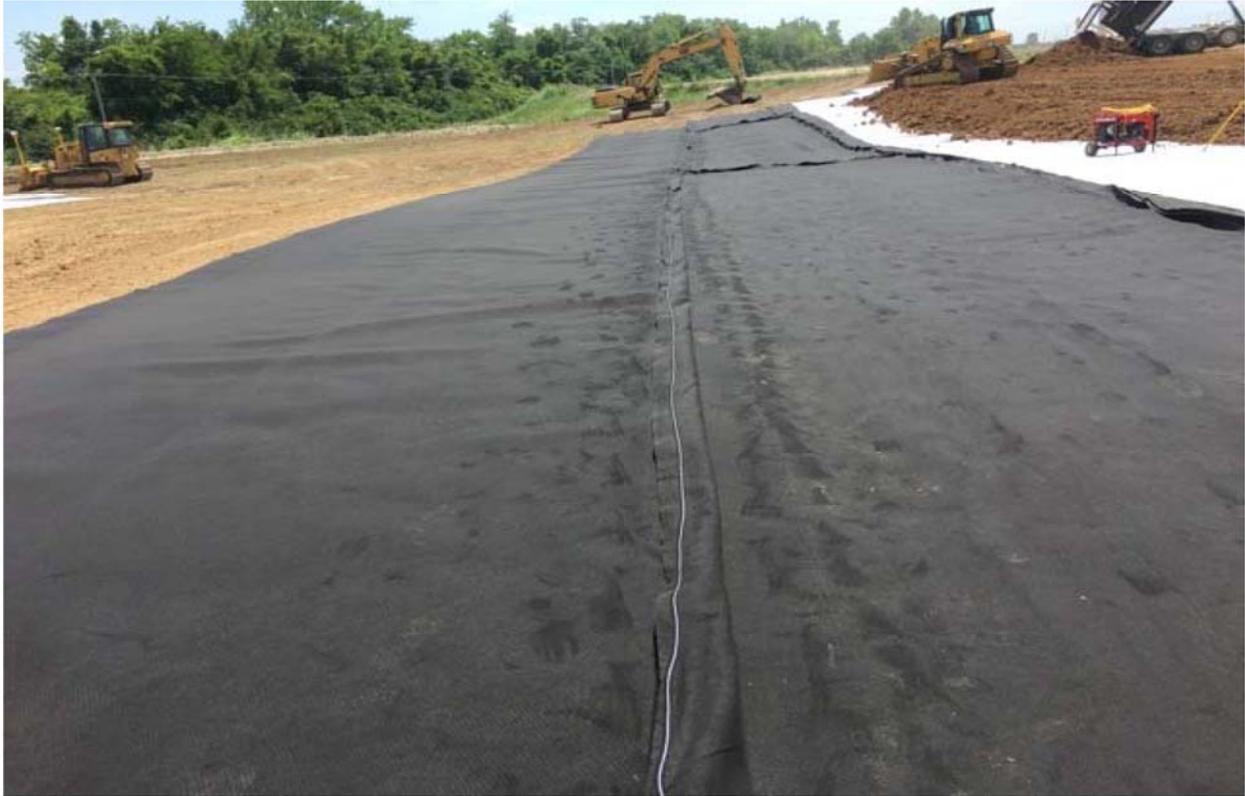
Figure 3: Geotextile panels completely sewn together for the Geocomposite drainage layer (facing northwest)

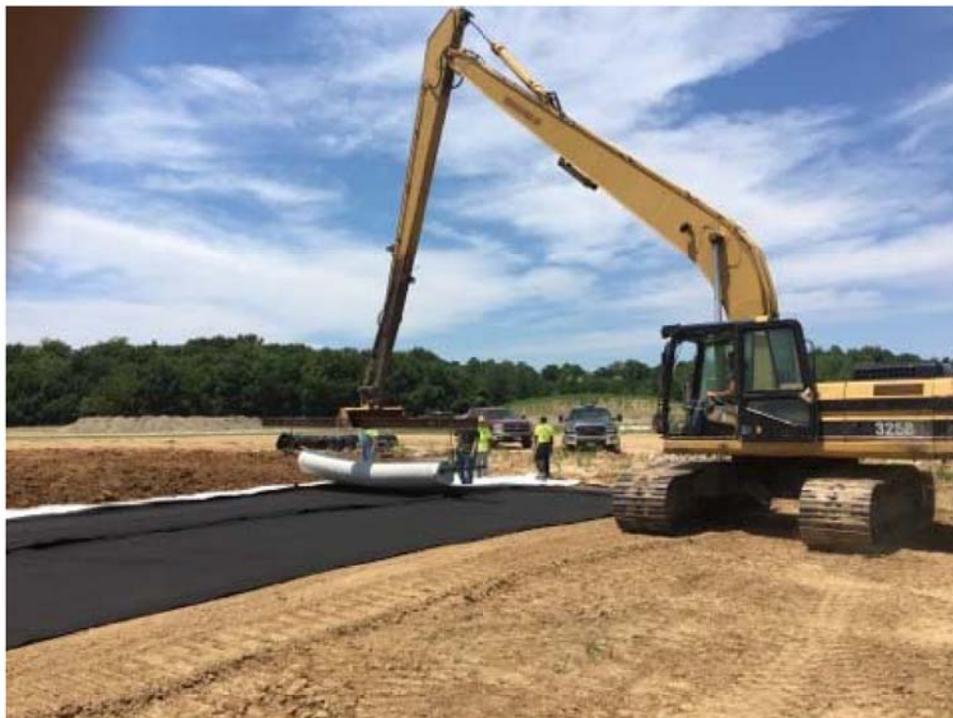
Figure 4: Deploying CAR GCL liner over the Geocomposite panels in the North fly ash pond (facing northwest)

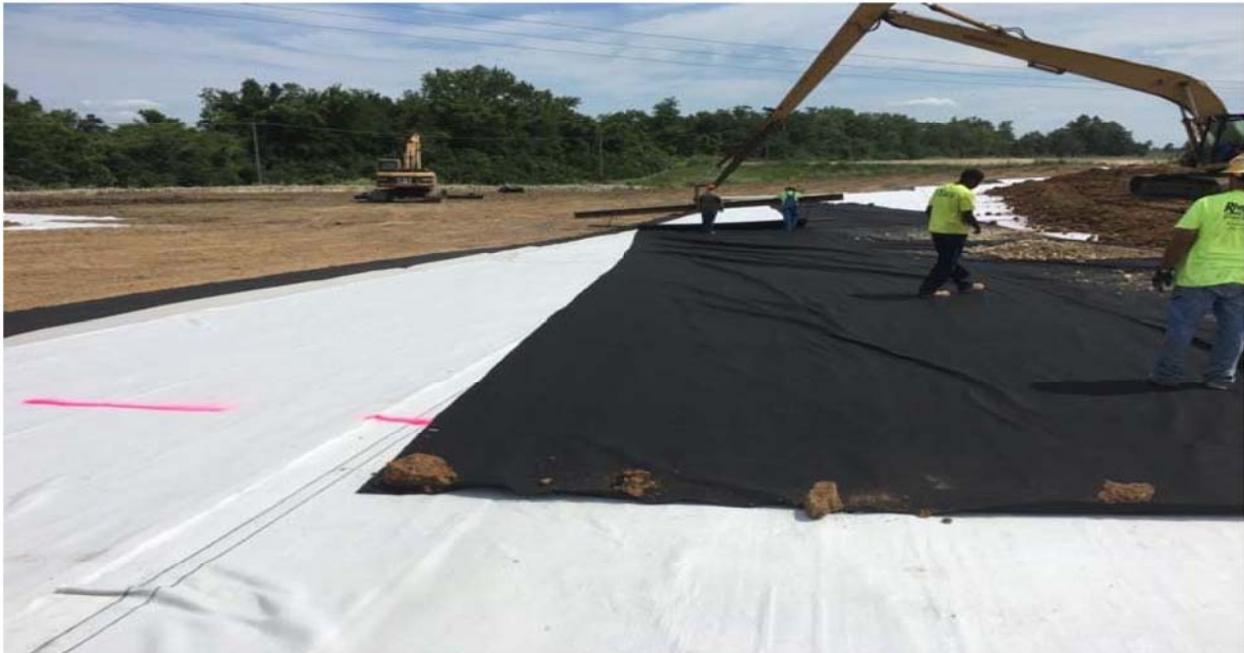
Figure 5: Deploying Geotextile panels over the CAR GCL placing in the drainage area of the North fly ash pond (facing northeast)

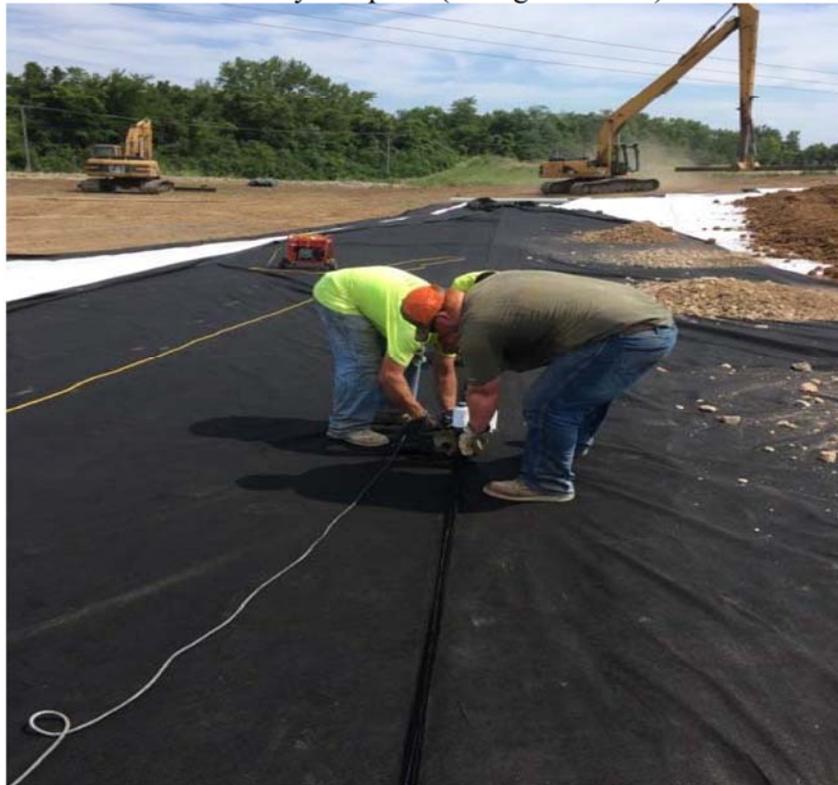
Figure 6: Sewing together the Geotextile panels placed over the CAR GCL in the drainage area of the North fly ash pond (facing northeast)

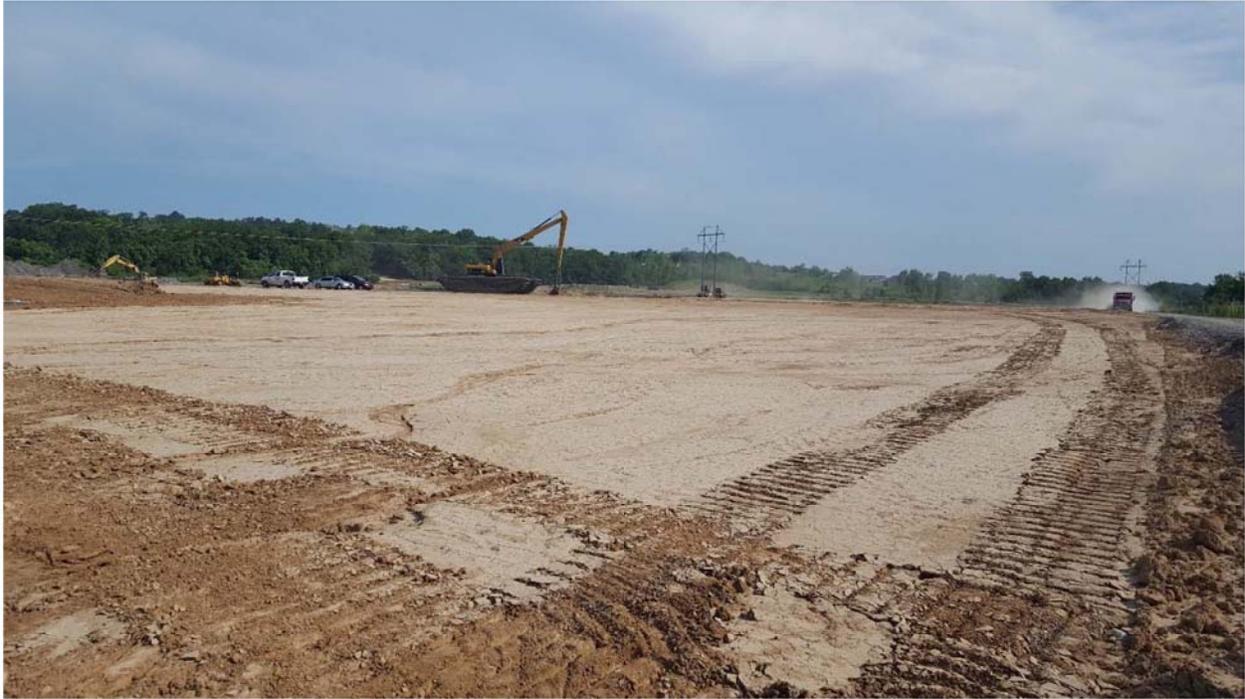
Figure 1: The northeast side of the southeast fly ash pond covered with a foot of soil (facing northwest)

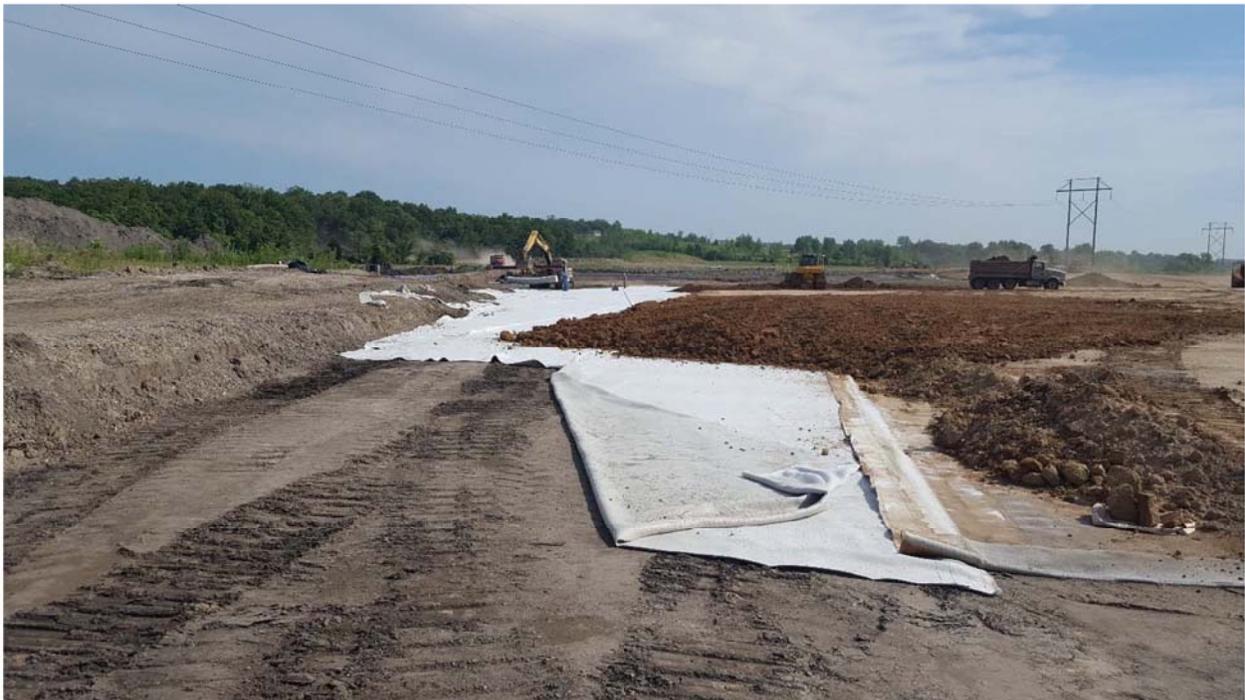
Figure 2: Deploying regular GCL panels on the northwest side of the southeast pond (facing northwest)

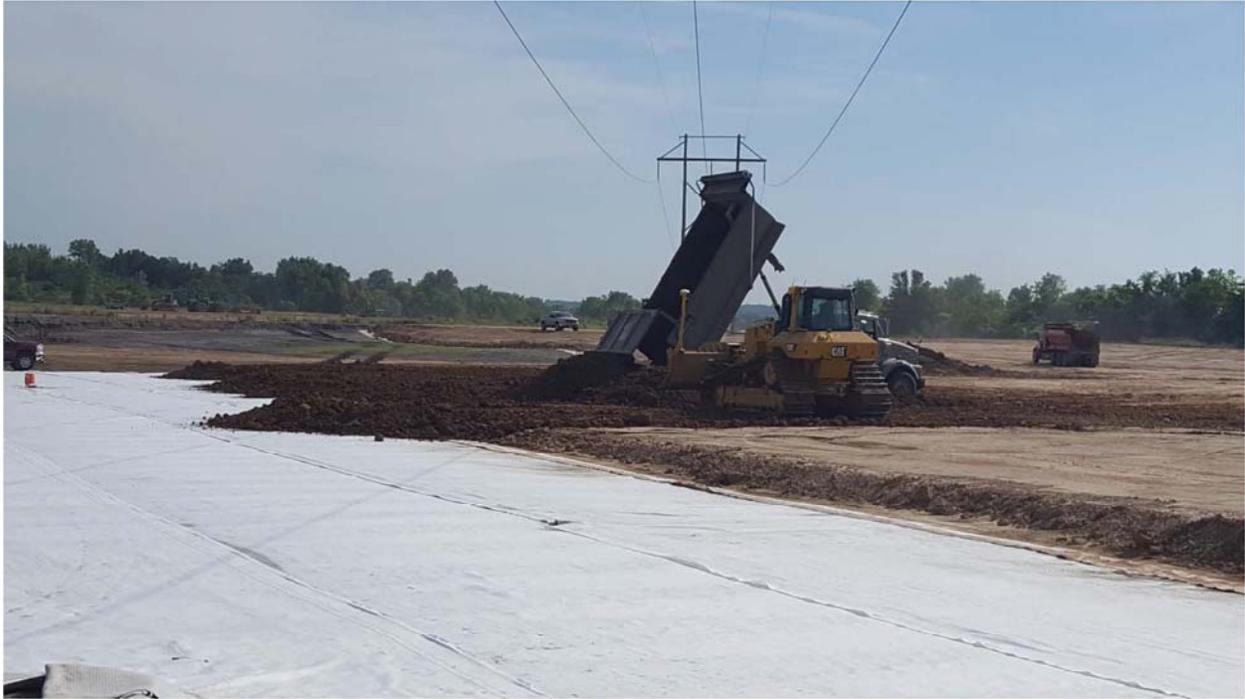
Figure 3: Haul trucks deposited soil from the borrow area as a D6 dozer placed it in 1 foot minimum thickness (facing northeast)

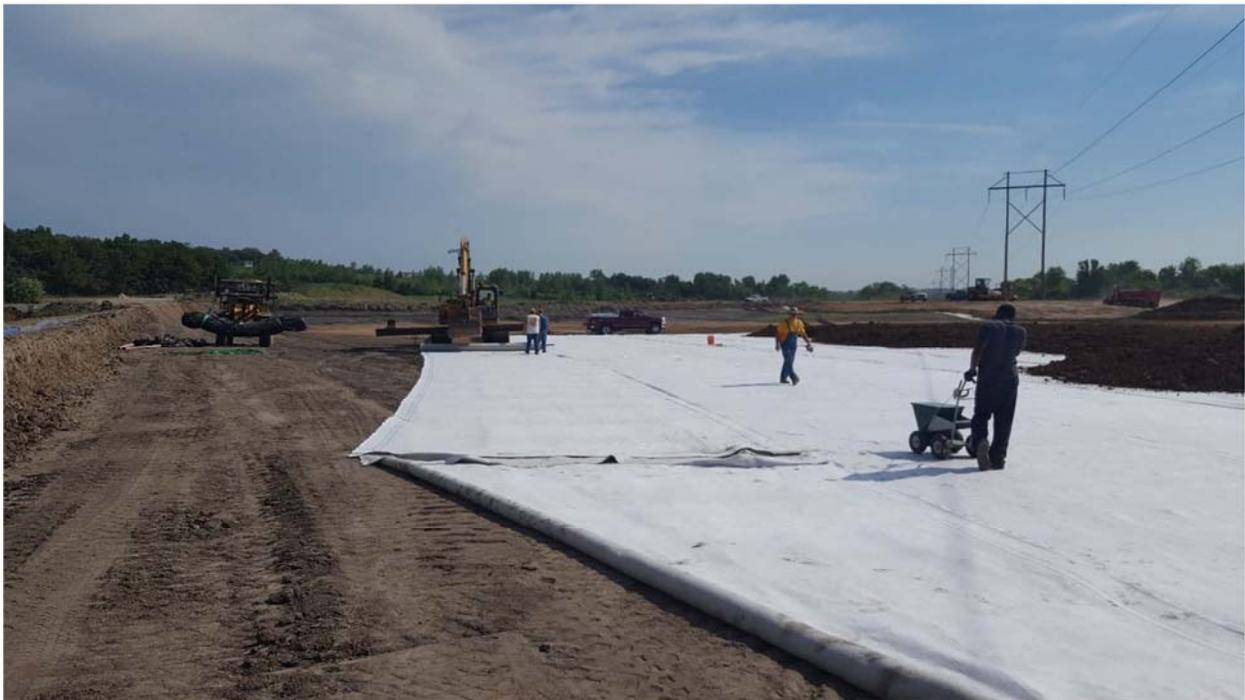
Figure 4: Deploying regular GCL and placing granular bentonite along each panel overlap in the southeast fly ash pond (facing north)

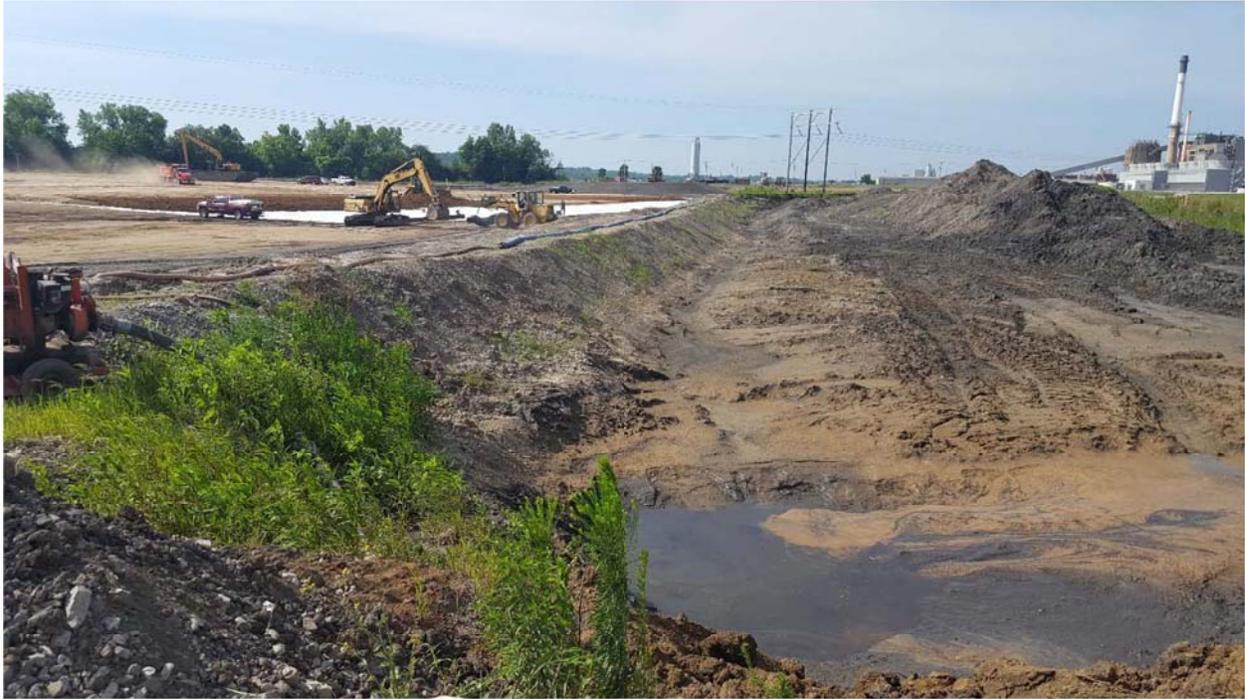
Figure 5: North drainage area of the southwest fly ash pond (facing south)

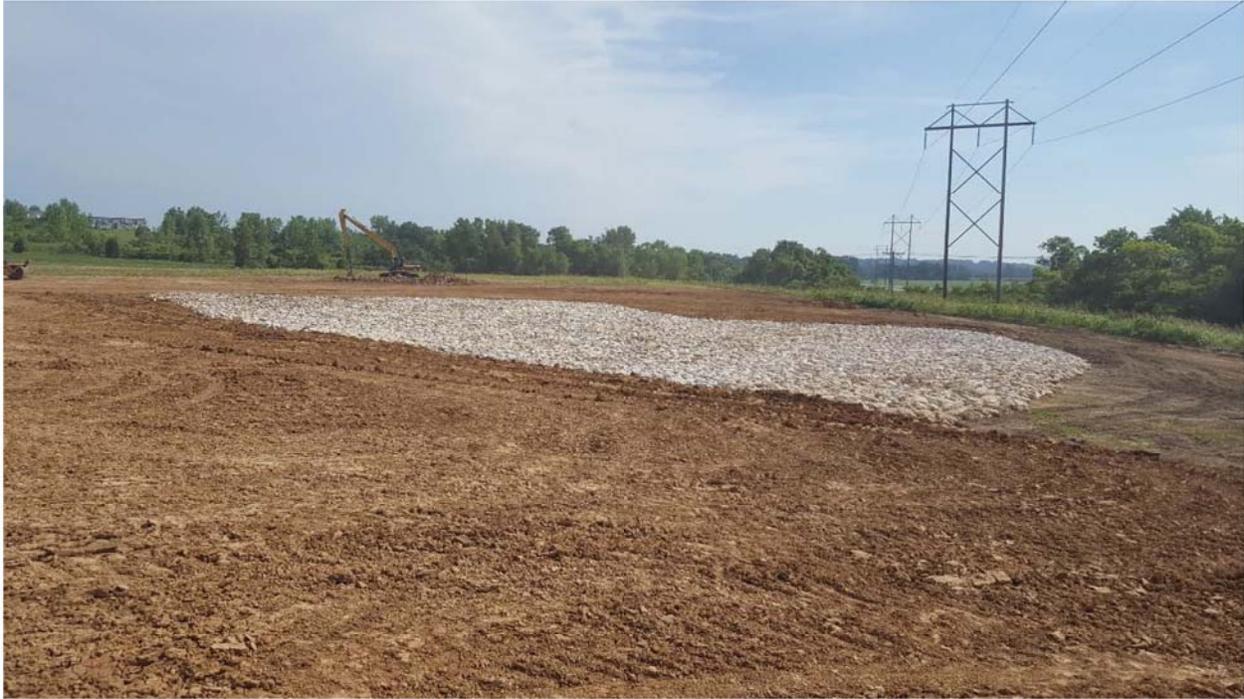
Figure 7: Drainage rip-rap rock placed over the Geocomposite and CAR GCL layers in the north fly ash pond (facing north)

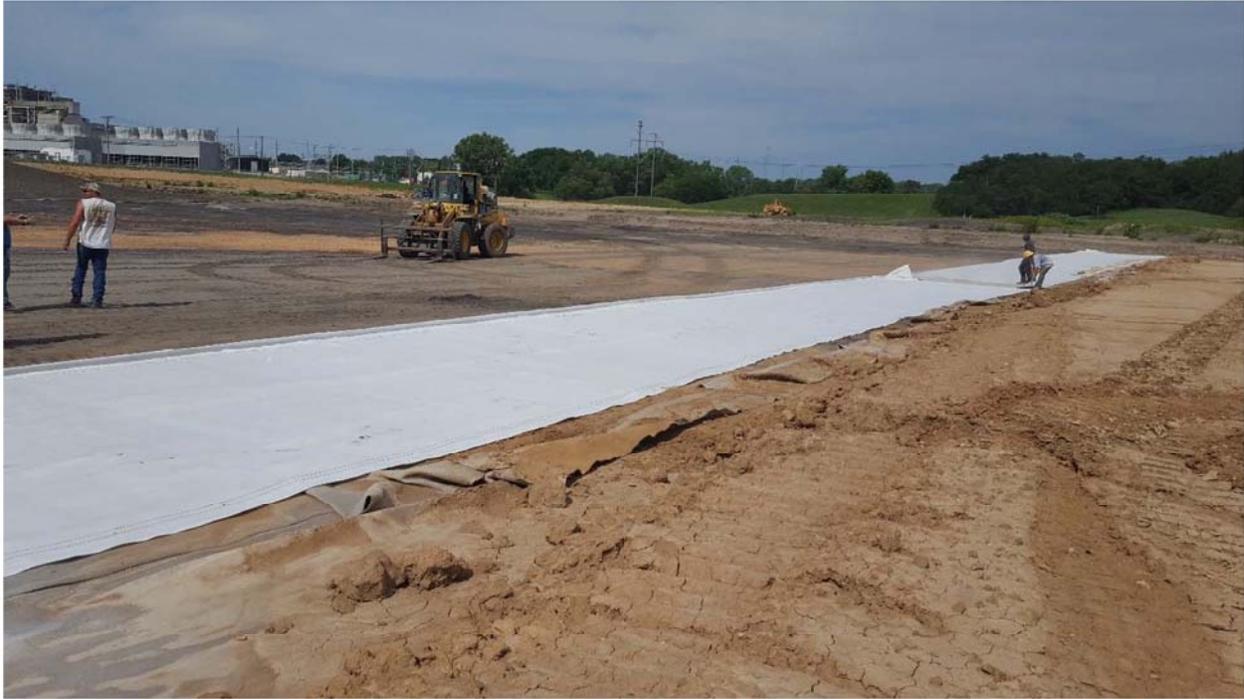
Figure 9: Placing regular GCL in the middle of the southeast fly ash pond (facing southwest)

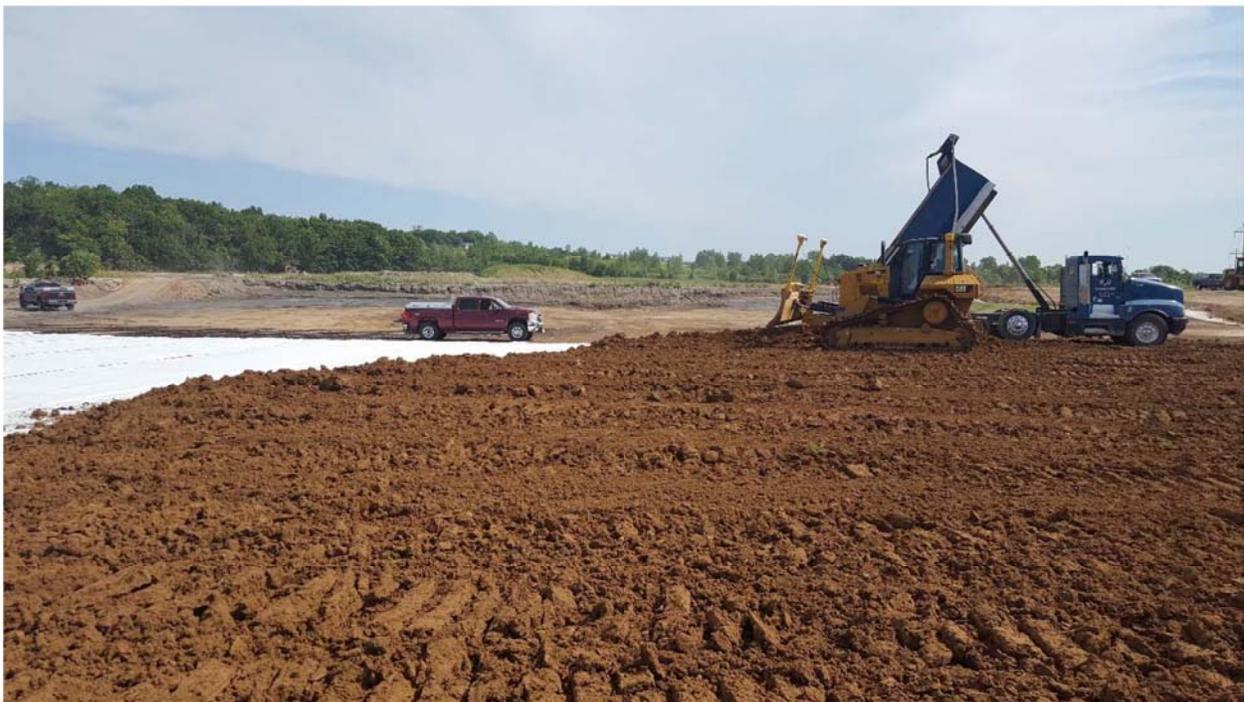
Figure 10: D6 dozer placing soil from the borrow area over the GCL panels (facing north)

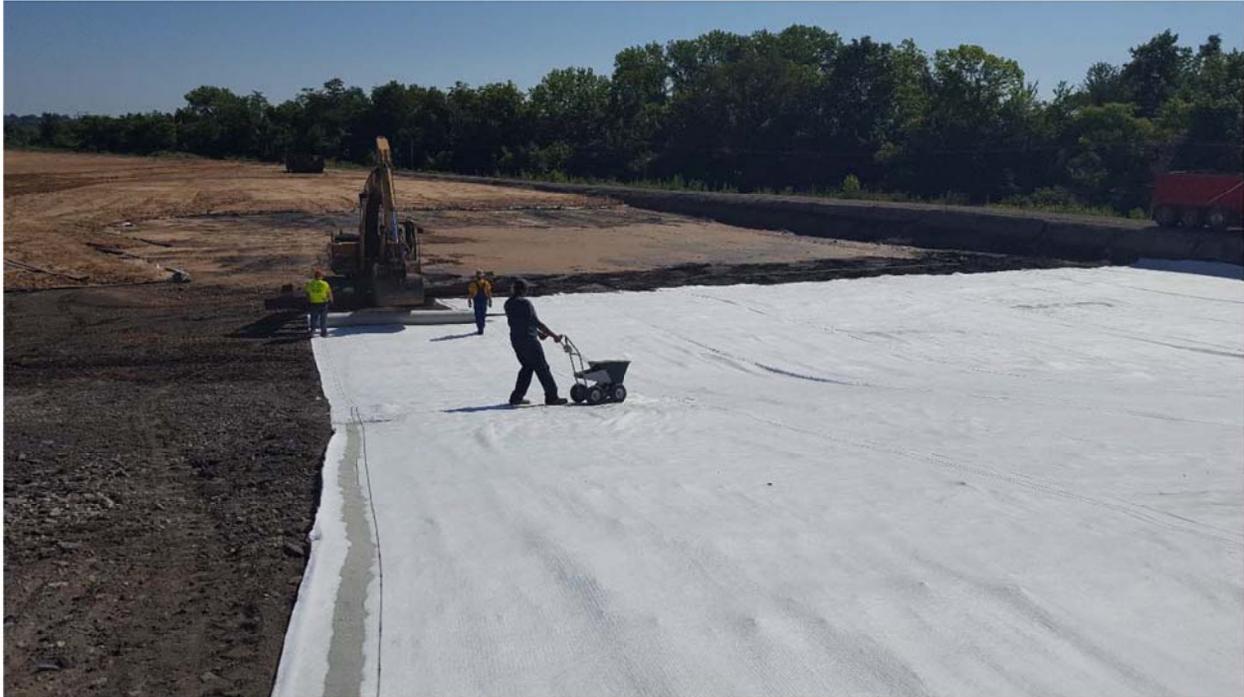
Figure 1: 7/17/2017 Deploying regular GCL panels in the southeast corner of the southeast fly ash pond (facing northeast)

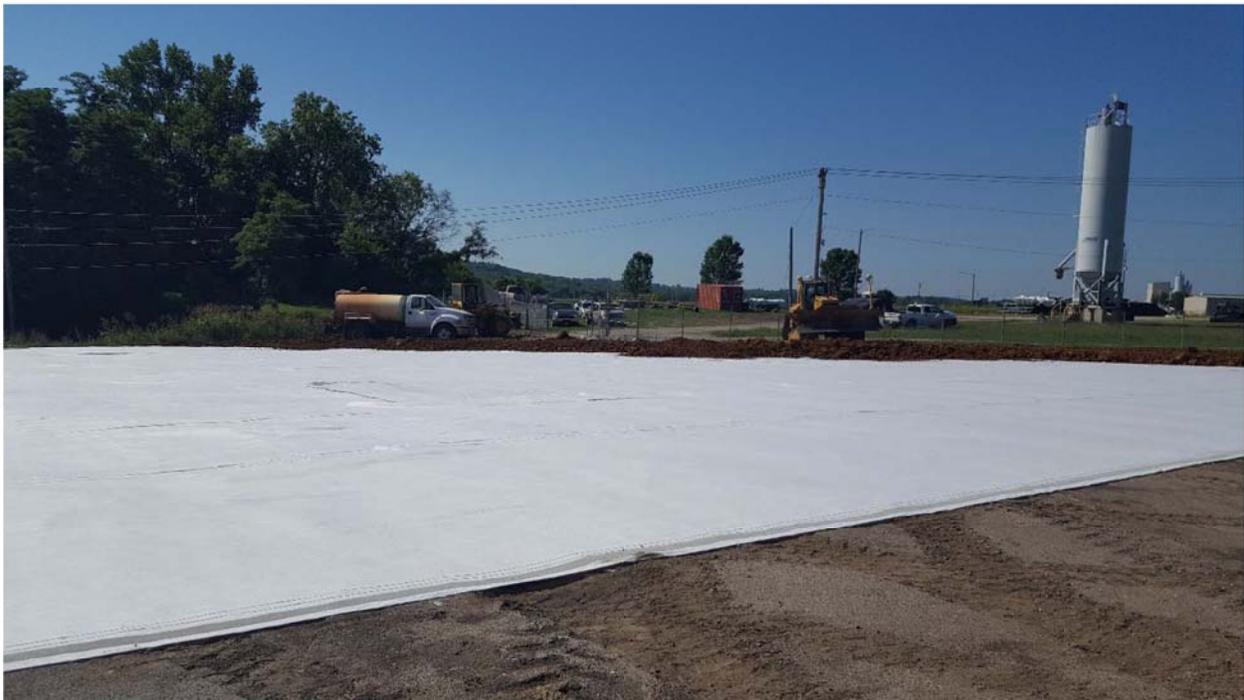
Figure 2: 7/17/2017 A D6 dozer placing soil from the borrow area over the GCL placed in the southeast corner of the southeast pond (facing northwest)

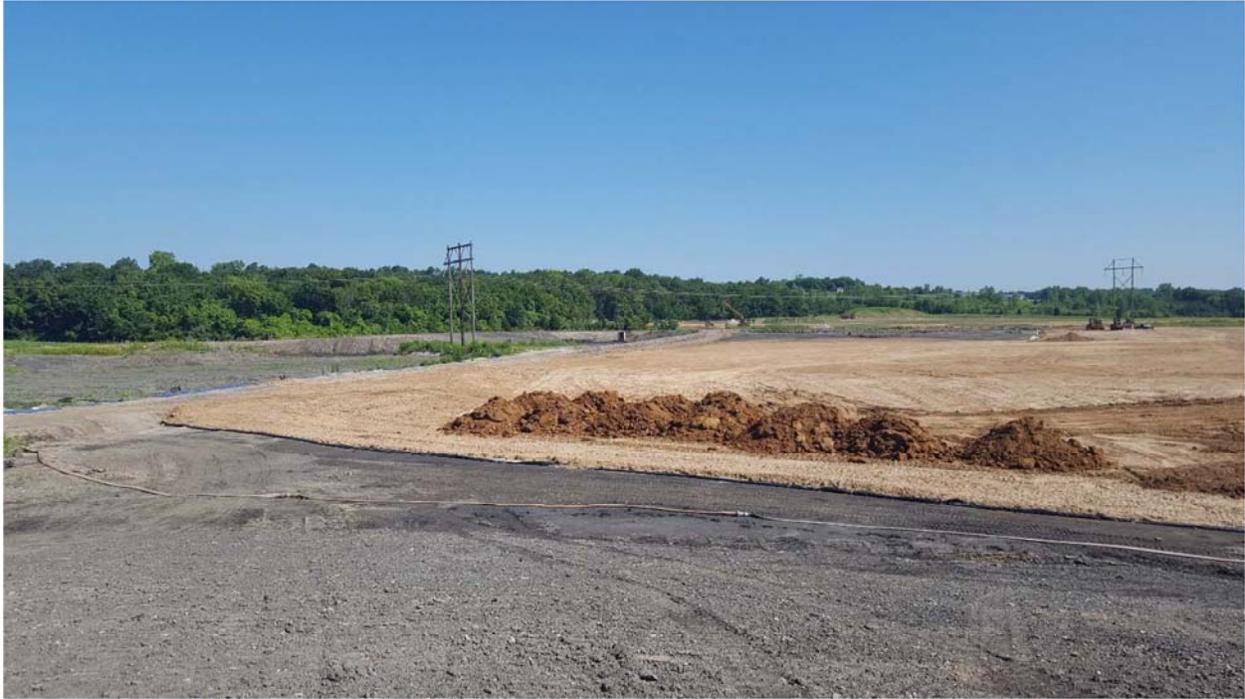
Figure 3: 7/17/2017 Soil had been placed completely over the GCL on the north half of the southeast fly ash pond (facing northwest)

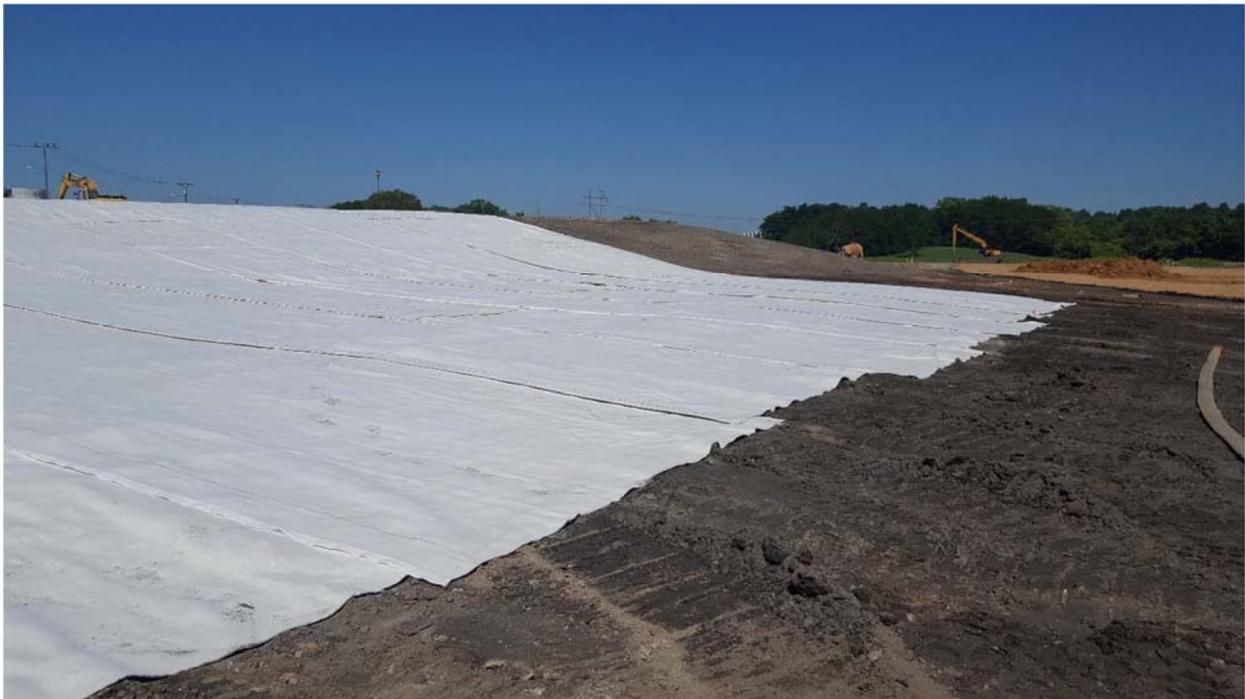
Figure 4: 7/17/2017 Regular GCL panels placed over the mounded area of the southeast fly ash pond (facing east)

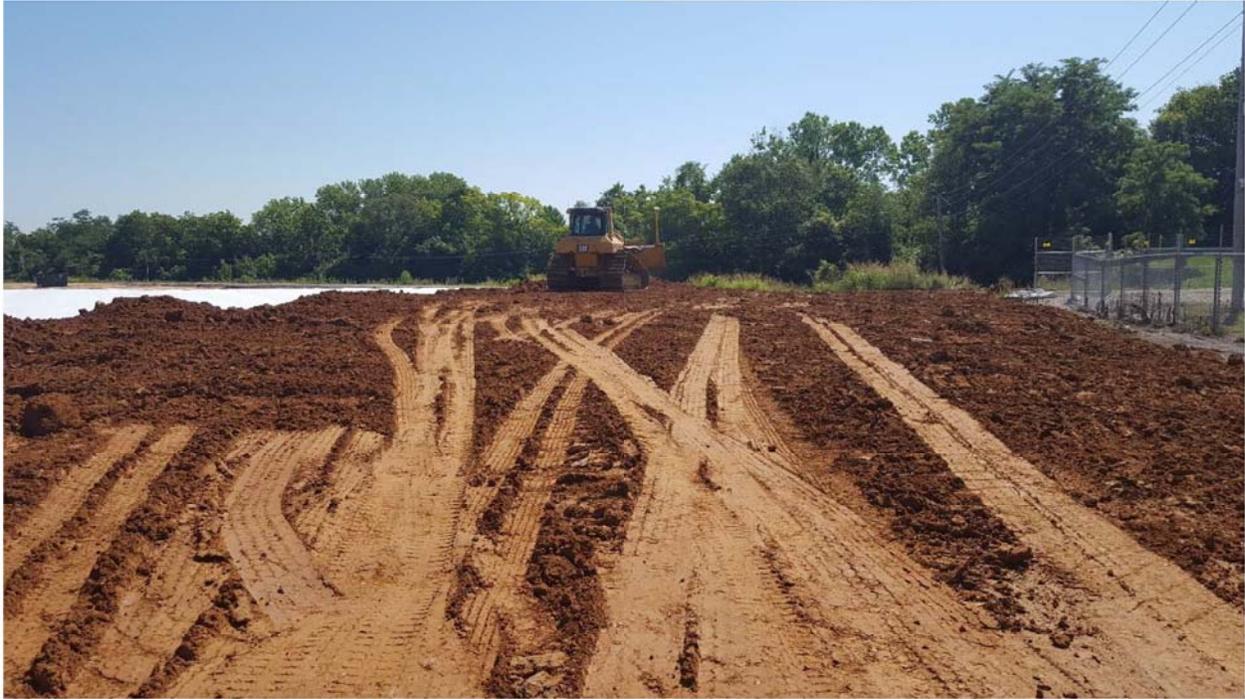
Figure 5: 7/17/2017 The D6 dozer placed soil 1 foot minimum to completely cover the GCL panels deployed in the morning (facing east)

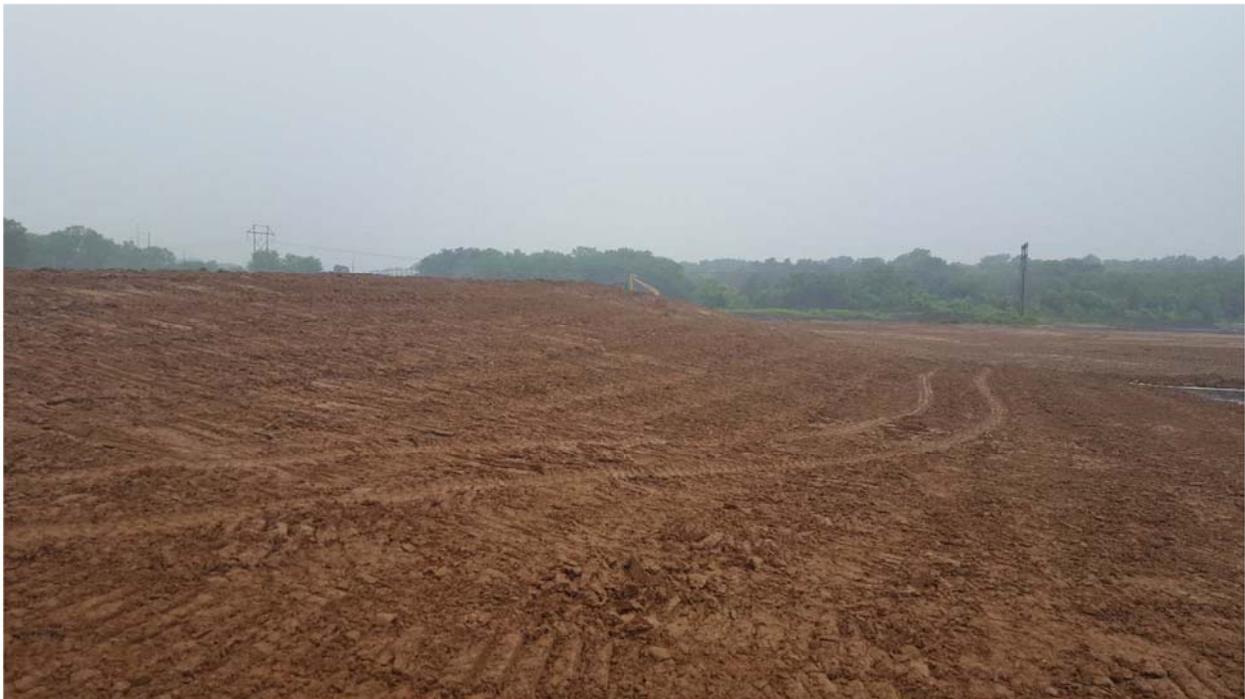
Figure 6: 7/19/2017 Soil completely covering the mounded area of the southeast fly ash pond (facing west)
