## **Ash Impoundment Closure Report**

Independence Power & Light  
Blue Valley Power Station  
21500 East Truman Road  
Independence, Missouri 64056

**SCS ENGINEERS**  
7311 West 130th Street, Suite 100  
Overland Park, Kansas 66213  
(913) 681-0030

April 2018  
Revised June 2018  
File No. 27215142.00

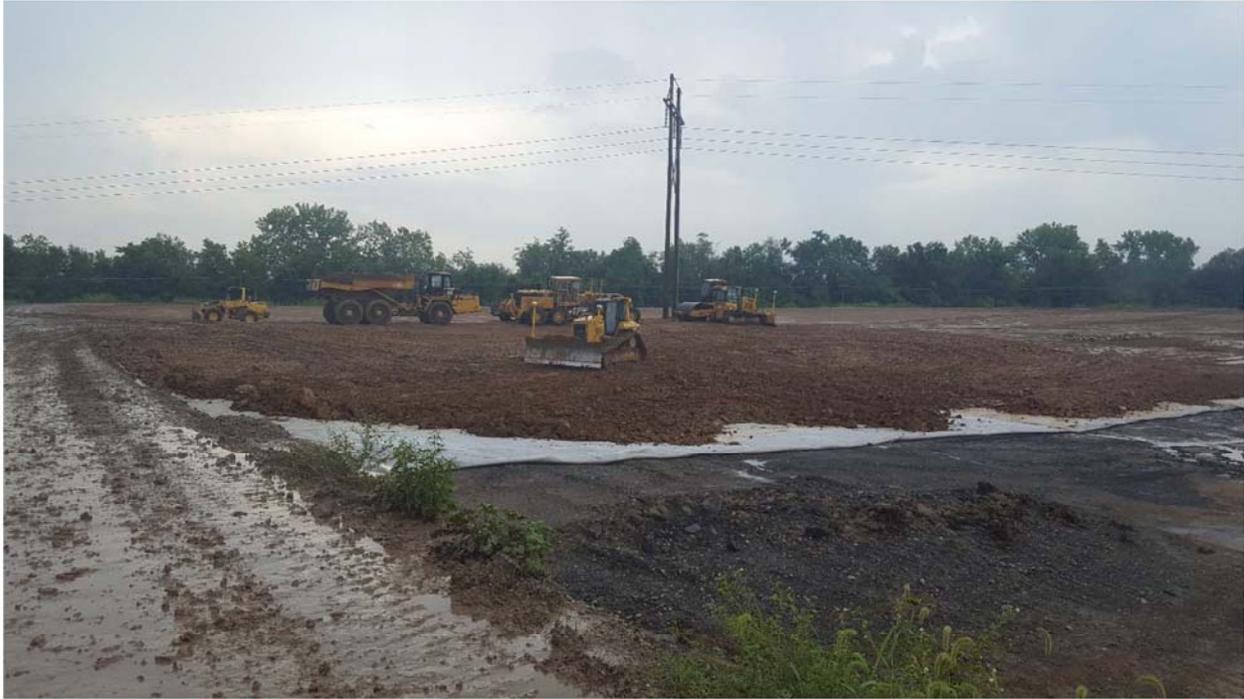
Figure 7: 7/19/2017 A D6 dozer placing soil from the borrow area to cover the regular GCL panels placed in the morning in the southeast fly ash pond (facing southeast)

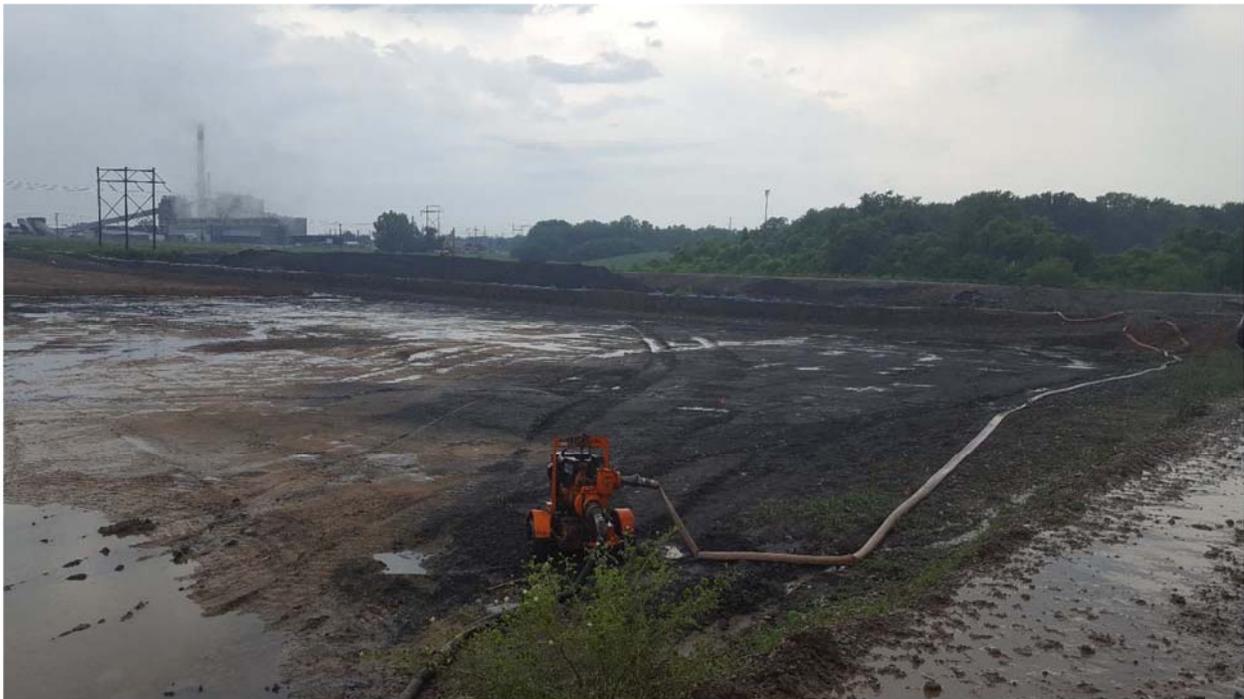
Figure 8: 7/19/2017 Overview of the standing water in the northwest corner of the southeast fly ash pond (facing southwest)

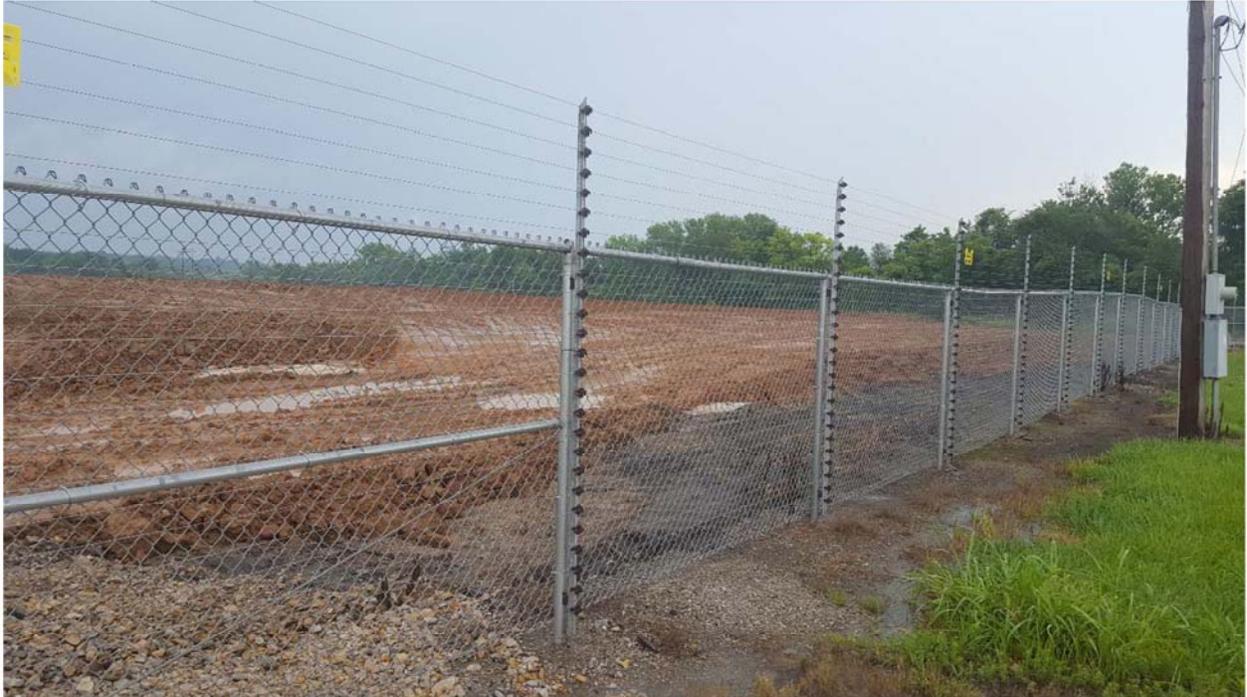
Figure 9: 7/19/2017 Overview of the soil covering the GCL placed in the southeast corner of the southeast fly ash pond (facing northeast)

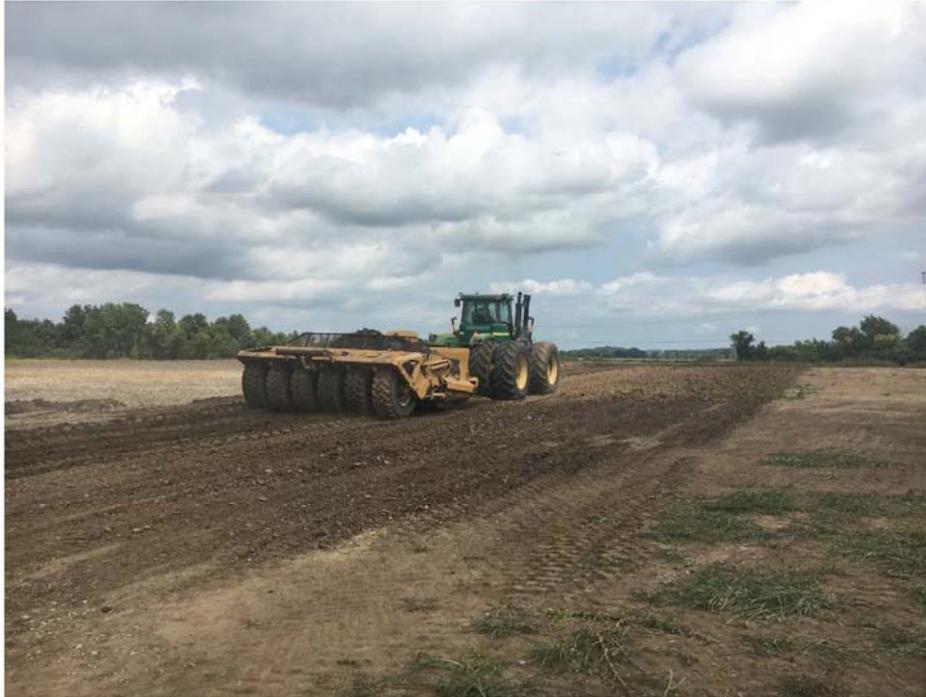
Figure 1: Placing sand over clay in the north fly ash pond with John Deere tractor and scraper.

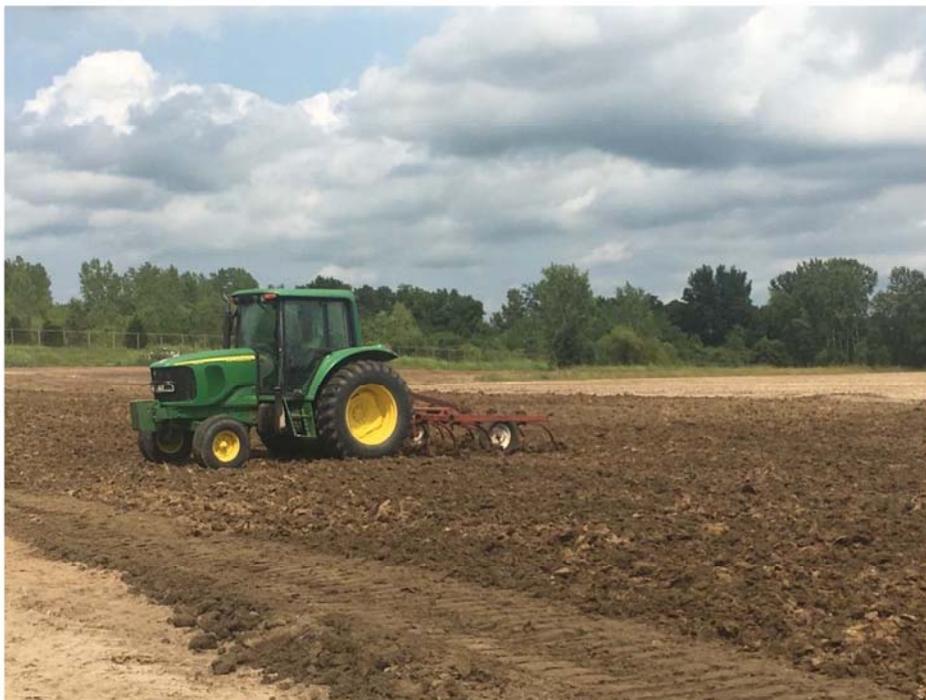
Figure 2: Using a spring tooth harrow on tractor to mix in the sand with clay across the north fly ash pond.

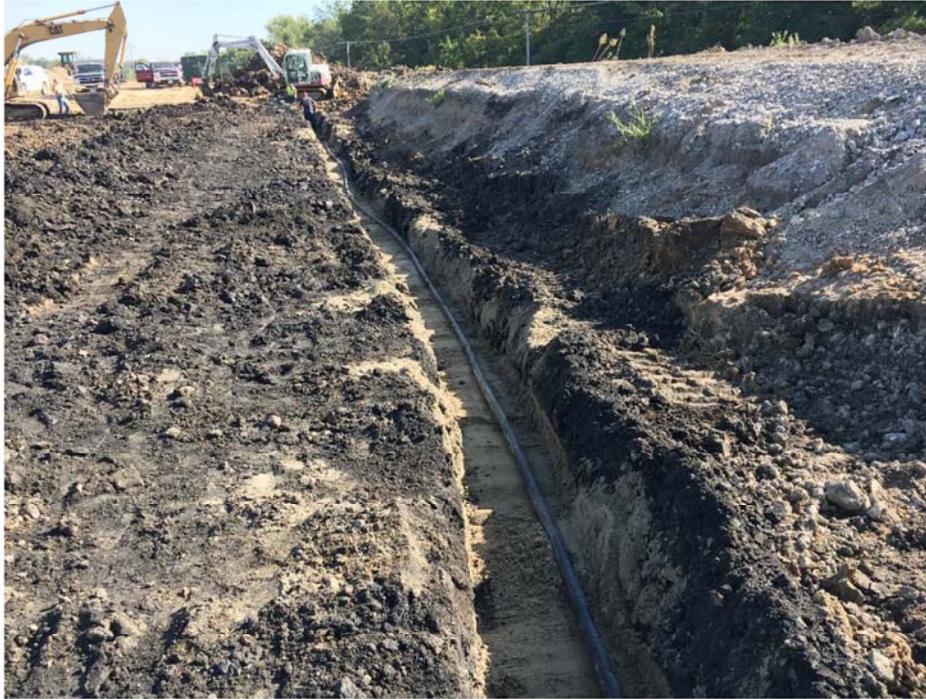
Figure 1: Collection pipe trench located on the southeast discharge location of the SEFAP (facing north)

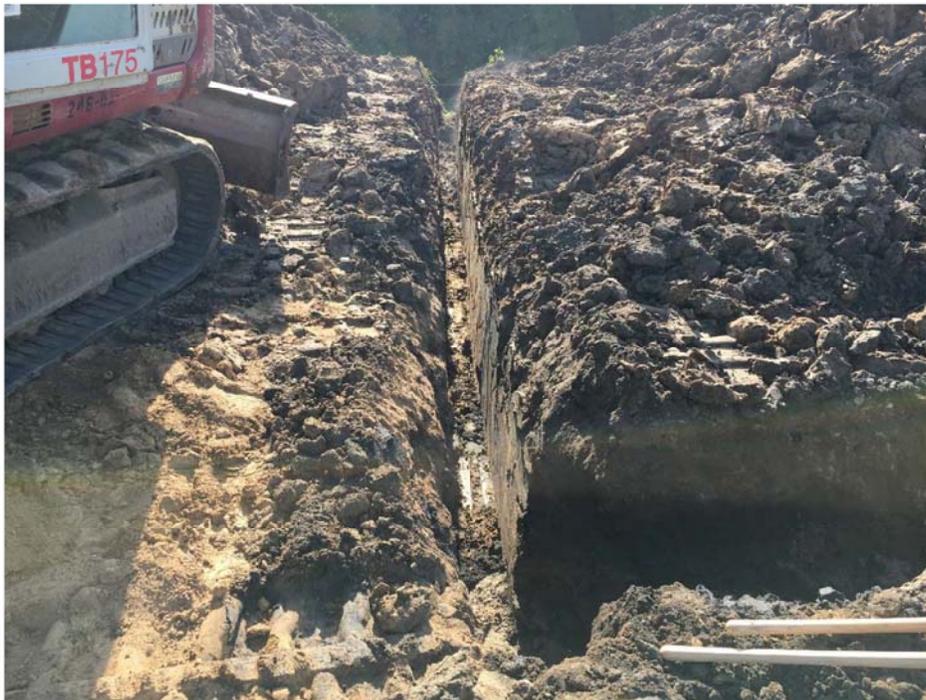
Figure 2: Solid pipe discharge trench located on the north end of the southeast discharge location of the SEFAP. (facing east)

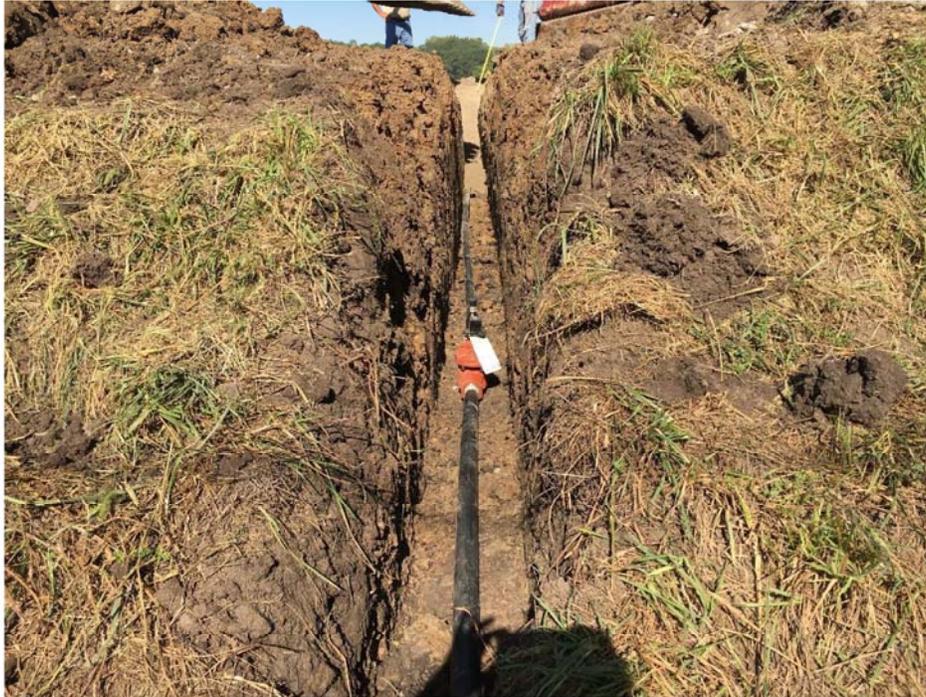
Figure 3: Solid discharge pipe extending through the east berm of the SEFAP. Discharge and pressure relief valves are installed. (facing west)

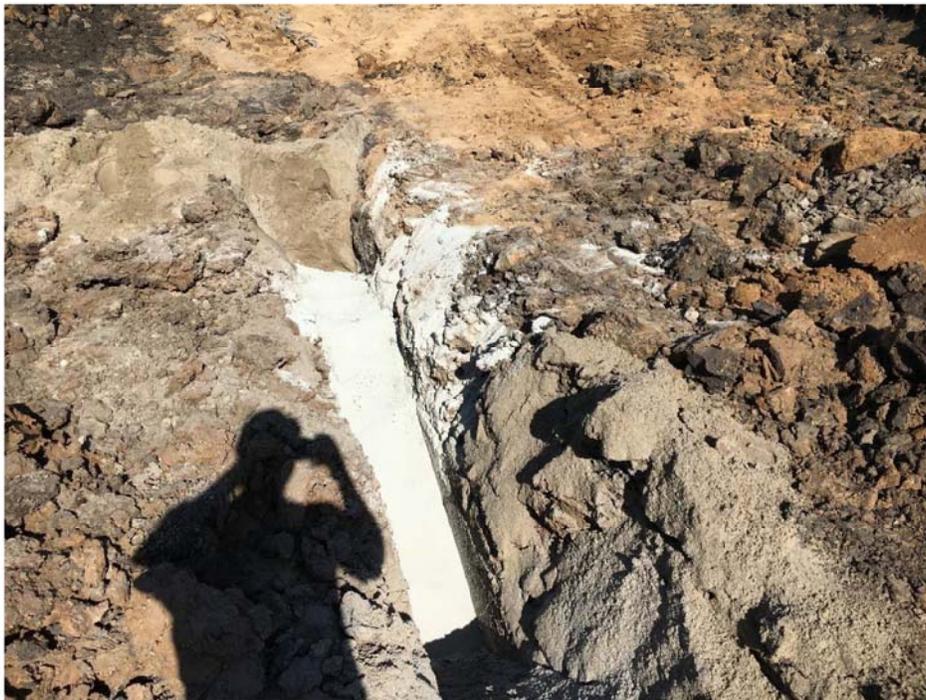
Figure 4: Bentonite plug around solid discharge pipe of the southeast discharge location. (facing east)

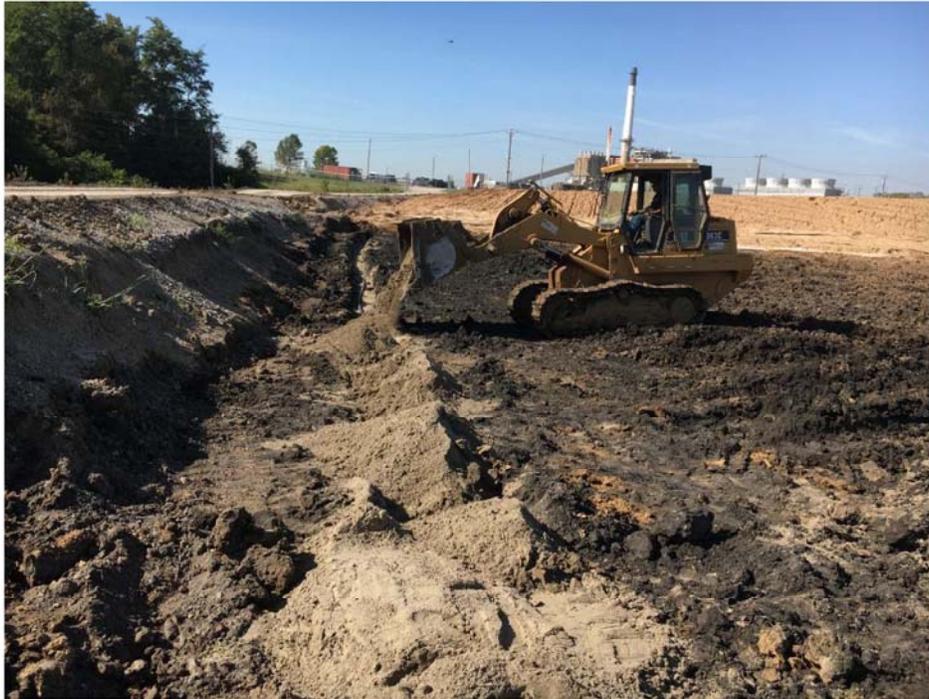
Figure 5: Radmacher placing sand over the slotted pipe in the southeast discharge location trench. (facing south)

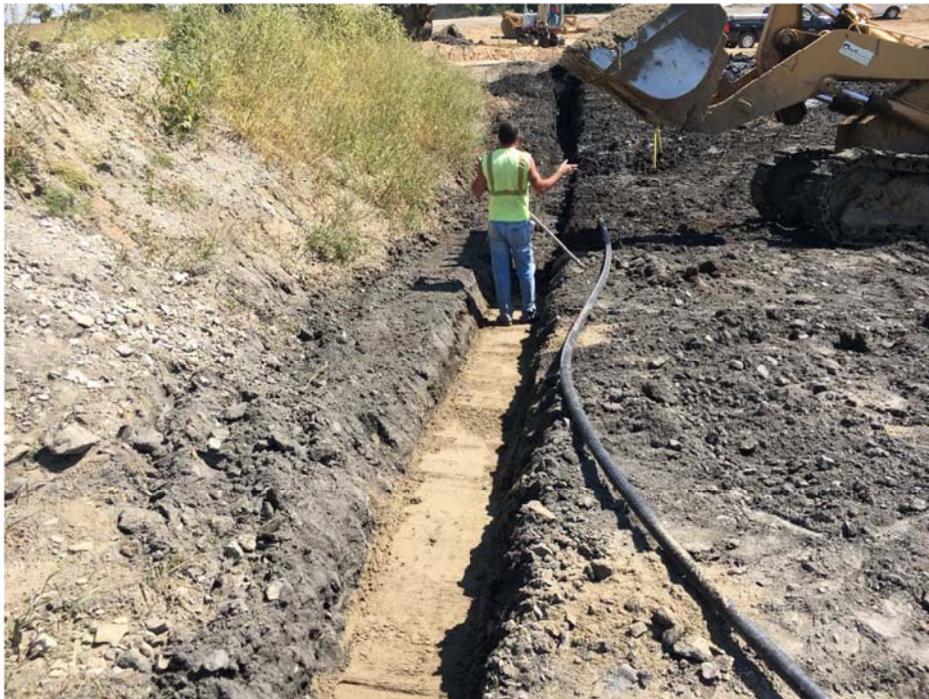
Figure 6: Placing sand pipe bedding in the north discharge location pipe trench of the SEFAP. (facing east)

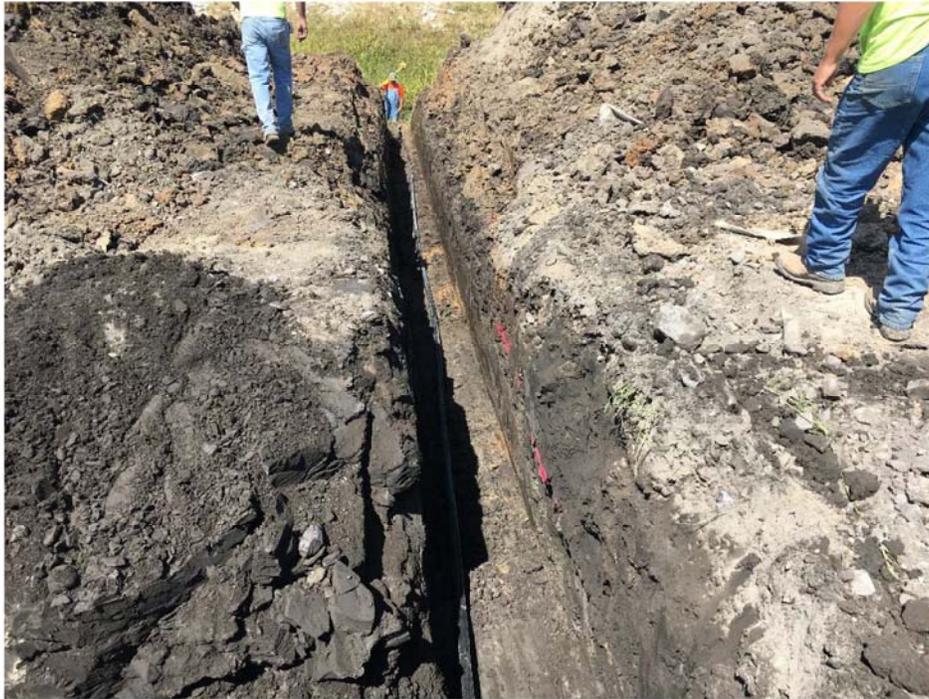
Figure 7: Solid discharge pipe trench through the north berm. (facing north)

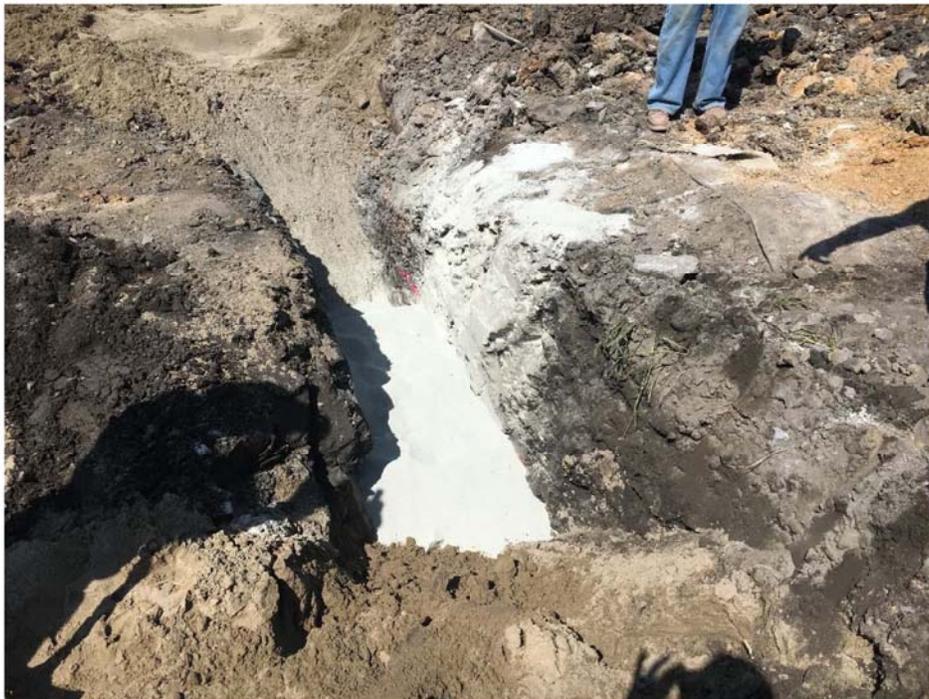
Figure 8: Bentonite plug around the solid discharge pipe. (facing southeast)

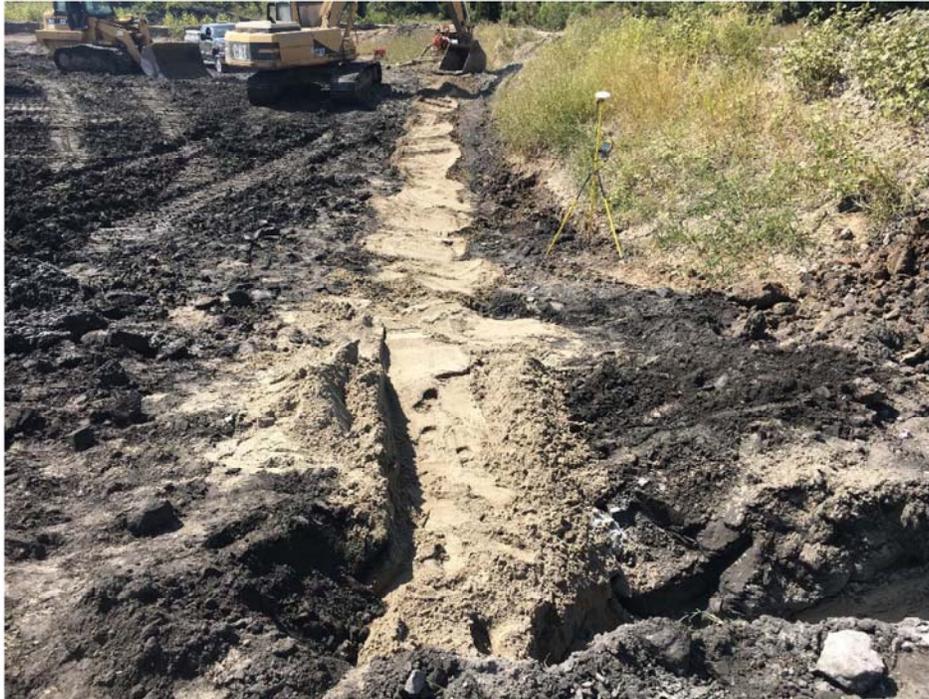
Figure 9: North collection trench backfilled with sand.  
(facing west)

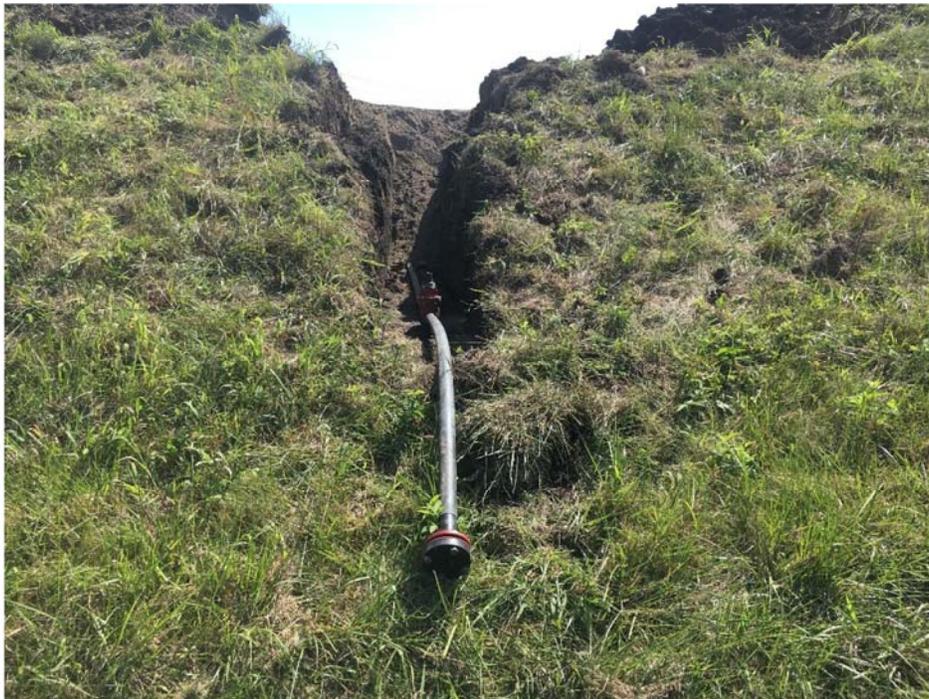
Figure 10: Solid discharge pipe with valves installed extending through the north berm  
(facing south)

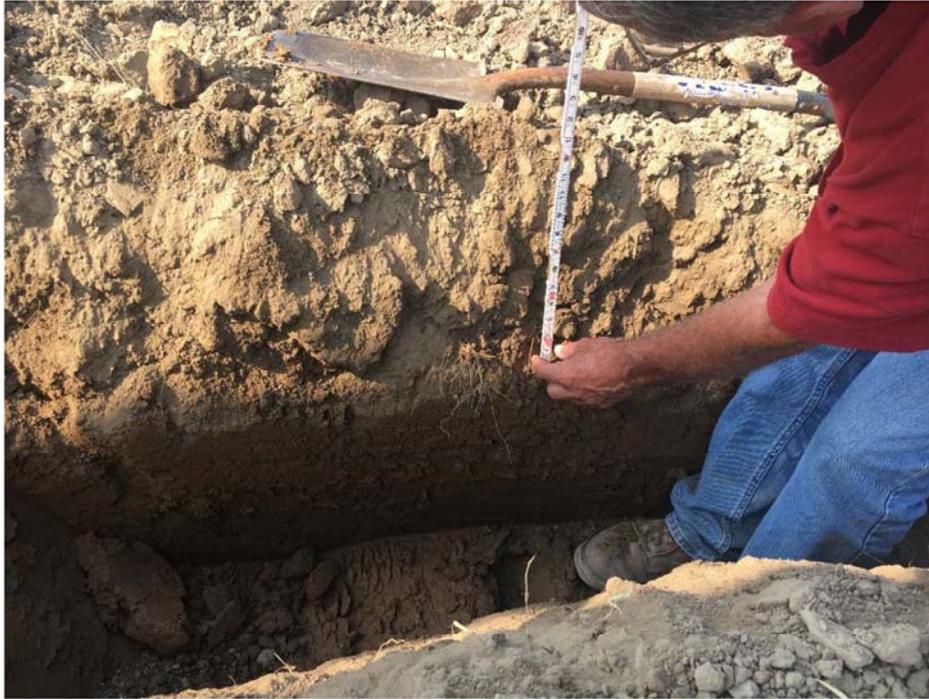
Figure 1: Measuring mixed topsoil on the north fly ash pond.

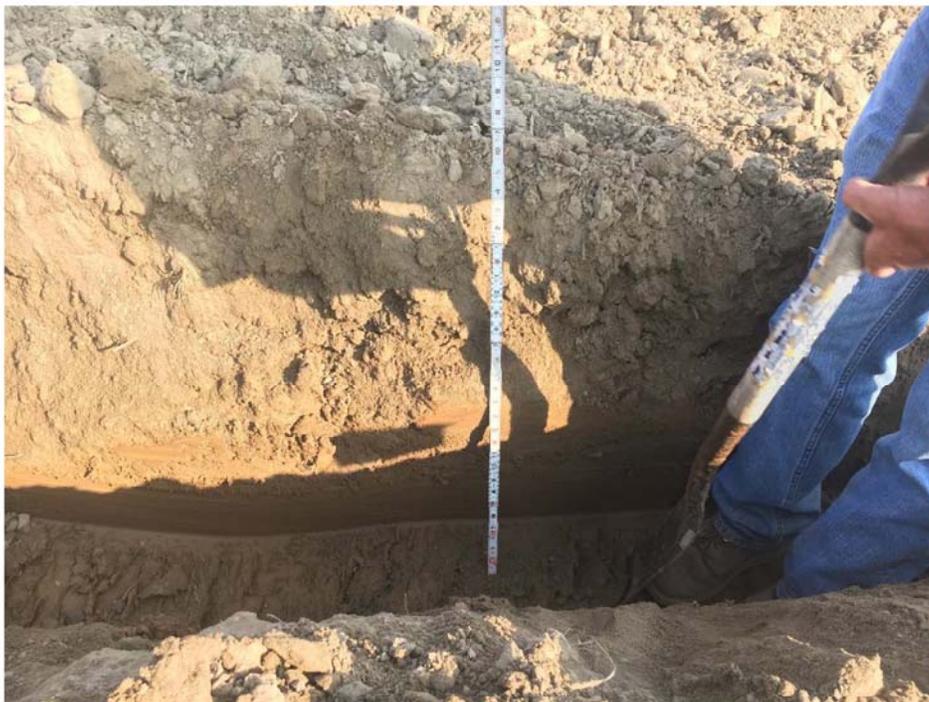
Figure 2: Measuring mixed topsoil and clay on the north fly ash pond.

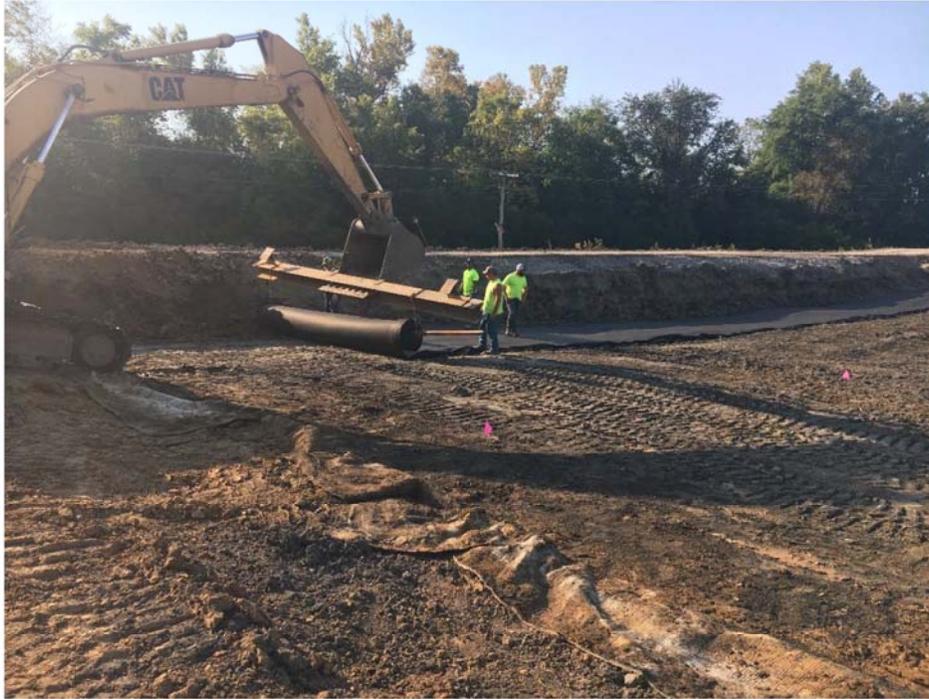
Figure 1: 9/11/2017 Deploying geocomposite over pipe trench of the southeast discharge location of the SEFAP (facing east)

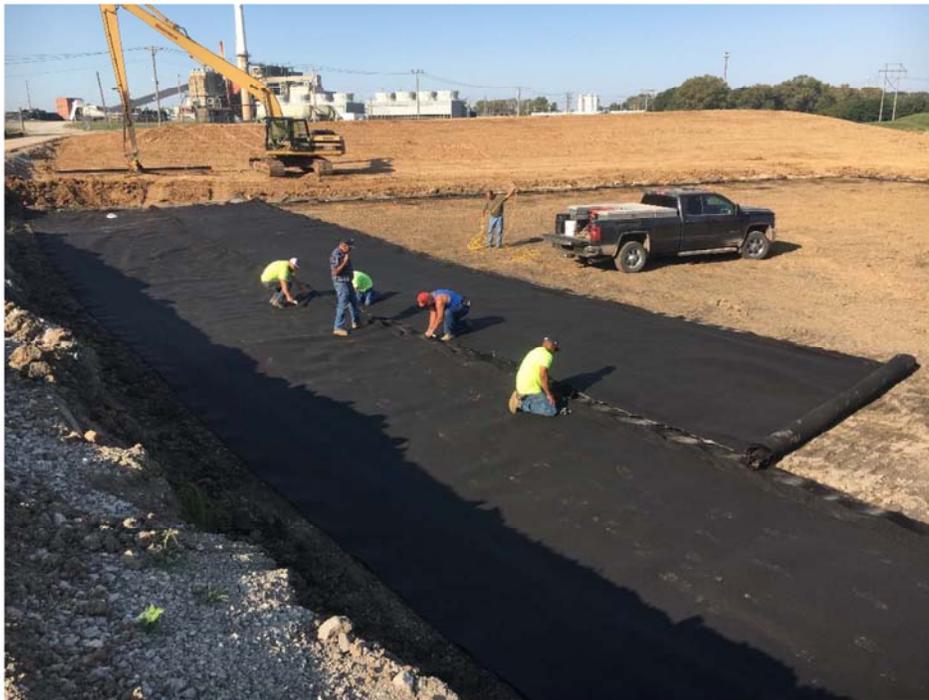
Figure 2: 9/11/2017 Zip tying geocomposite panels together. (facing southwest)

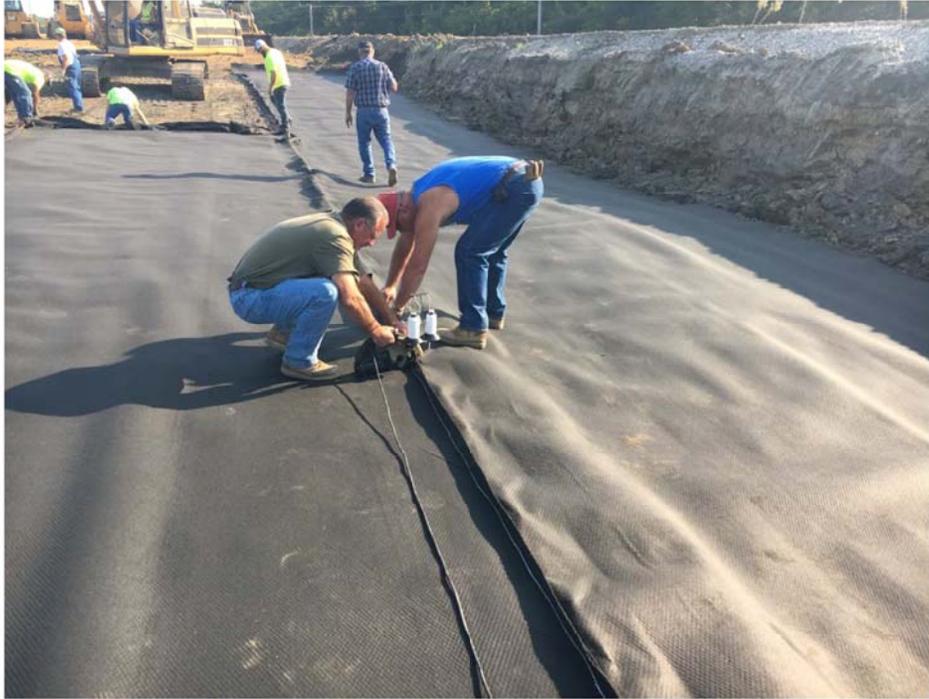
Figure 3: 9/11/2017 Sewing geocomposite panels together. (facing north)

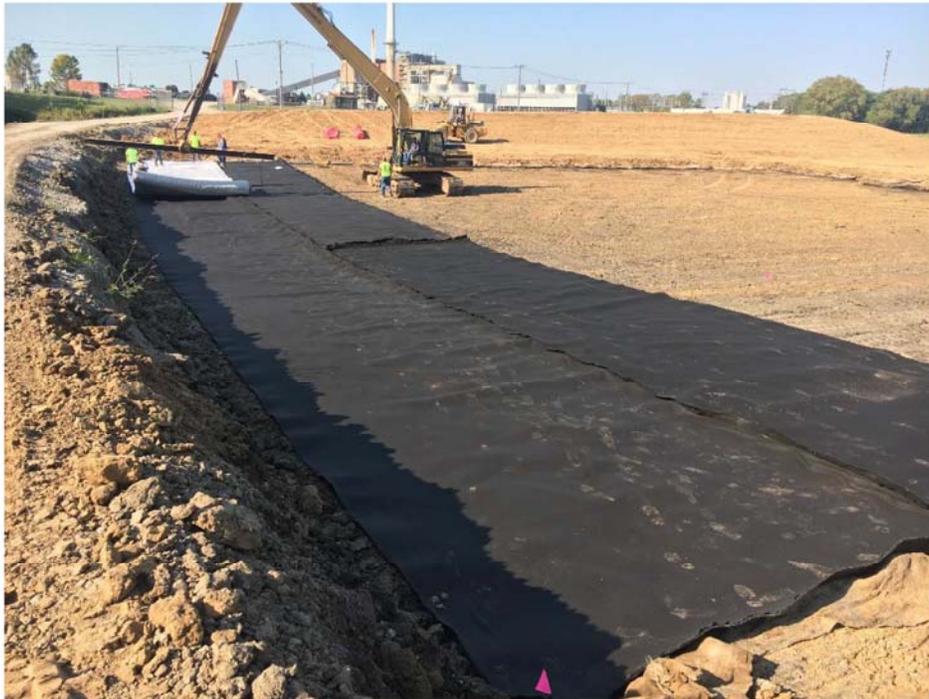
Figure 4: 9/11/2017 Deploying CAR GCL over geocomposite in southeast discharge location. (facing south)

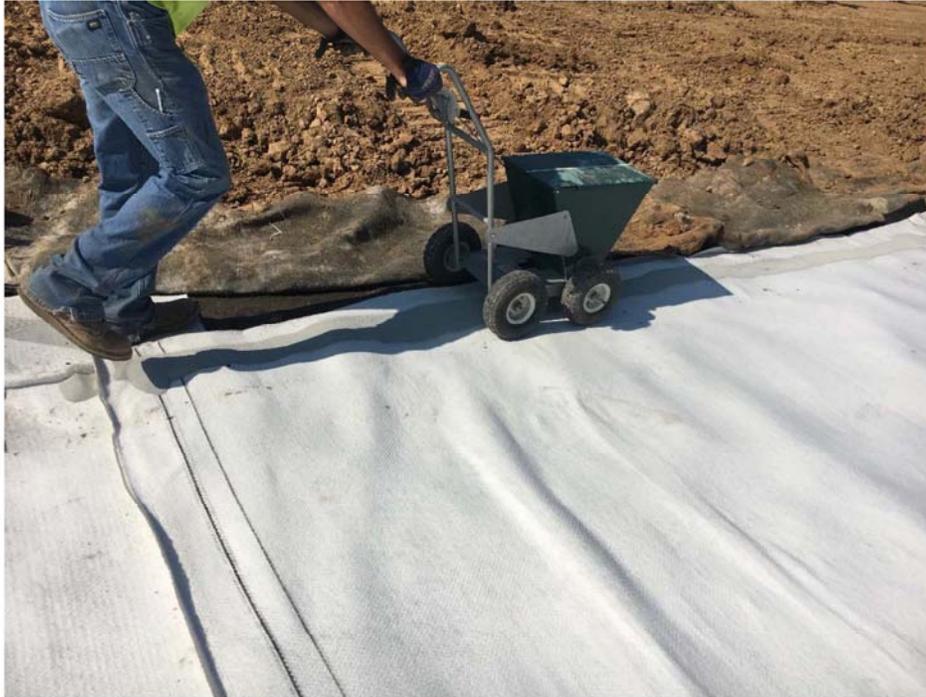
Figure 5: 9/11/2017 Placing bentonite between the GCL overlaps.

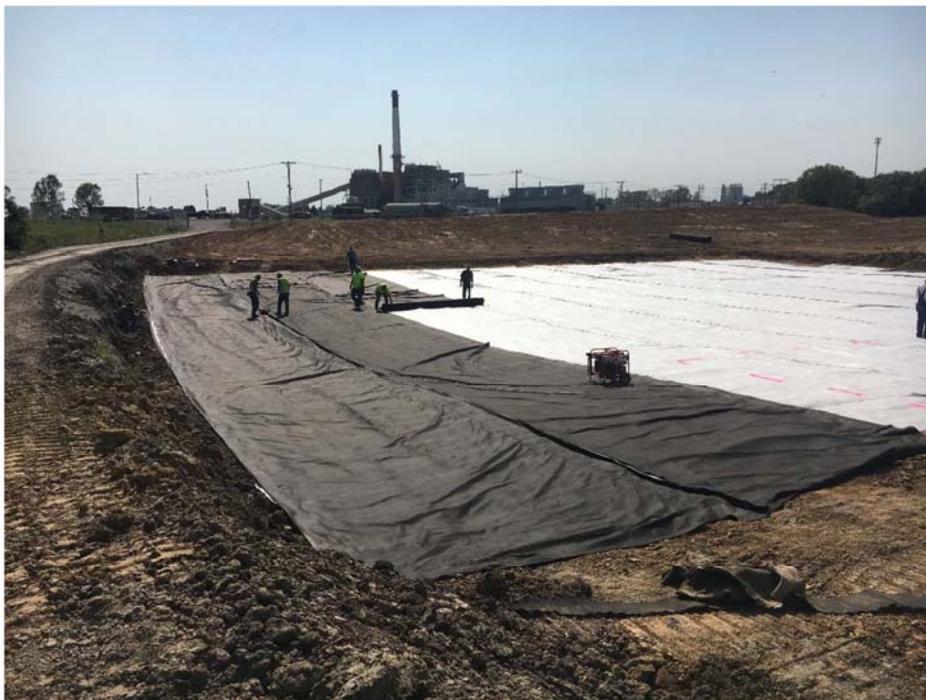
Figure 6: 9/11/2017 Deploying geotextile over CAR GCL. (facing south)

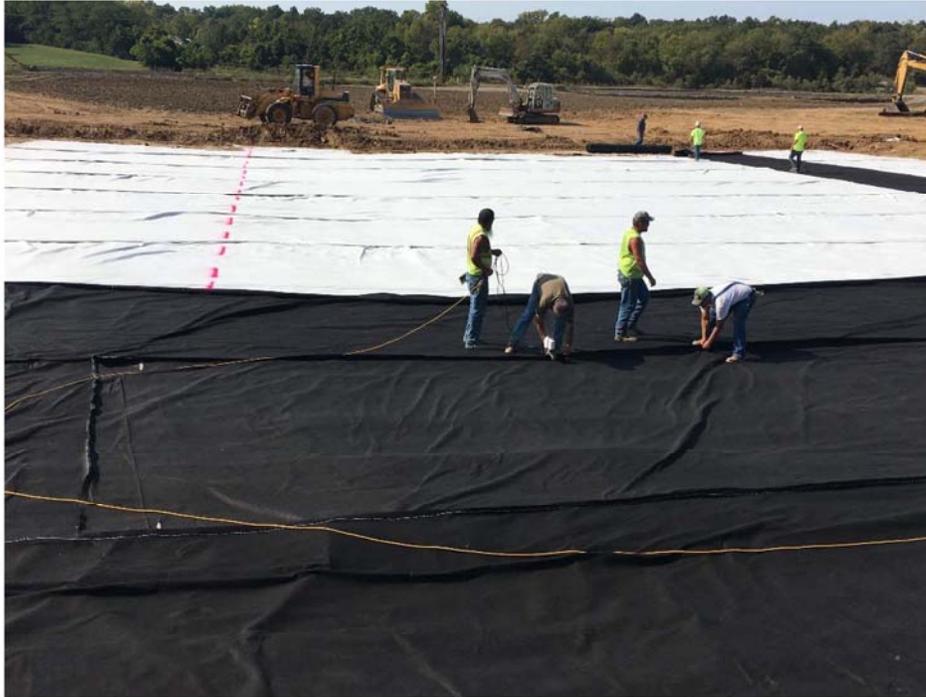
Figure 7: 9/11/2017 Sewing geotextile panels together. (facing west)

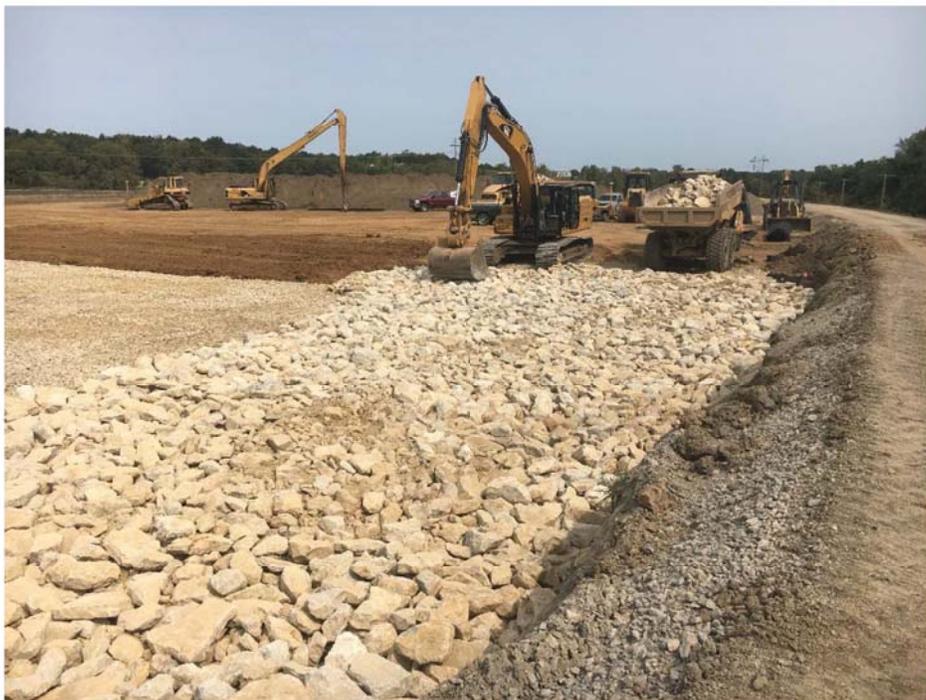
Figure 8: 9/12/2017 Placement of rip-rap over bedding on the southeast discharge location. (facing north)

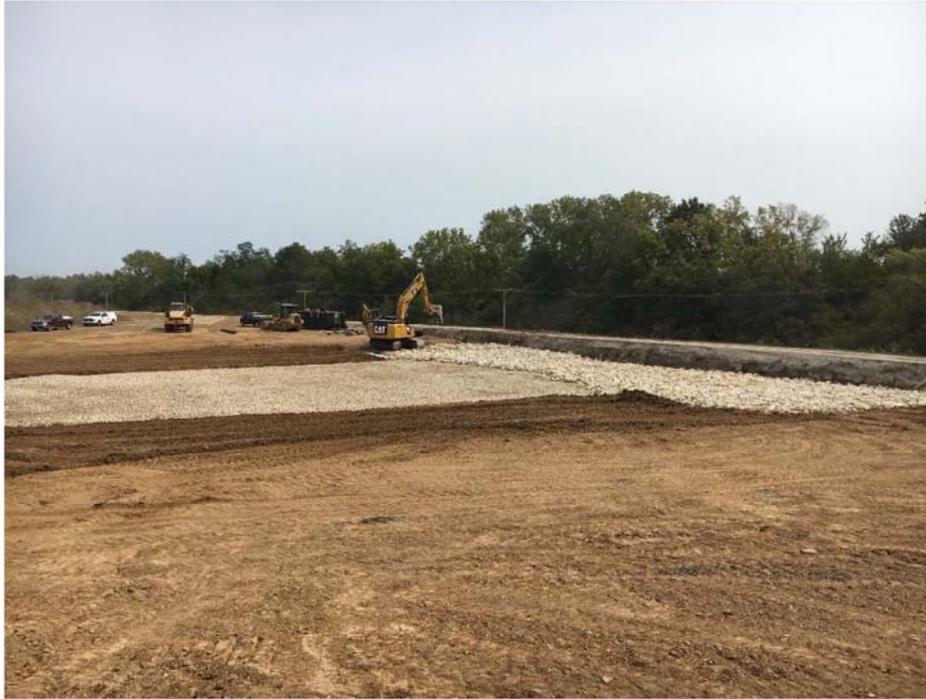
Figure 9: 9/12/2017 View of southeast discharge location of the SEFAP.  
(facing northeast)

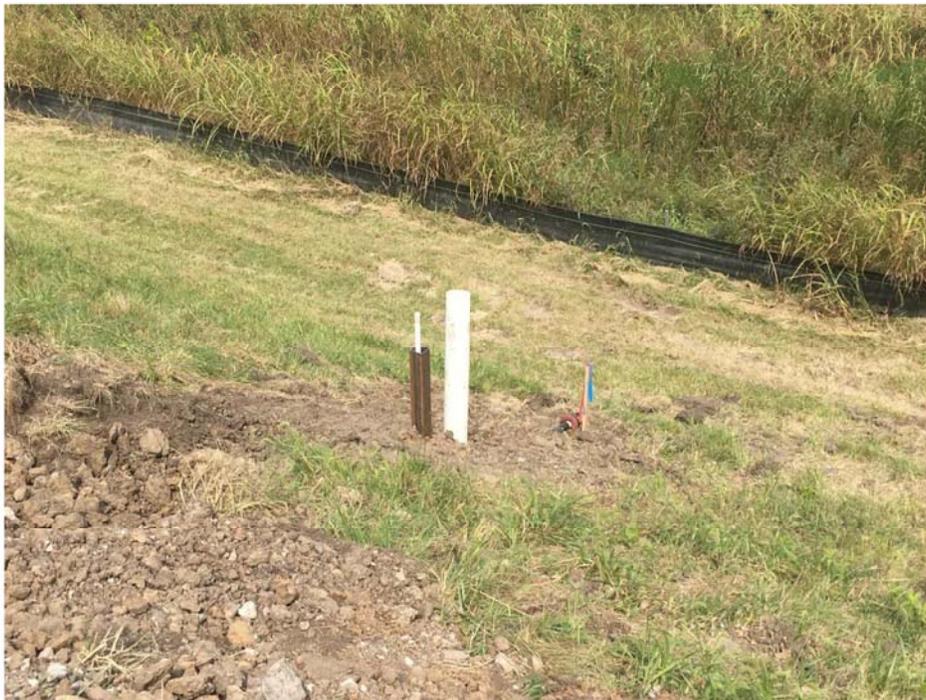
Figure 10: 9/12/2017 Pressure Relief System valves risers. (facing east)

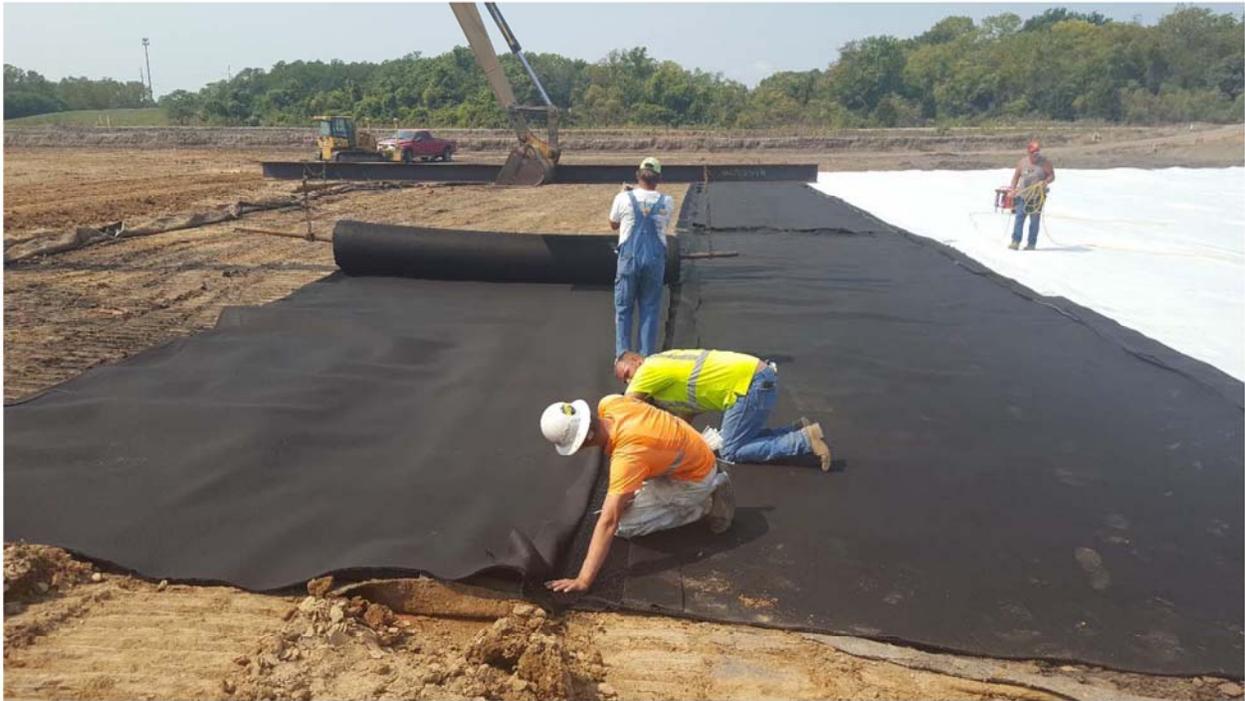
Figure 11: 9/13/2017 Deploying geocomposite over north discharge location of the SEFAP.  
(facing west)

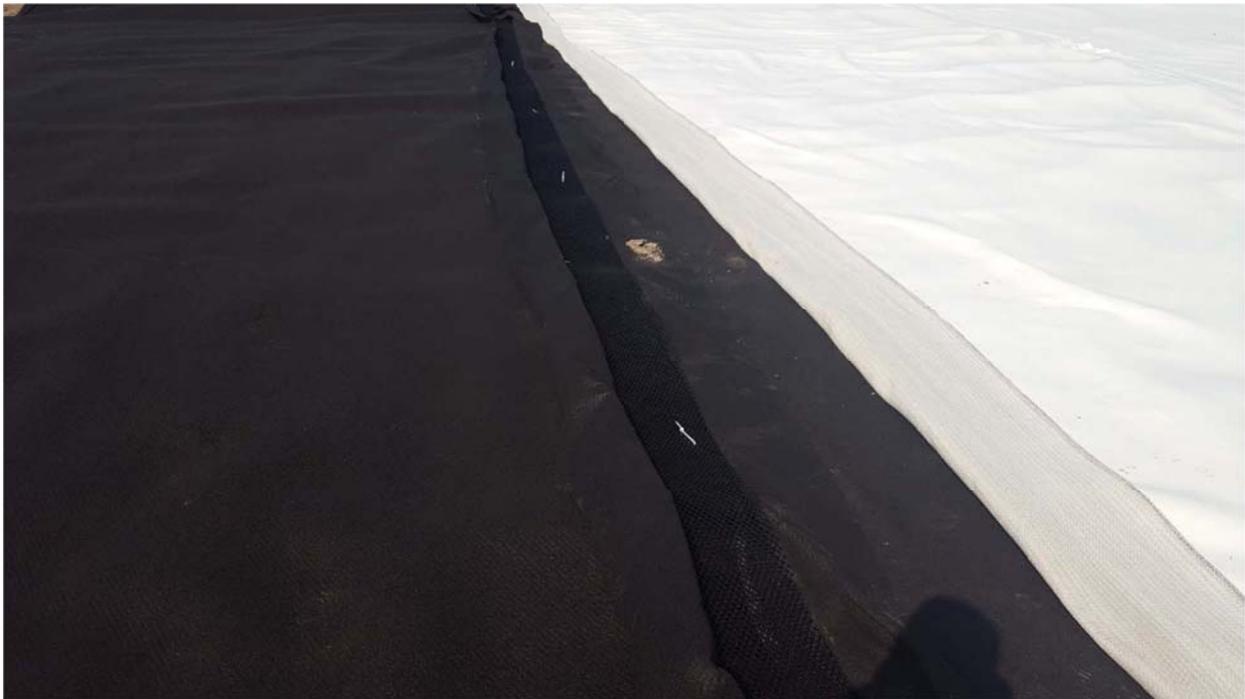
Figure 12: 9/13/2017 Geocomposite panels zip tied together.

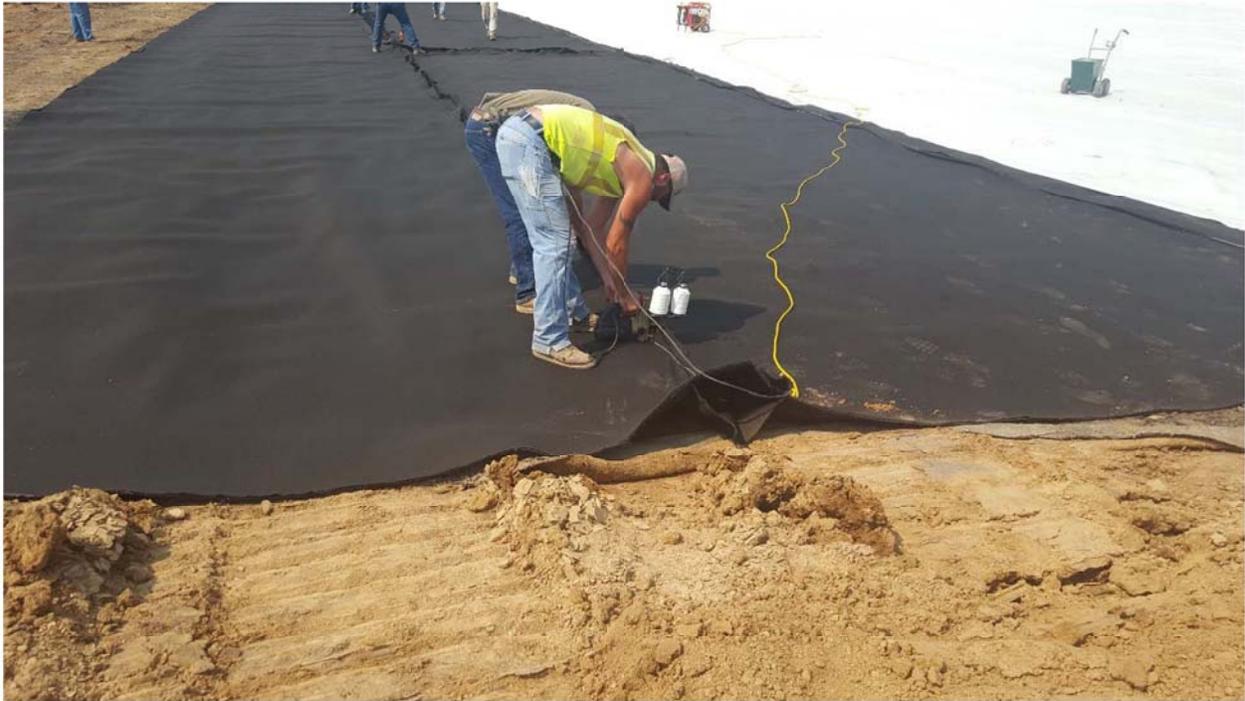
Figure 13: 9/13/2017 Sewing geocomposite panels together. (facing west)

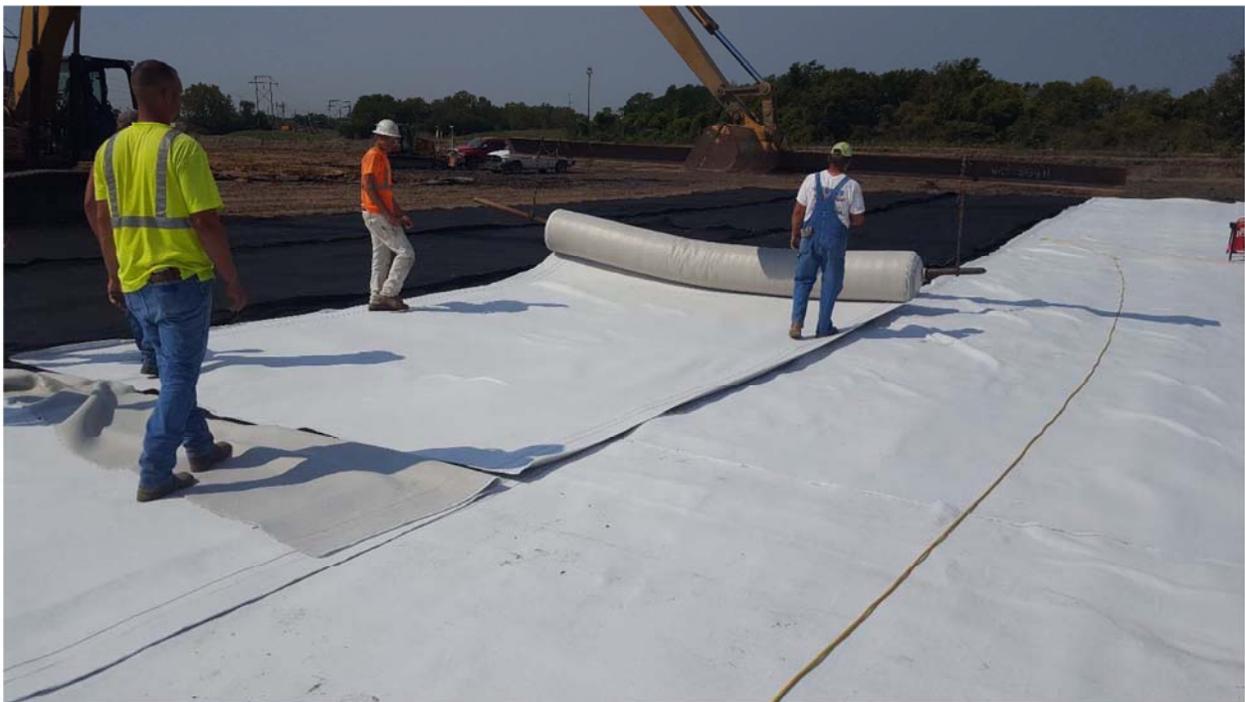
Figure 14: 9/13/2017 Deploying CAR GCL over the geocomposite. (facing west)
