## **Ash Impoundment Closure Report**

Independence Power & Light  
Blue Valley Power Station  
21500 East Truman Road  
Independence, Missouri 64056

**SCS ENGINEERS**  
7311 West 130th Street, Suite 100  
Overland Park, Kansas 66213  
(913) 681-0030

April 2018  
Revised June 2018  
File No. 27215142.00

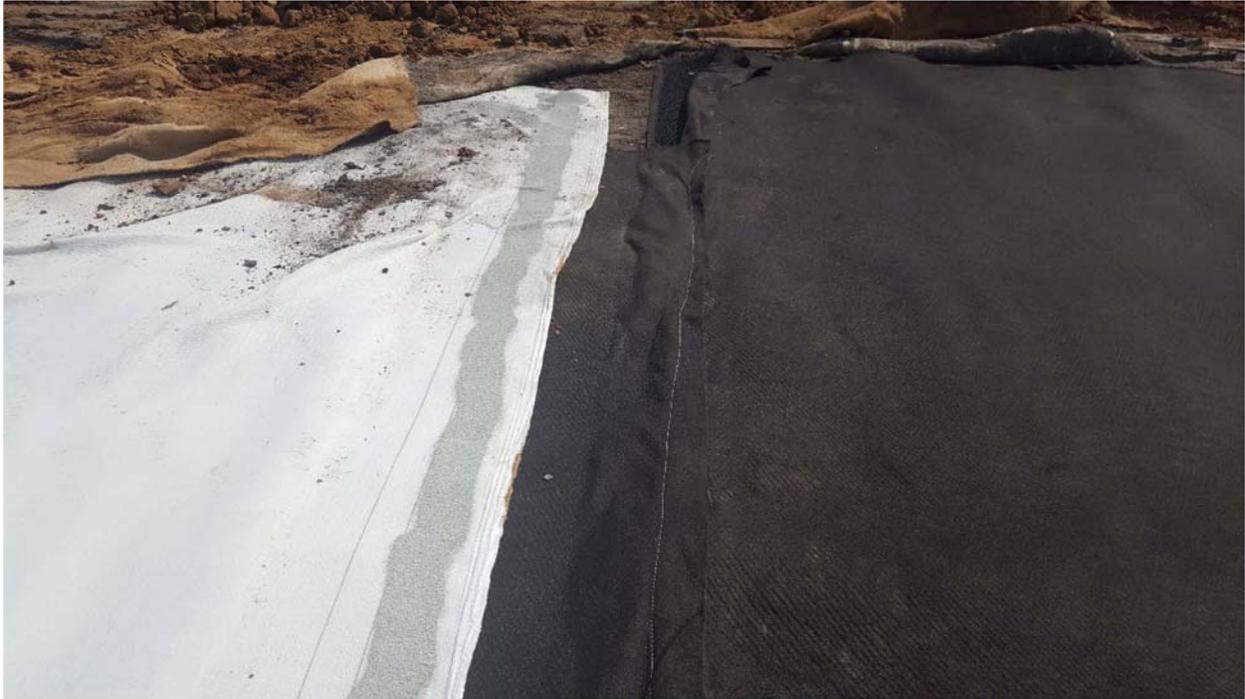
Figure 15: 9/13/2017 Bentonite placed on overlaps of CAR GCL.

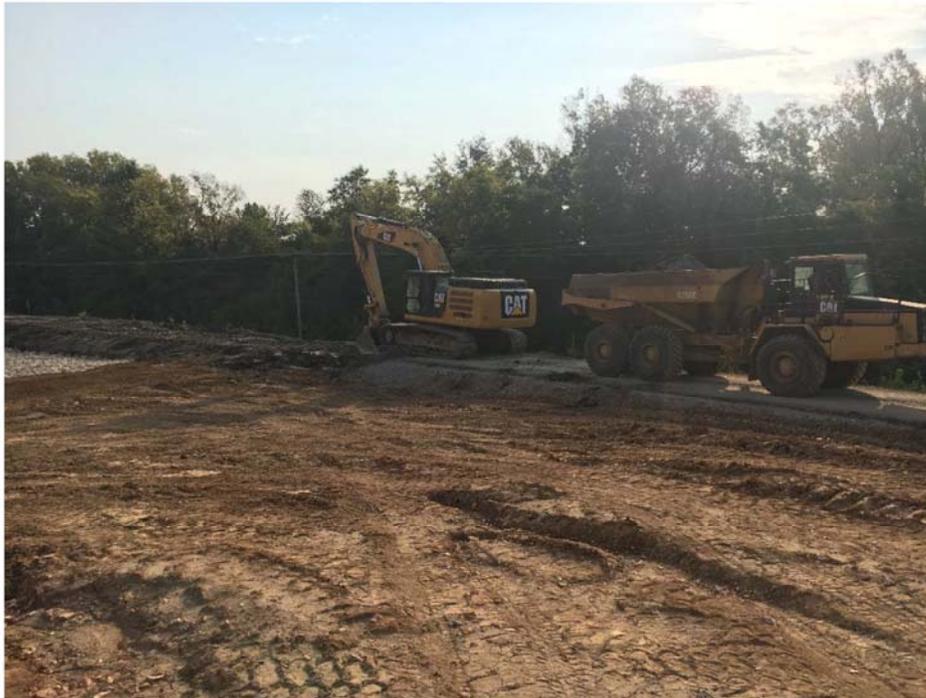
Figure 16: 9/14/2017 Lowering of east road along the southeast discharge location of the SEFAP. (facing northwest)

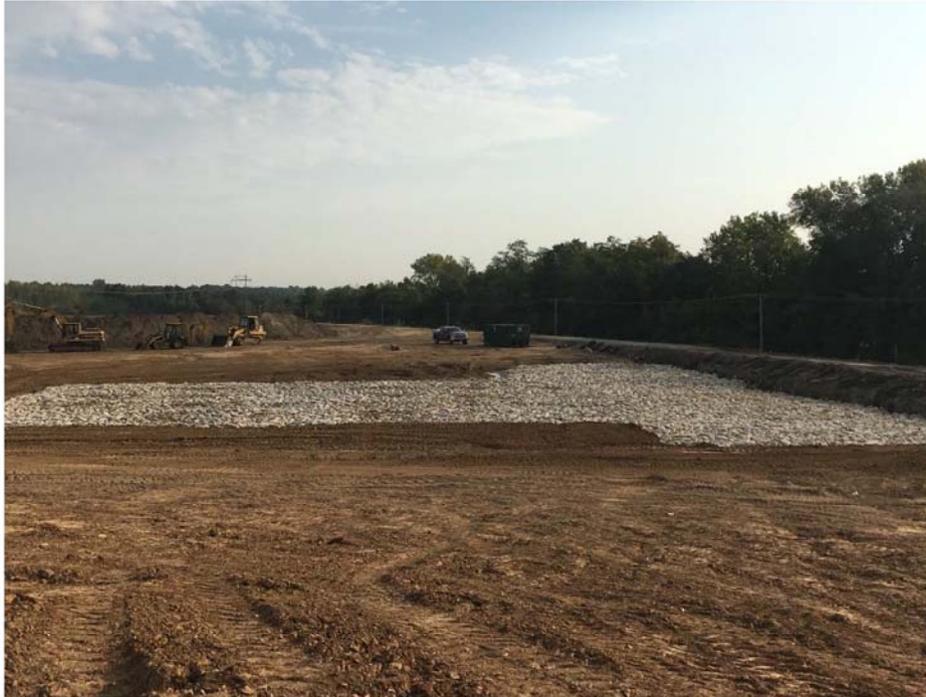
Figure 17: 9/14/2017 View of the southeast discharge location with rip-rap.  
(facing north)

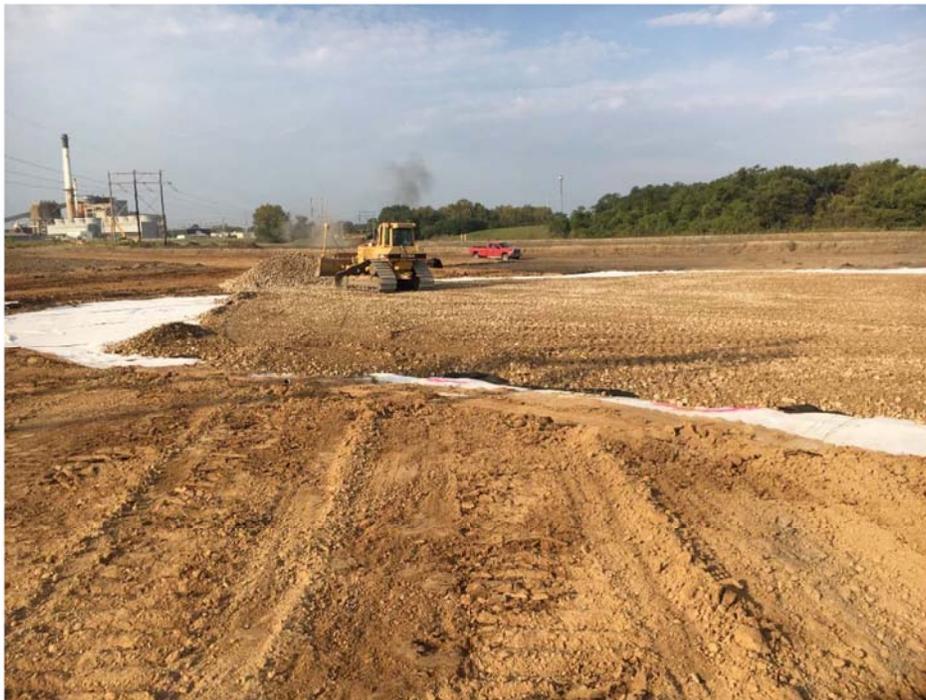
Figure 18: 9/14/2017 Placement of bedding material over geotextile of the north discharge  
location. (facing south)

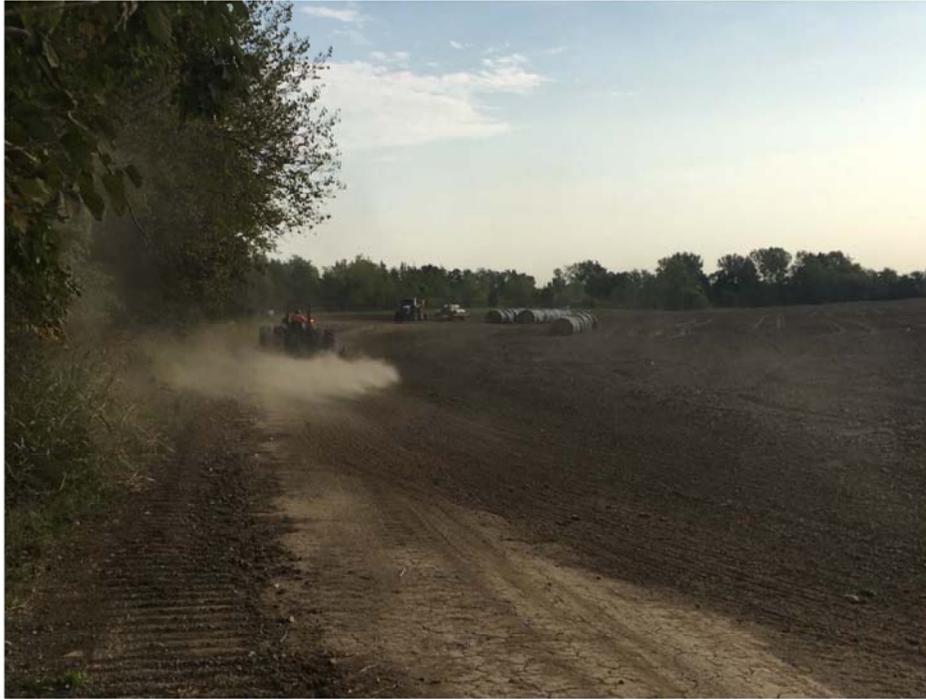
Figure 19: 9/14/2017 Pine Valley using tractor with spring tooth harrow and chain harrow rake to mix in fertilizer with topsoil in preparation of seeding. (facing north)

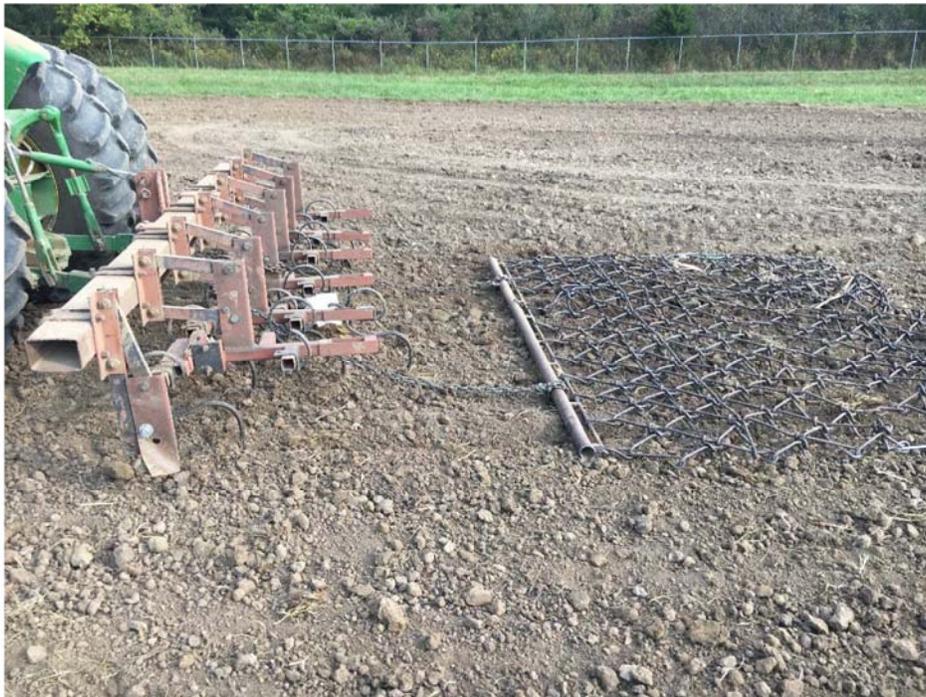
Figure 20: 9/14/2017 Spring tooth harrow and chain harrow rake used to mix in fertilizer and prep the topsoil for the seed. (facing north)

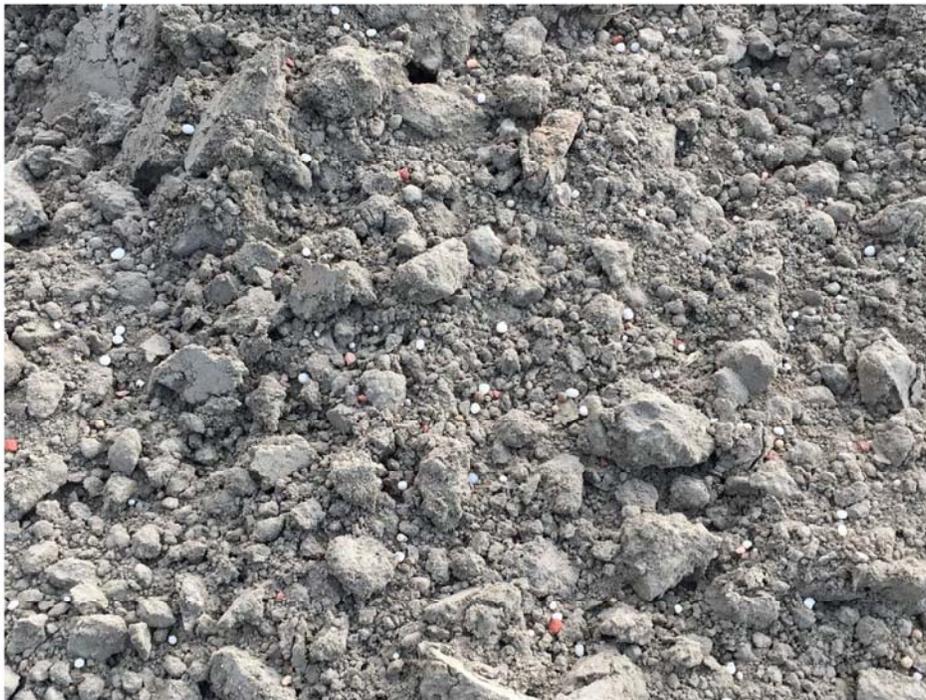
Figure 21: 9/14/2017 Dry fertilizer applied to the surface of the topsoil across the NFAP.

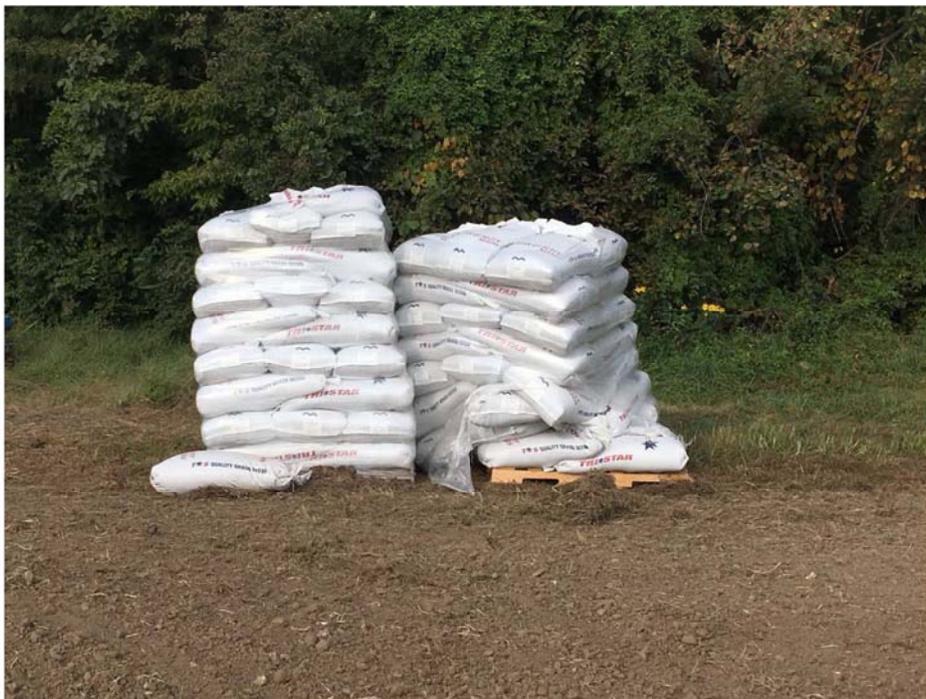
Figure 22: 9/14/2017 Seed temporary staged for seeding of the NFAP. (facing west)

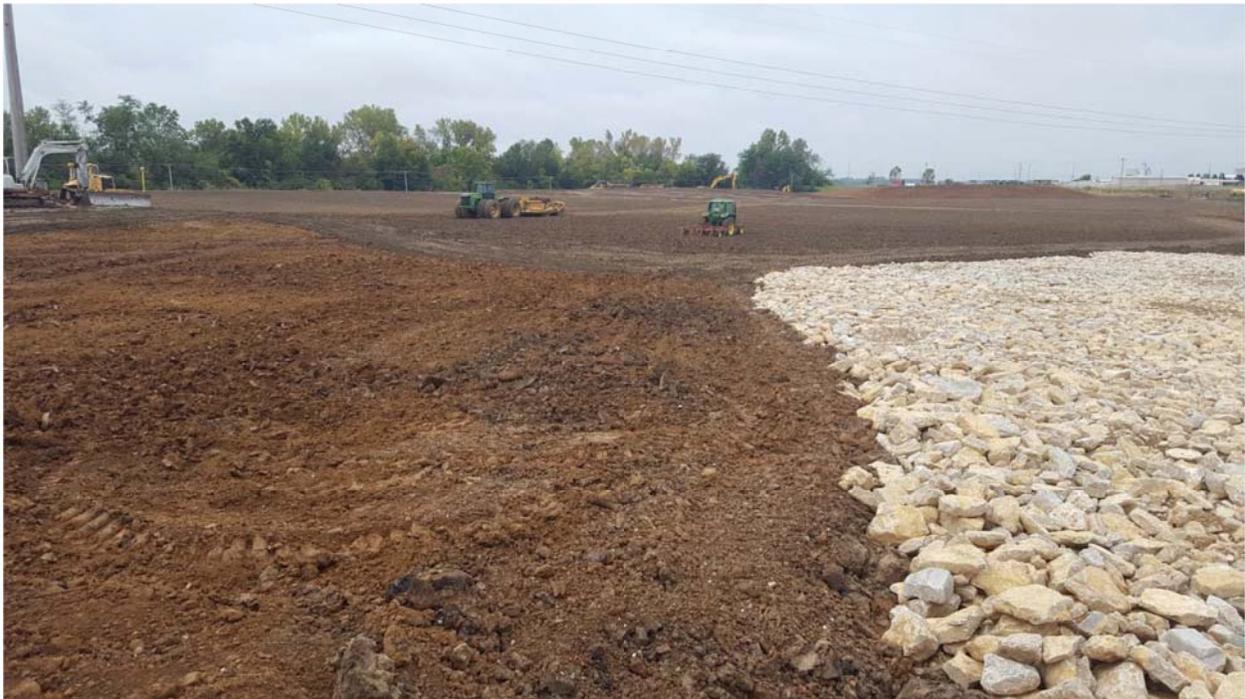
Figure 2: Scraper placing sand and soil being mixed through in the southeast fly ash pond.

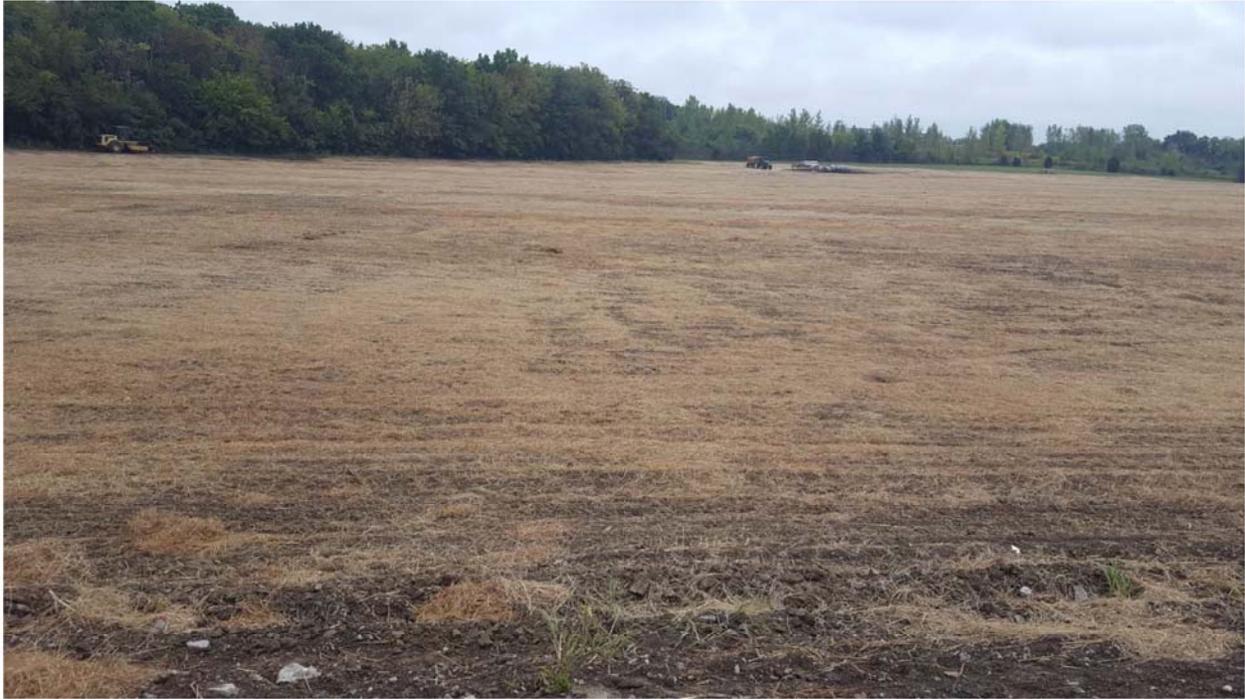
Figure 3: North fly ash pond completely covered with hay after seeding and fertilizing was completed.

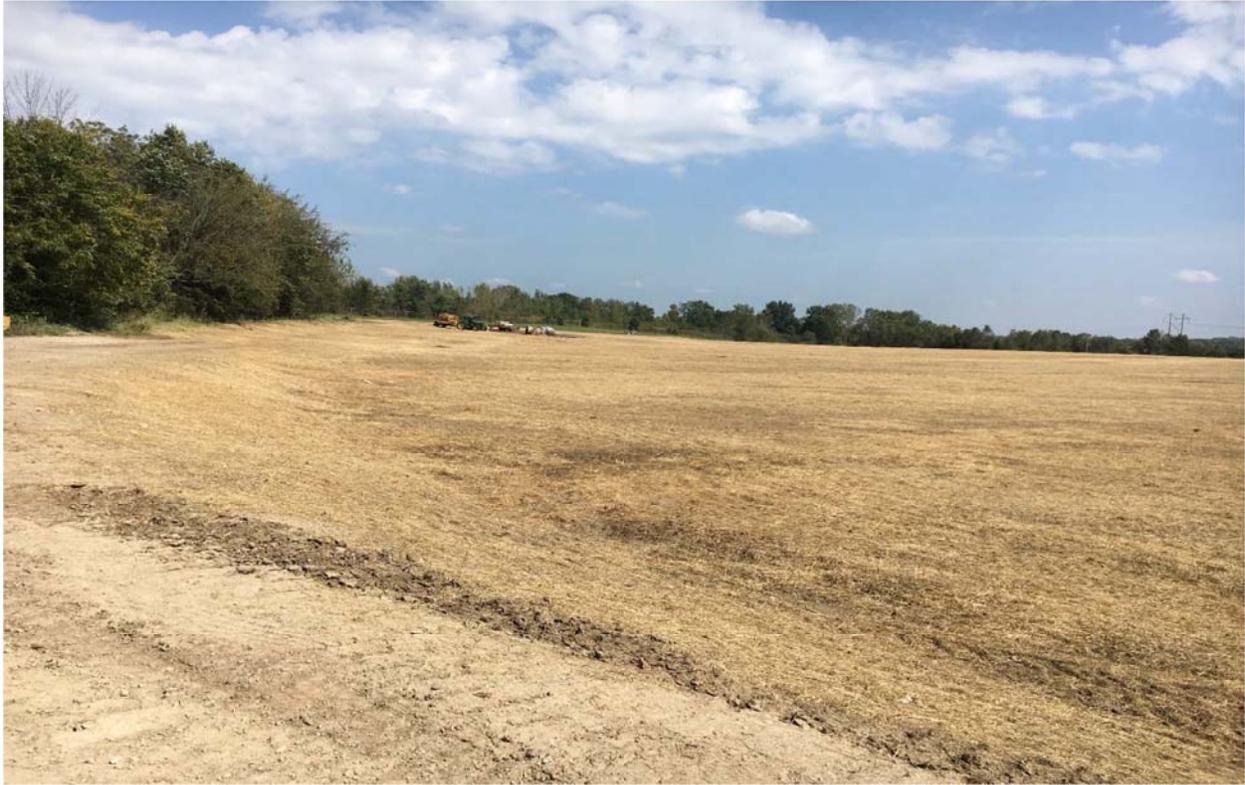
Figure 1: The seeding and fertilizer covered with hay over the topsoil on the north fly ash pond.

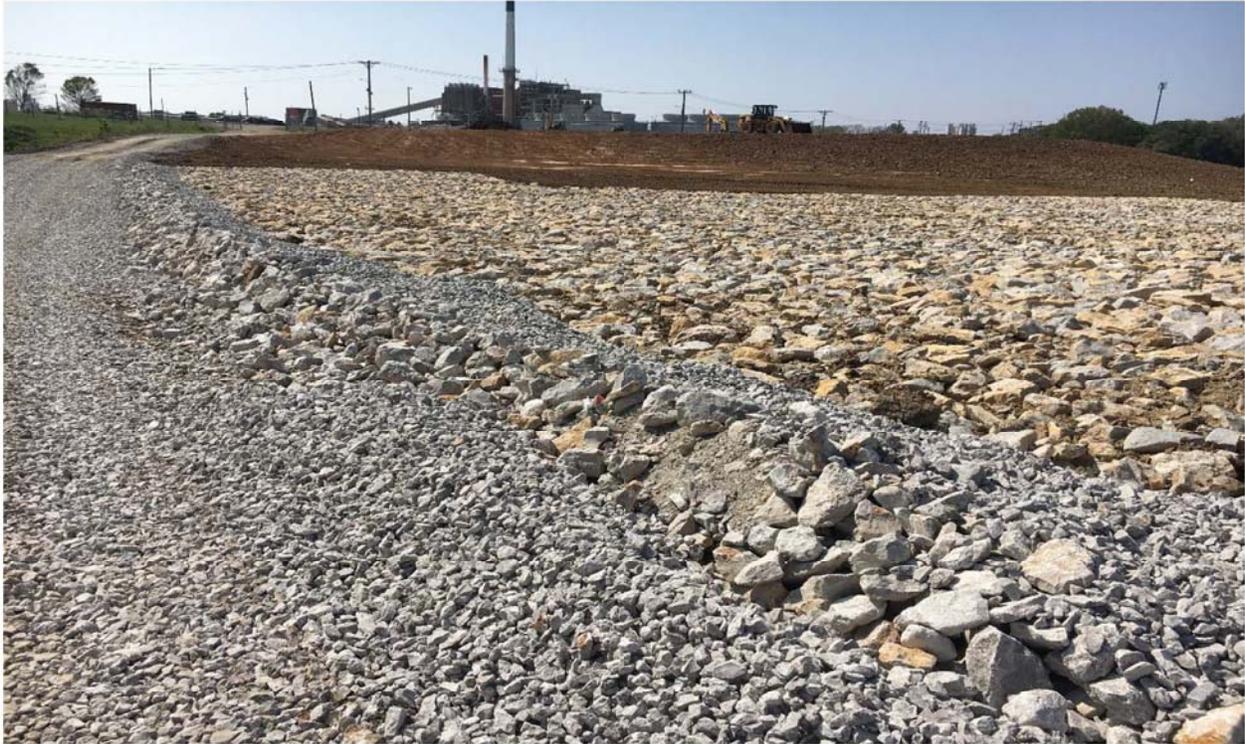
Figure 3: Rip-rap rock placed along the east access road of the southeast fly ash pond.

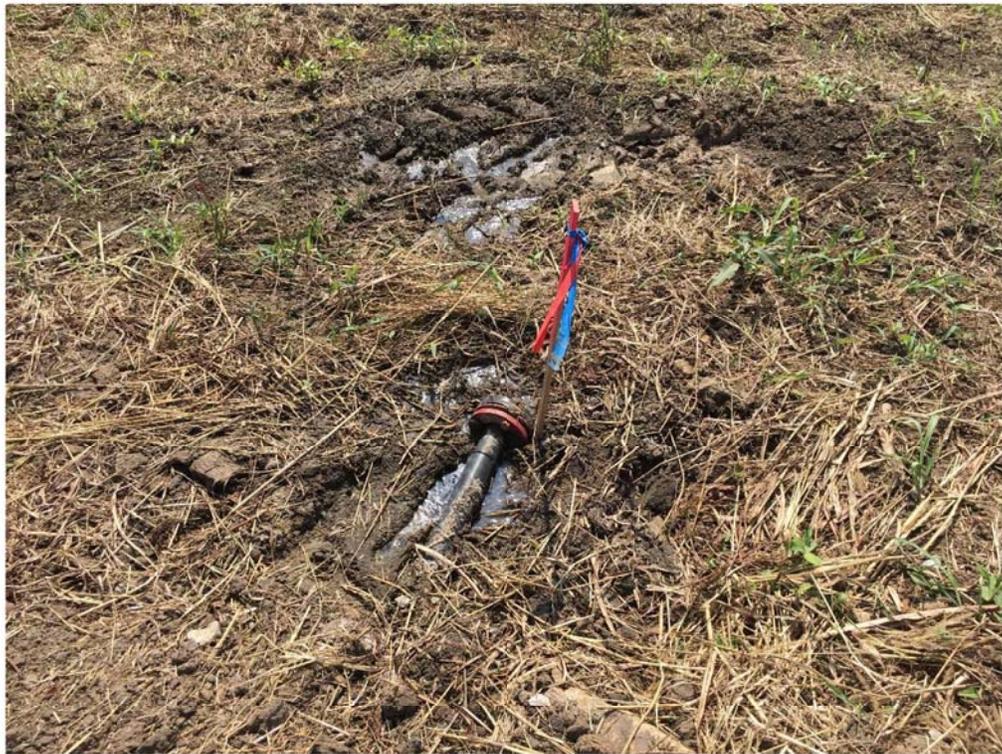
Figure 4: Pressure relief pipe end installed on south discharge of NFAP.

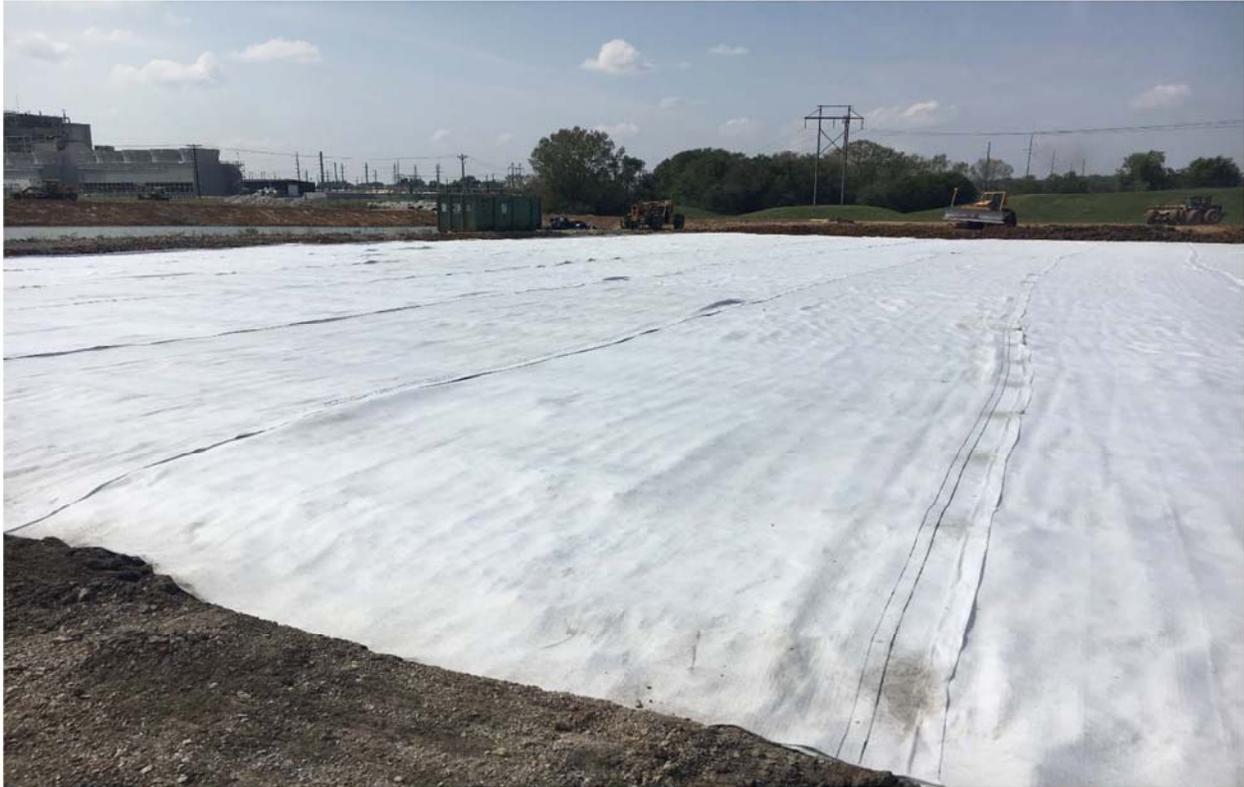
Figure 1: BentoLiner GCL installed on the south end of the bottom southwest fly ash pond.

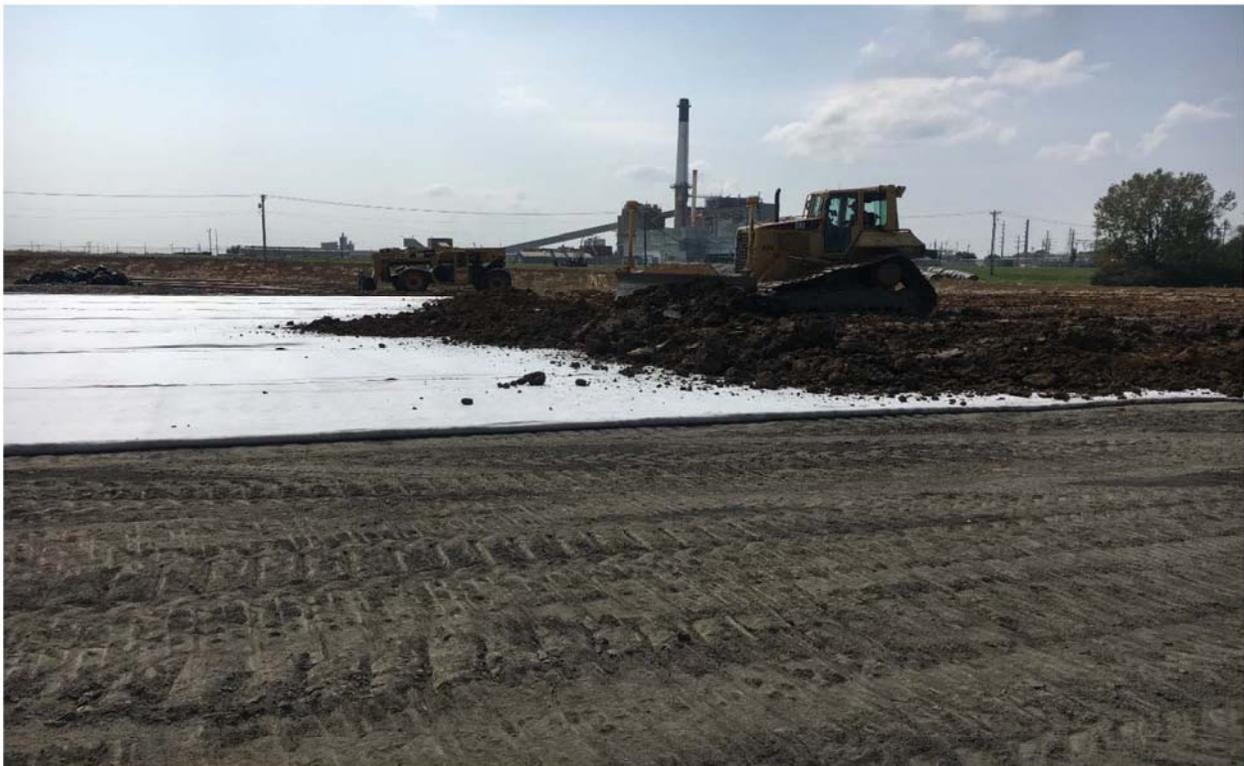
Figure 2: Dozer pushing a minimum of 1 foot of soil over the GCL panels on the southwest fly ash pond.

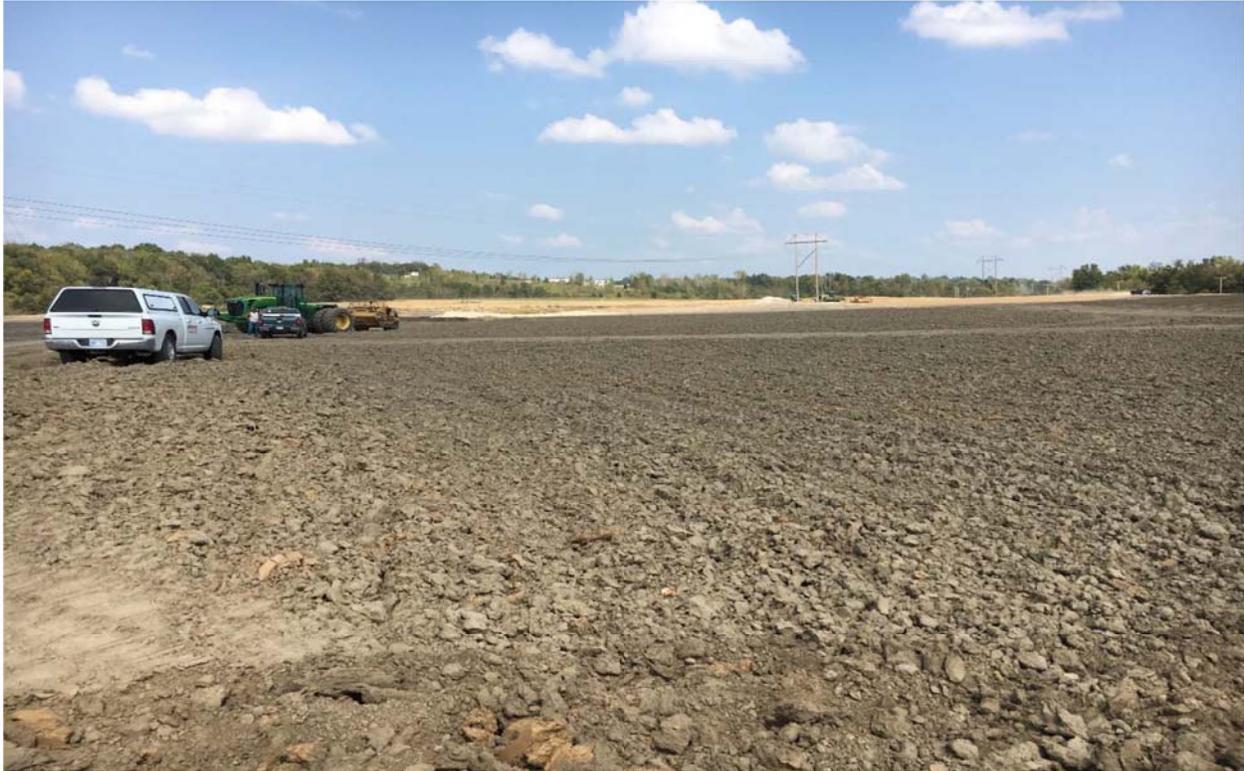
Figure 5: The southeast fly ash pond with tilled in topsoil mix prior to final discing.

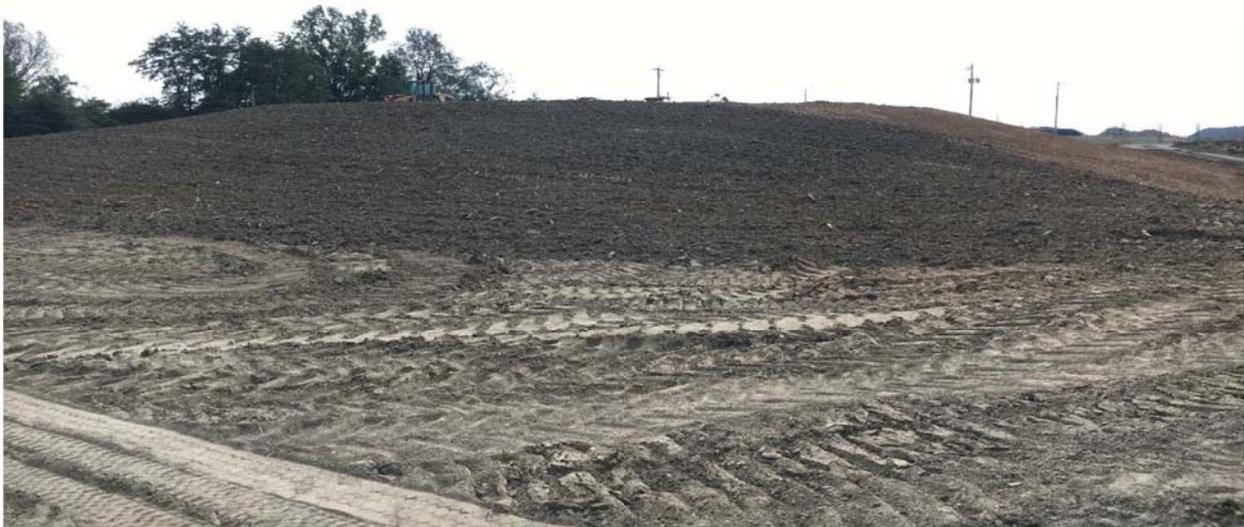
Figure 6: Topsoil mixed in with the clay on the south end of the southeast fly ash pond.

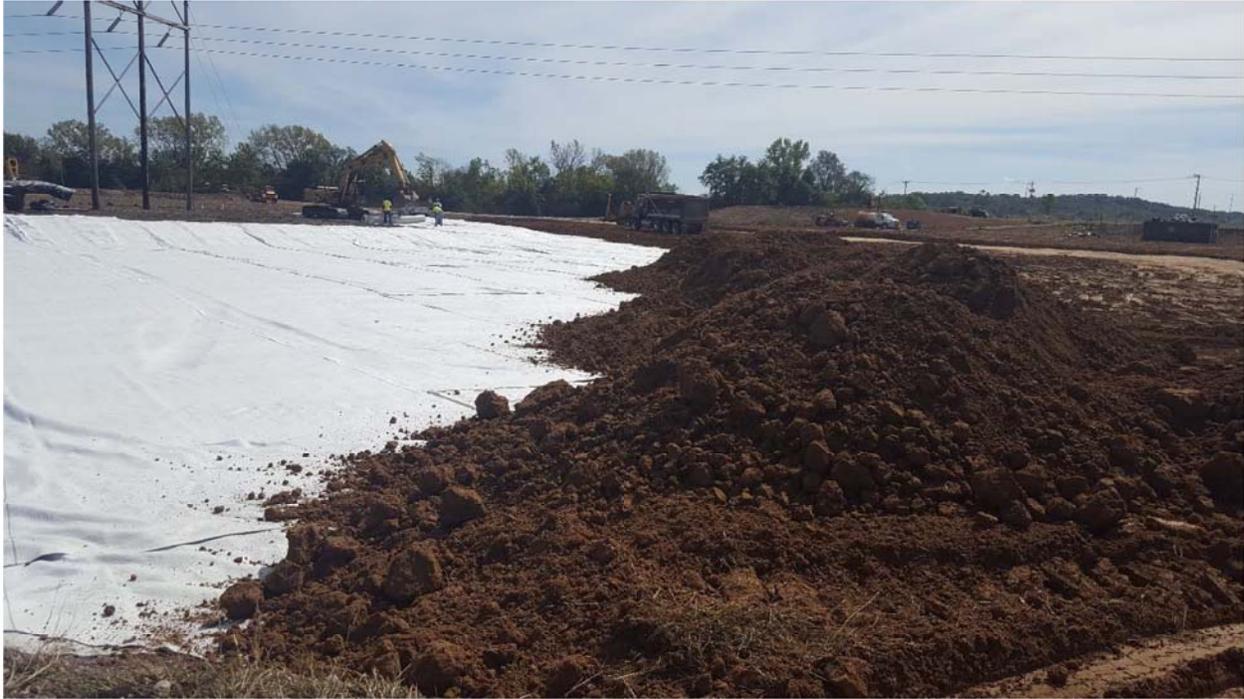
Figure 1: Radmacher installing BentoLiner GCL panels in the middle of the bottom southwest fly ash pond.

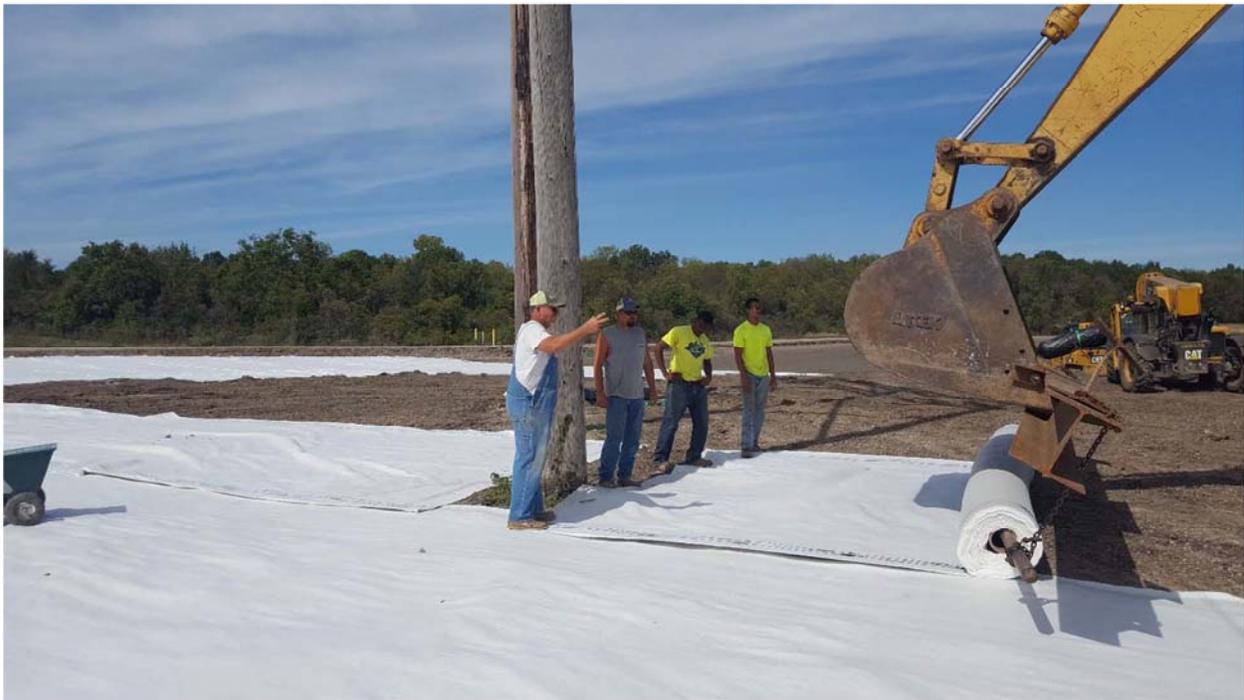
Figure 2: Radmacher installing GCL panels around the power poles in southwest fly ash pond.

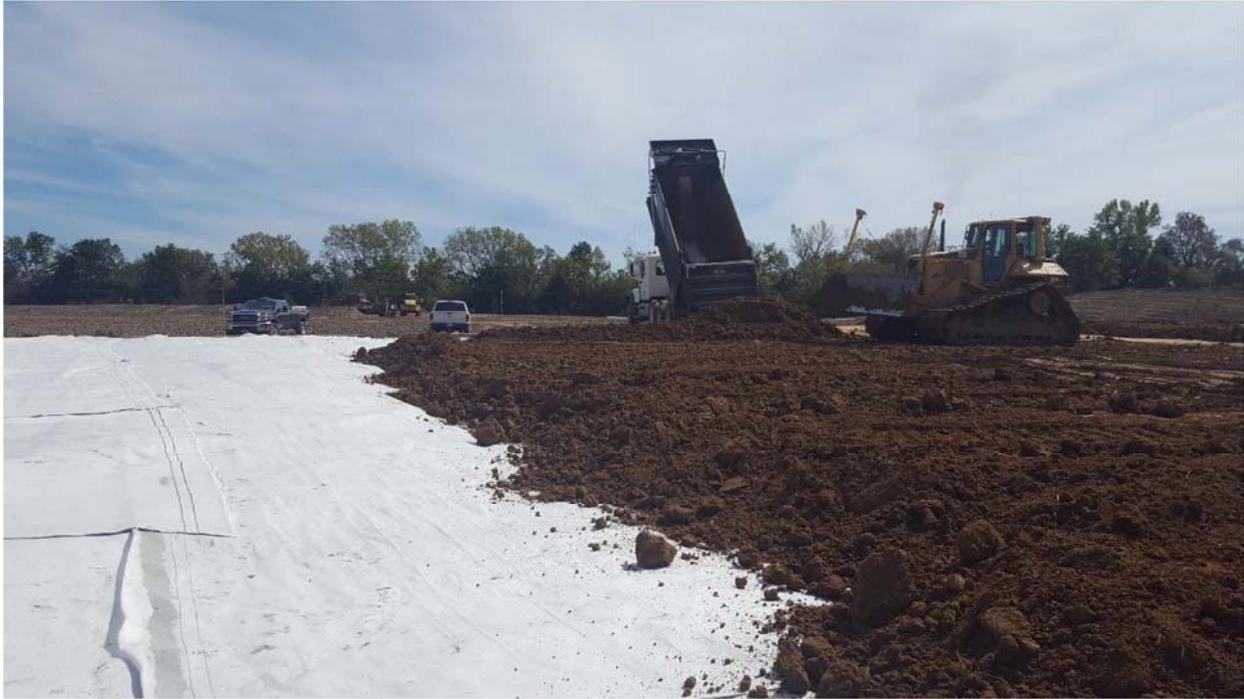
Figure 3: Haul trucks depositing clay and the dozer placing it a minimum of 1 foot thick over the GCL panels placed.

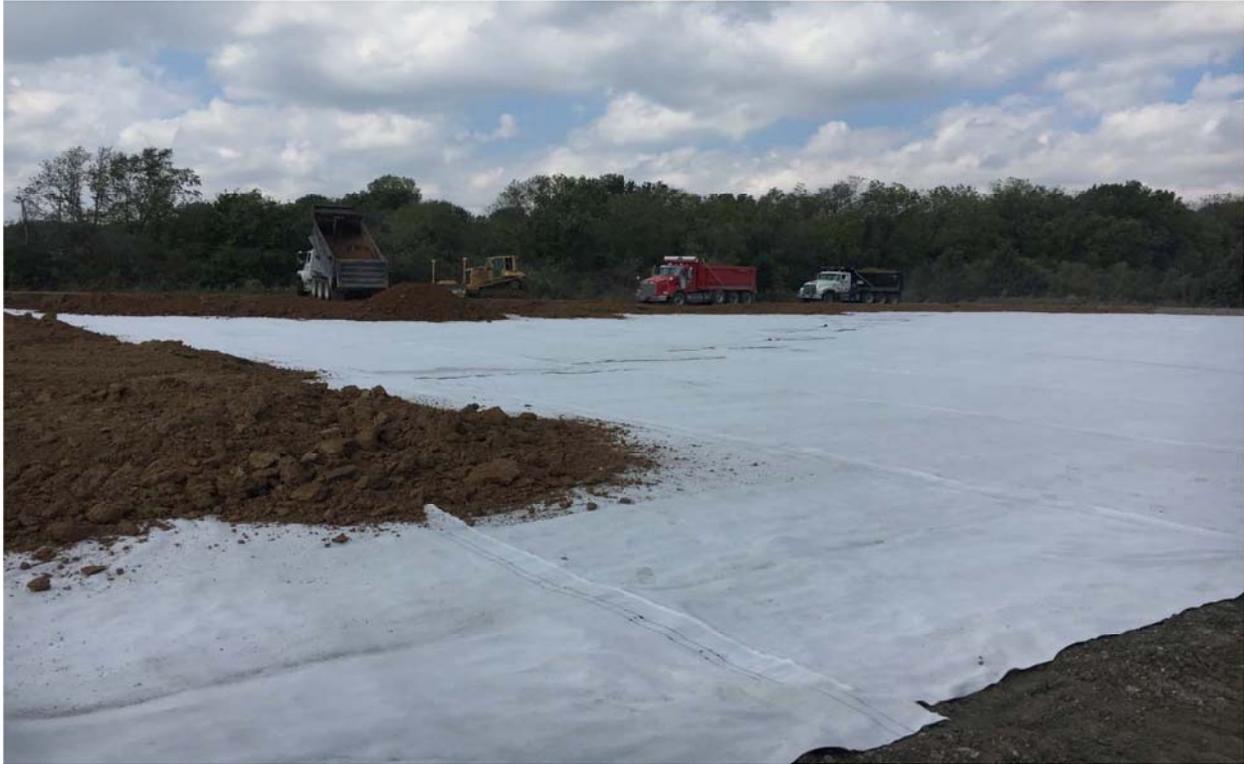
Figure 1: Haul trucks bringing in clay and dozer placing soil a minimum of 1 foot in the bottom southwest fly ash pond over installed GCL panels.

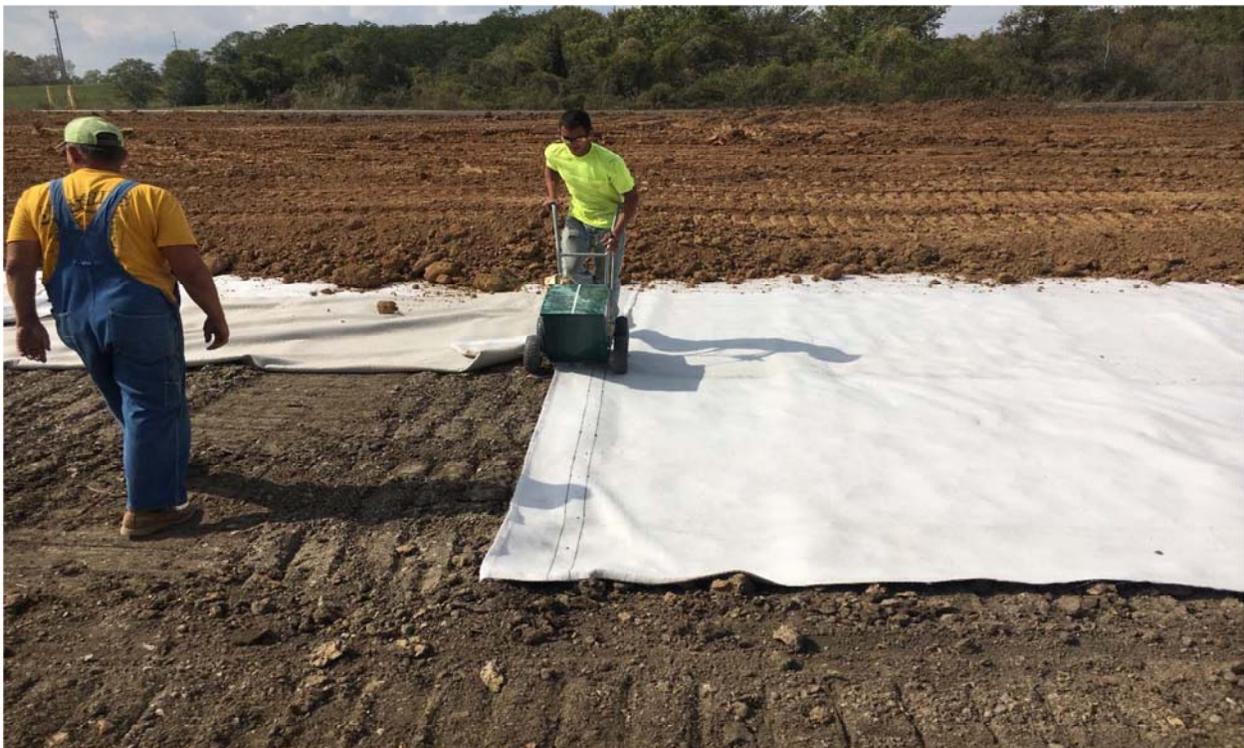
Figure 2: Radmacher personnel installing bentonite powder between the GCL panels in the north end of the southwest fly ash pond.

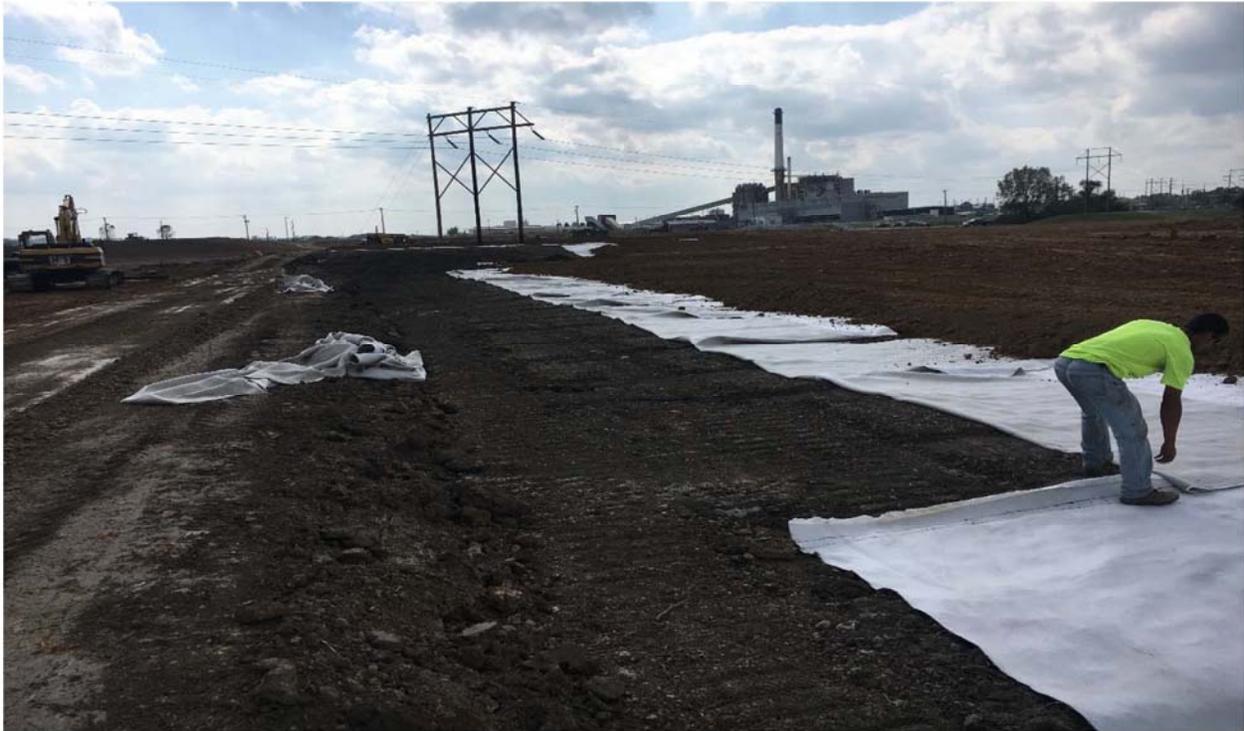
Figure 3: The east edge of the bottom southwest fly ash pond with GCL panels placed.

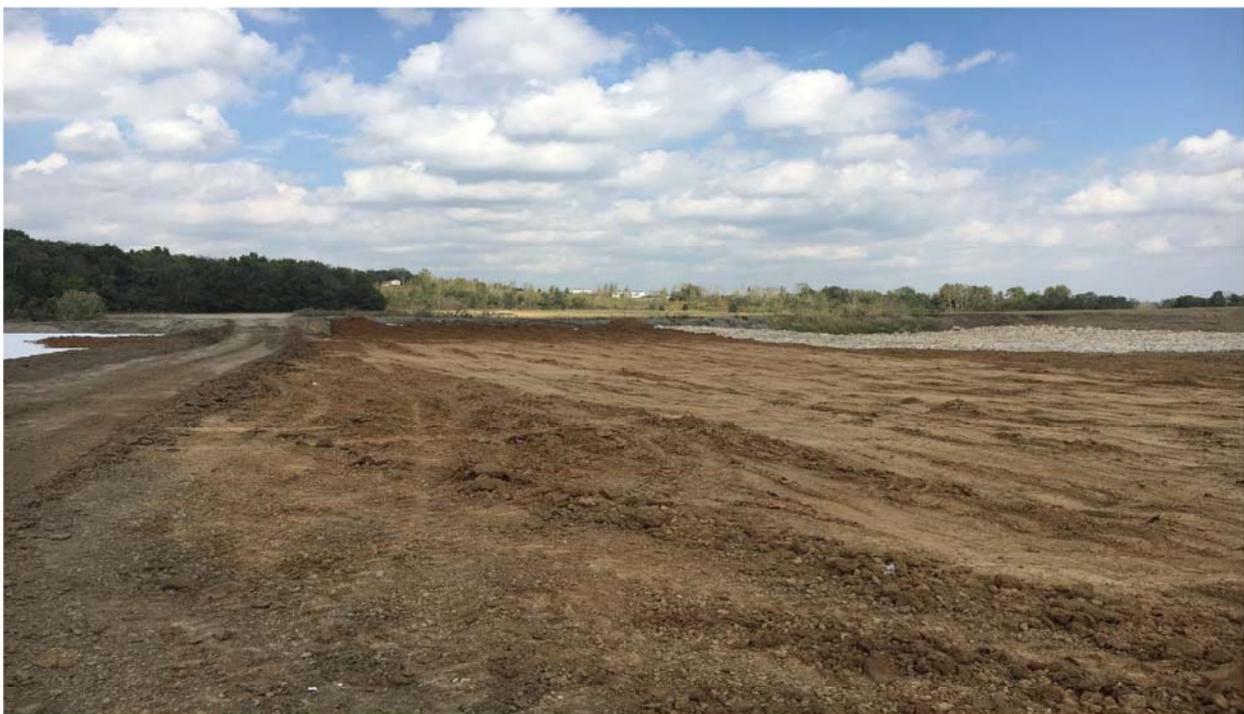
Figure 4: Soil was placed over the GCL installed in the northwest corner of the southeast fly ash pond and around the rip-rap rock.

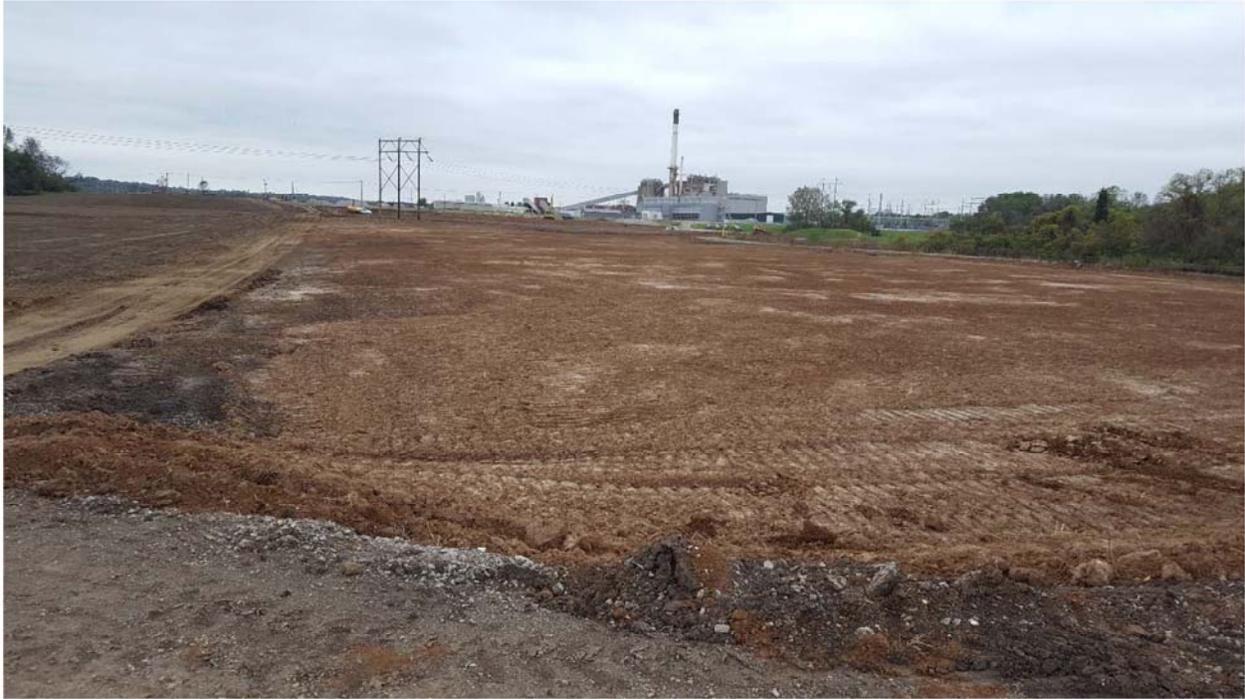
Figure 1: The bottom southwest fly ash pond with 1 foot of clay covering the installed GCL panels.

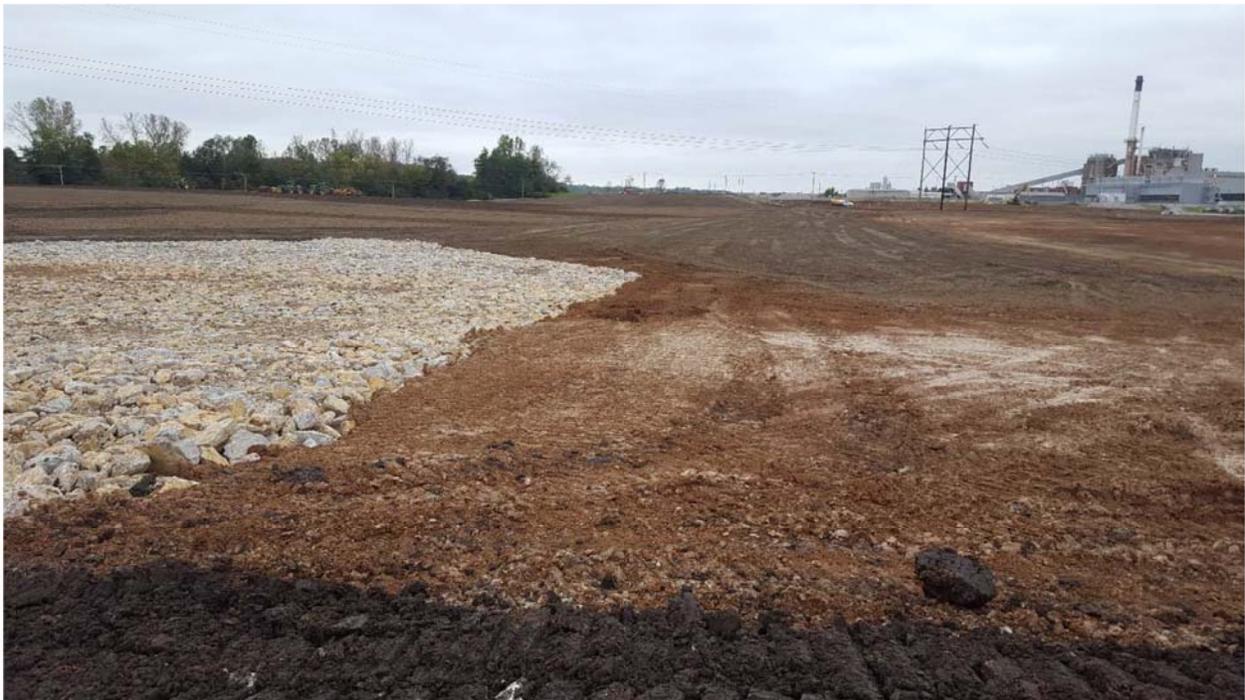
Figure 2: Clay was placed over the GCL panels up to the rip-rap rock in the northwest corner of the southeast fly ash pond.

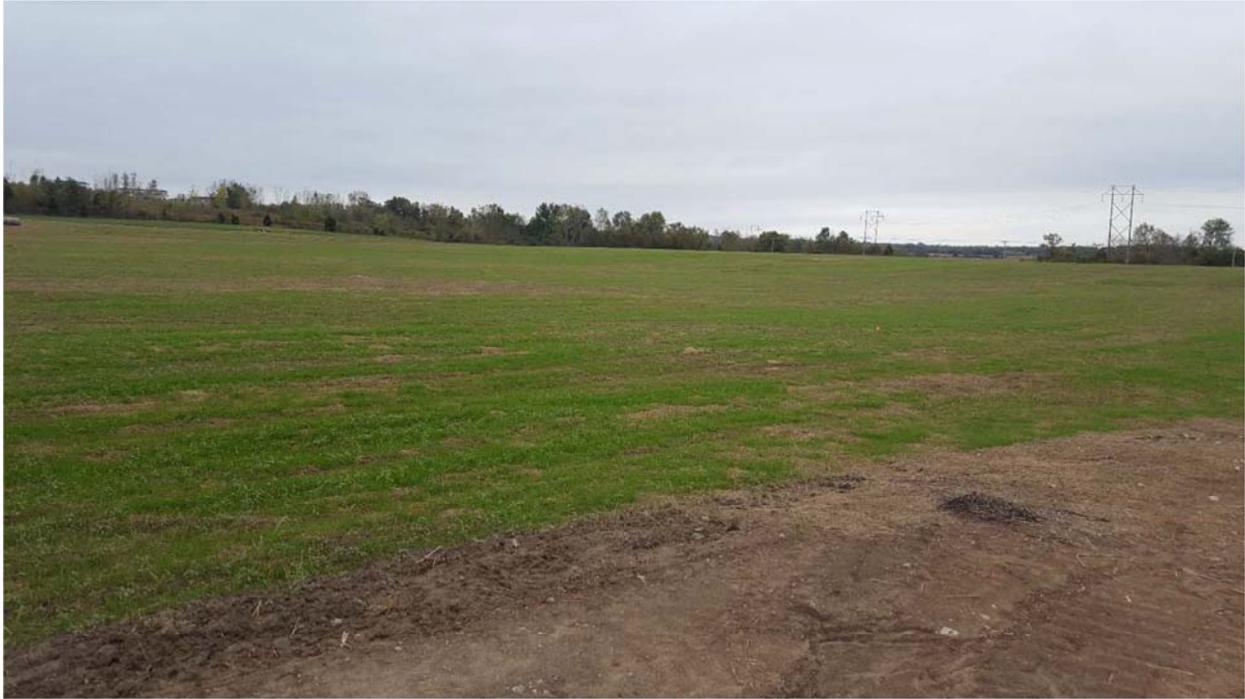
Figure 3: Grass beginning to grow in the north fly ash pond topsoil.
