## **Ash Impoundment Closure Report**

Independence Power & Light  
Blue Valley Power Station  
21500 East Truman Road  
Independence, Missouri 64056

**SCS ENGINEERS**  
7311 West 130th Street, Suite 100  
Overland Park, Kansas 66213  
(913) 681-0030

April 2018  
Revised June 2018  
File No. 27215142.00

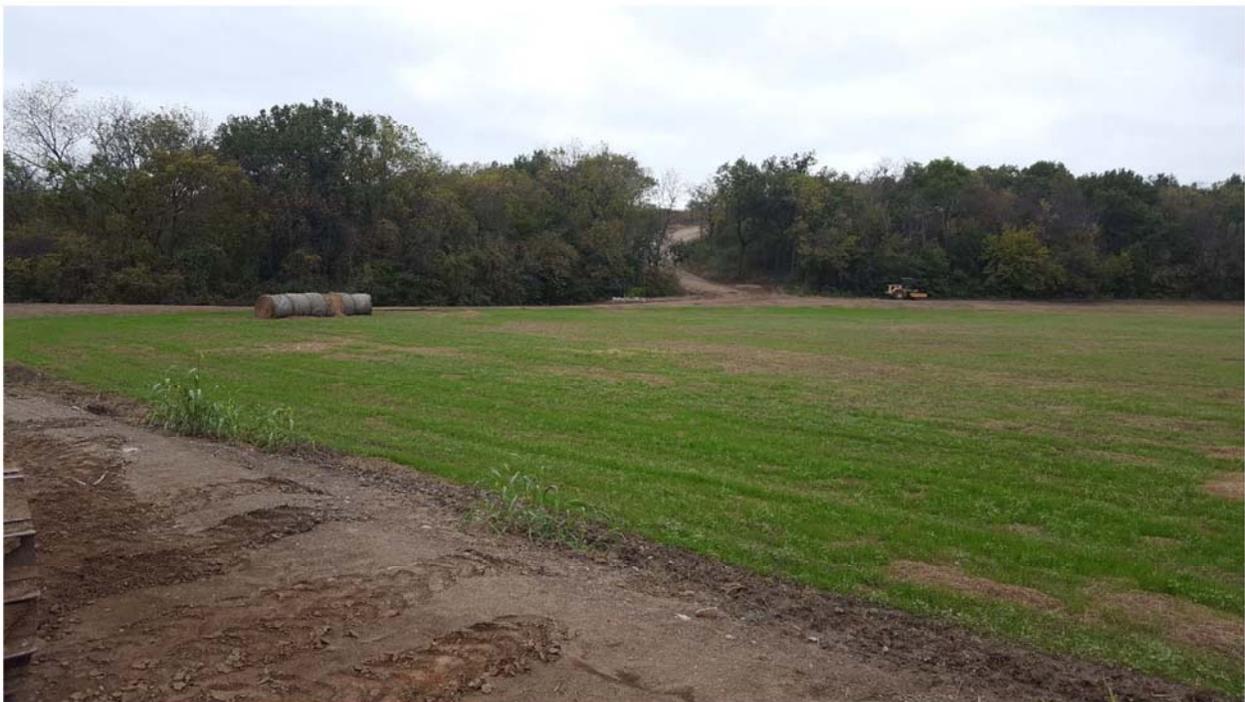
Figure 4: Grass beginning to grow in the north fly ash pond topsoil.

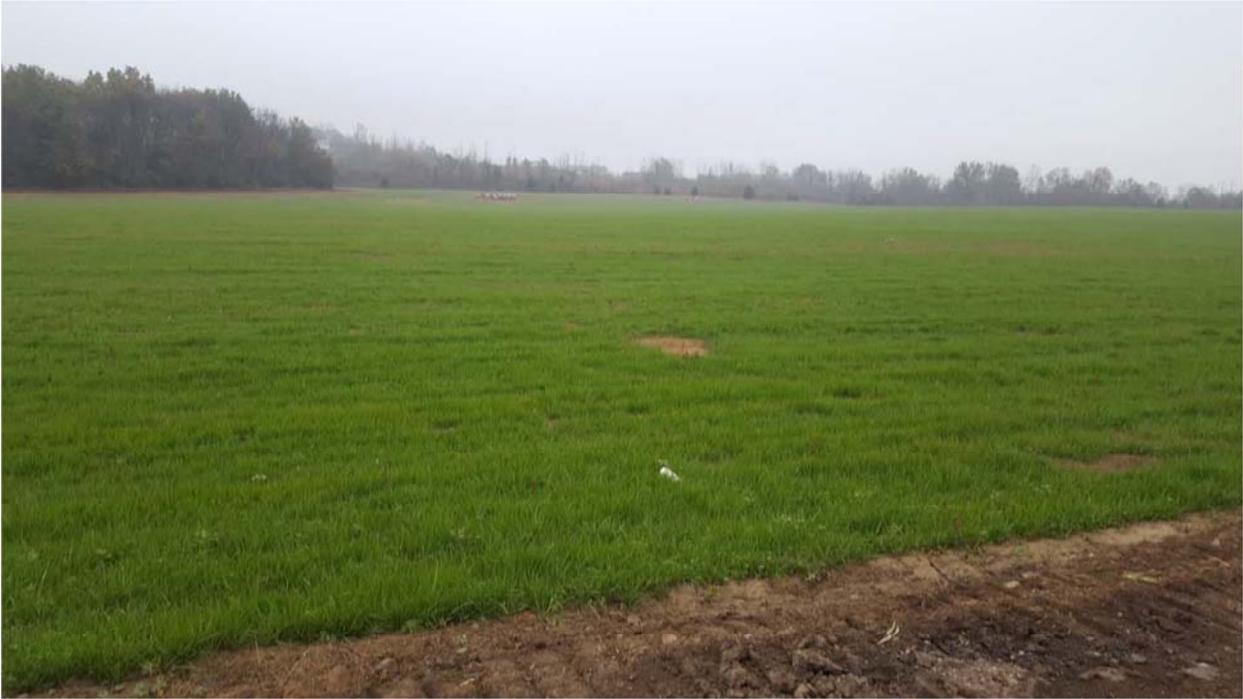
Figure 1: Overview of grass growing in north fly ash pond.

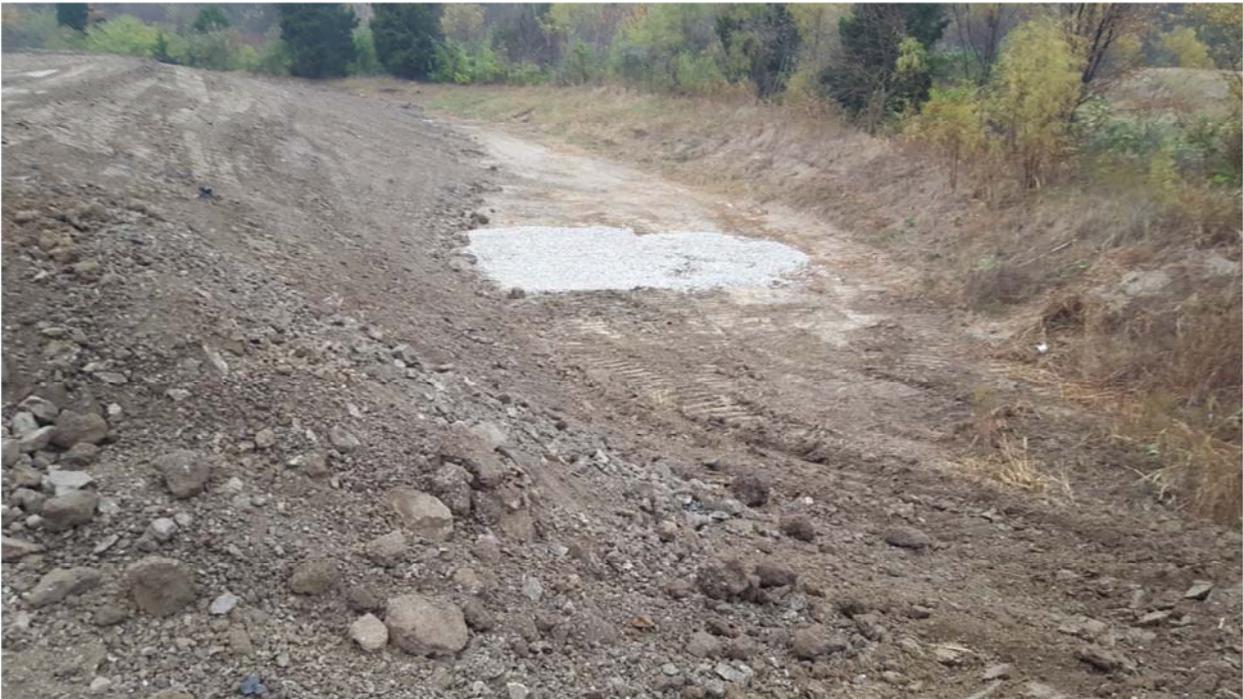
Figure 2: Gravel was placed over the drainage area where the pump house was previously located to help filter out suspended solids during rain events.

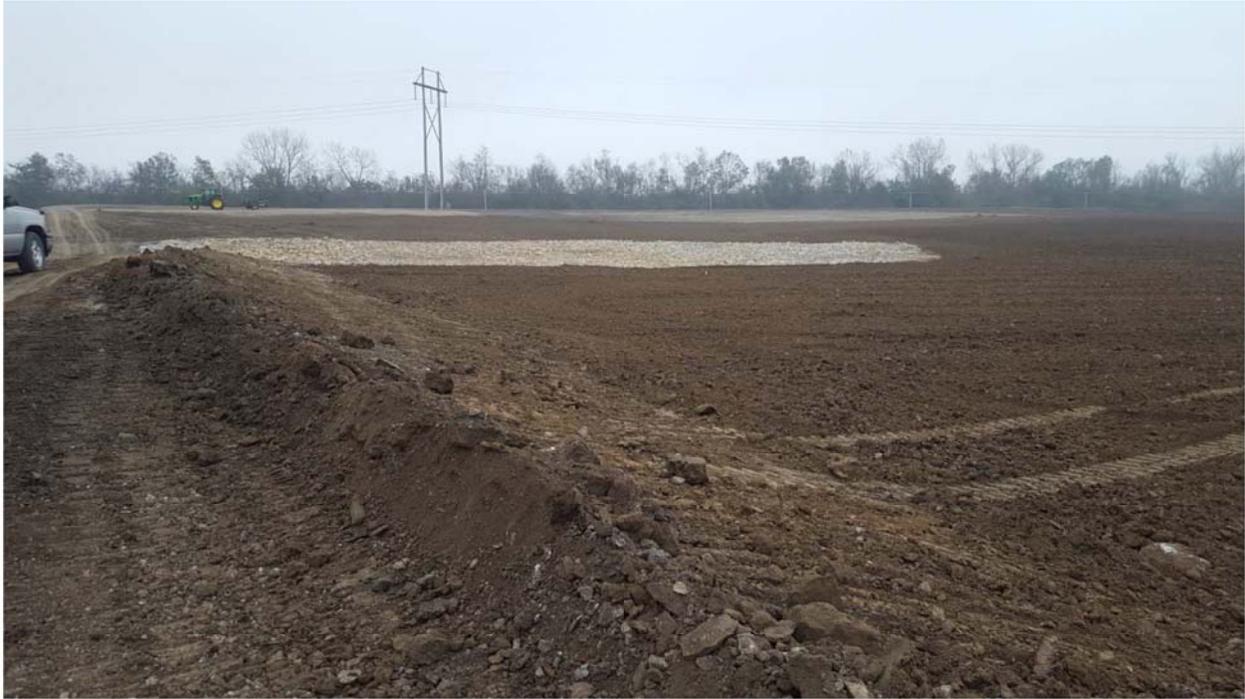
Figure 3: Overview of the south fly ash ponds with topsoil placement completed and mixed in with clay layer.

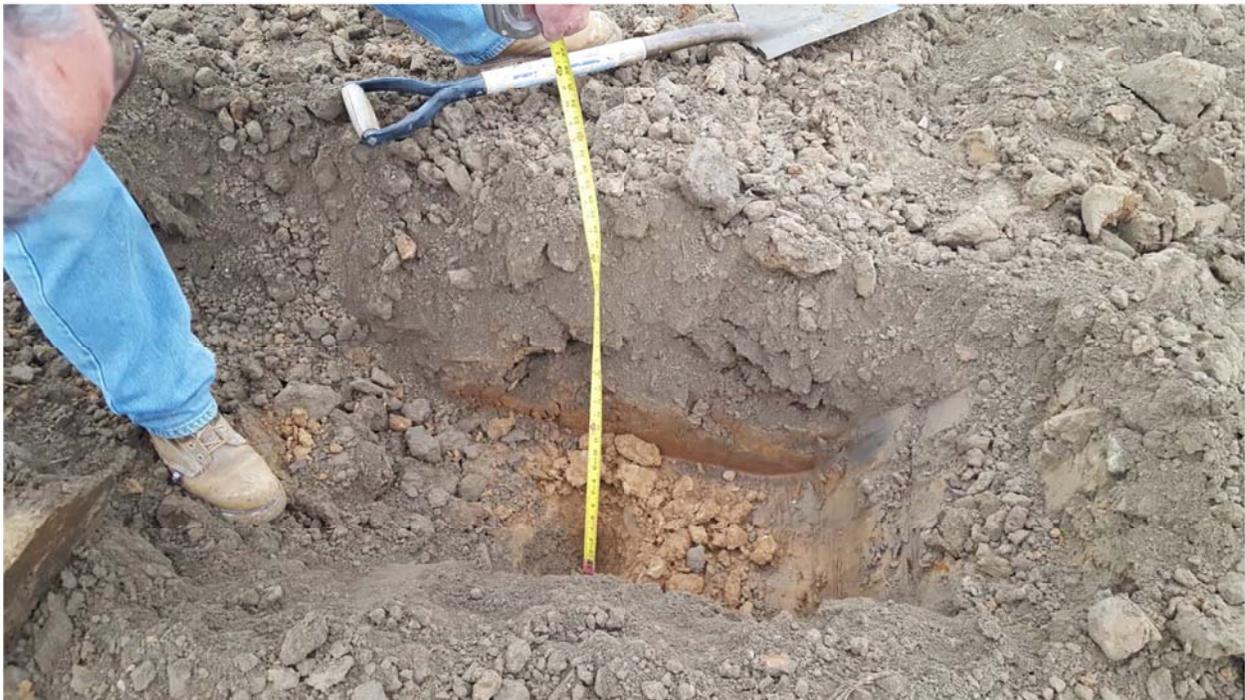
Figure 4: One of the test pot holes to verify a minimum of one foot of topsoil.

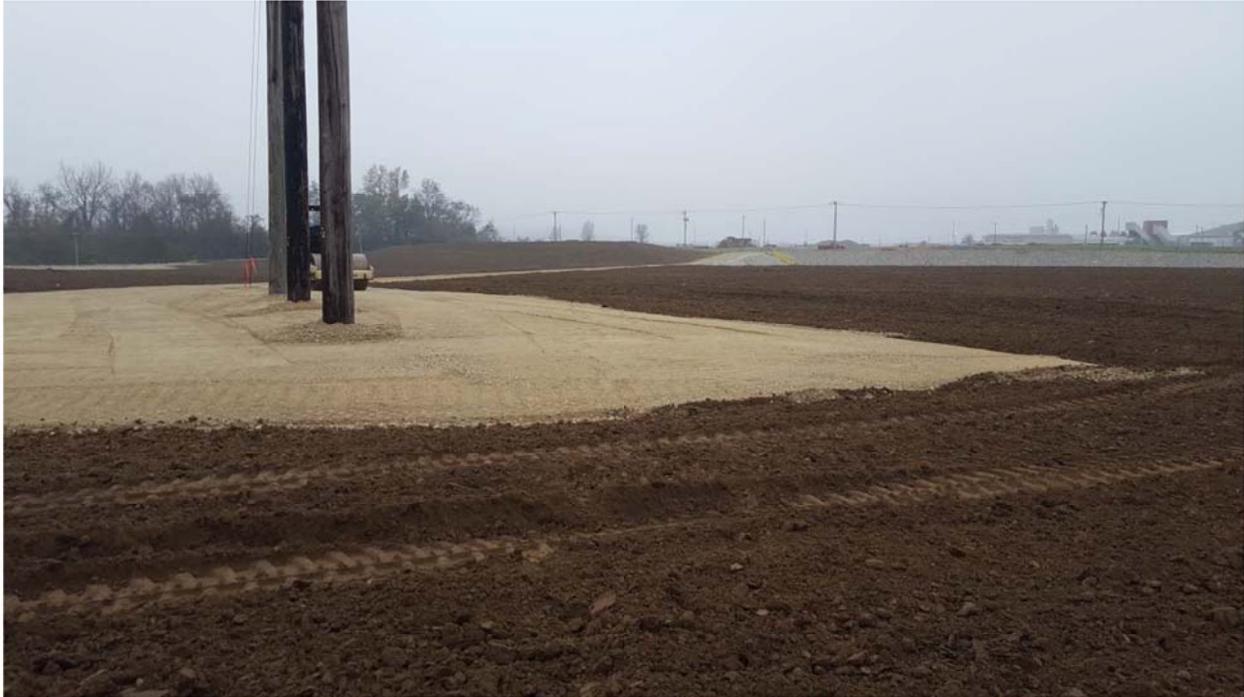
Figure 5: Gravel was placed around the base of the power poles in both the bottom ash and southeast fly ash ponds.

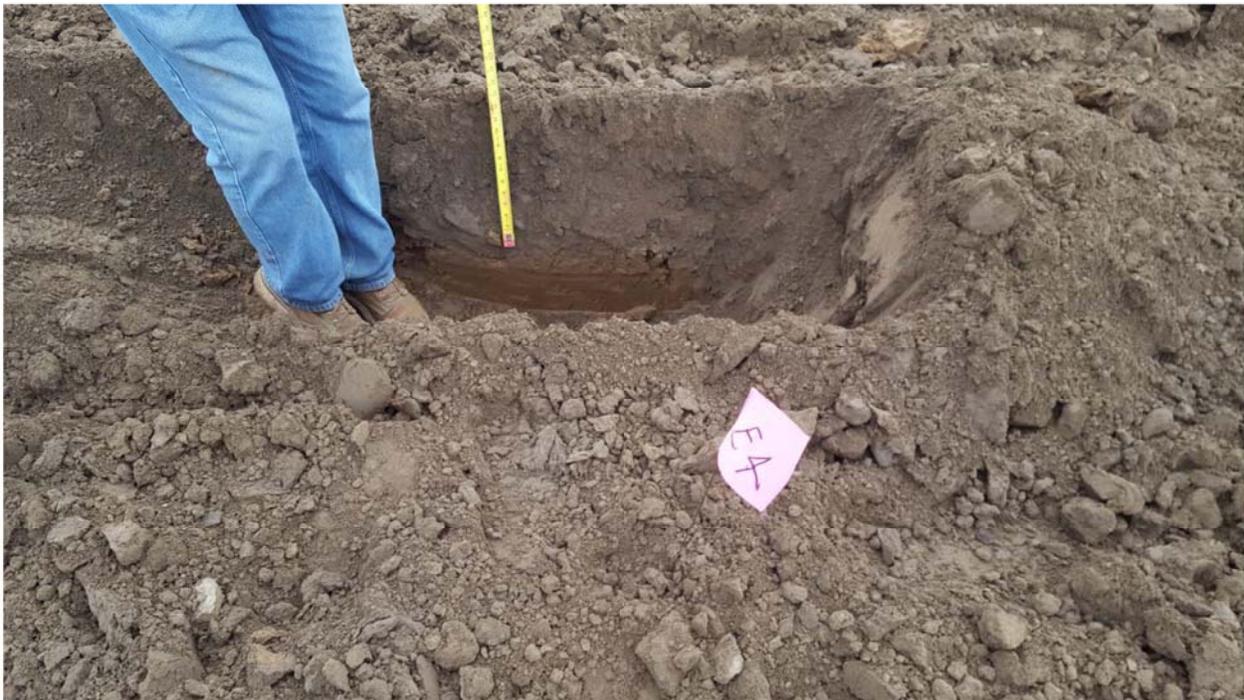
Figure 6: Verifying a minimum of one foot of topsoil mixed in with the clay at one of the test pot hole locations.

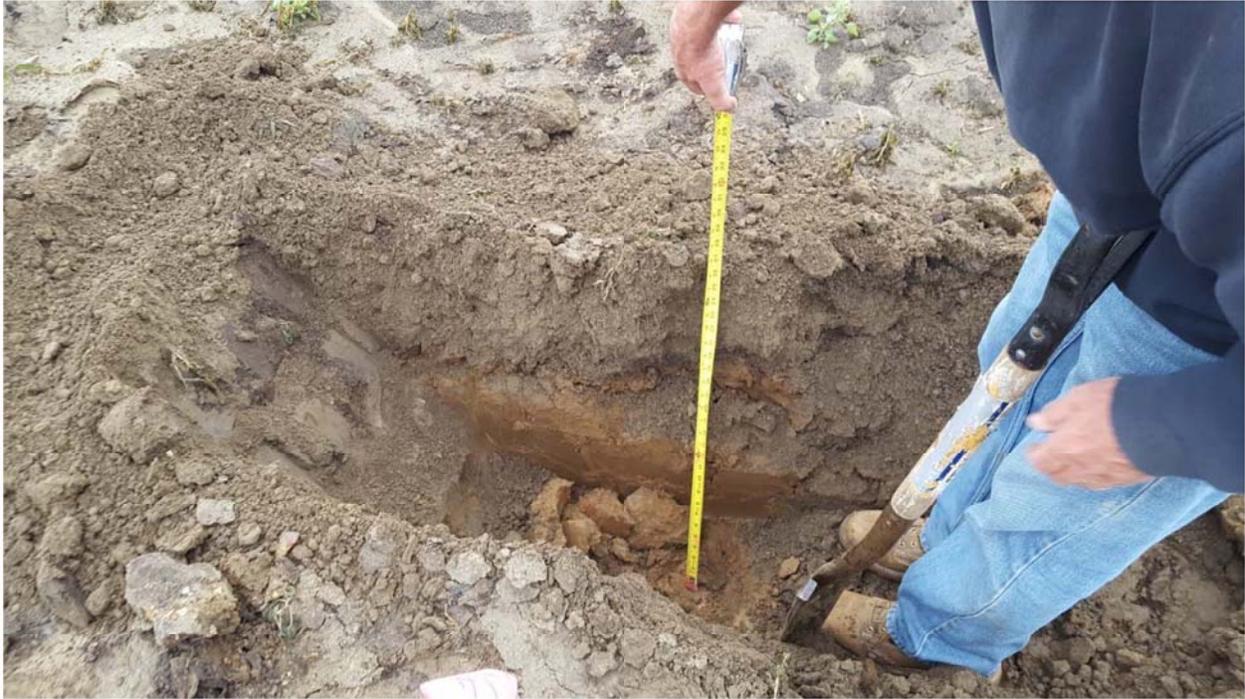
Figure 7: Verifying clay layer thickness and a minimum of one foot of topsoil mixed in with the clay layer at one of the test pot hole locations.

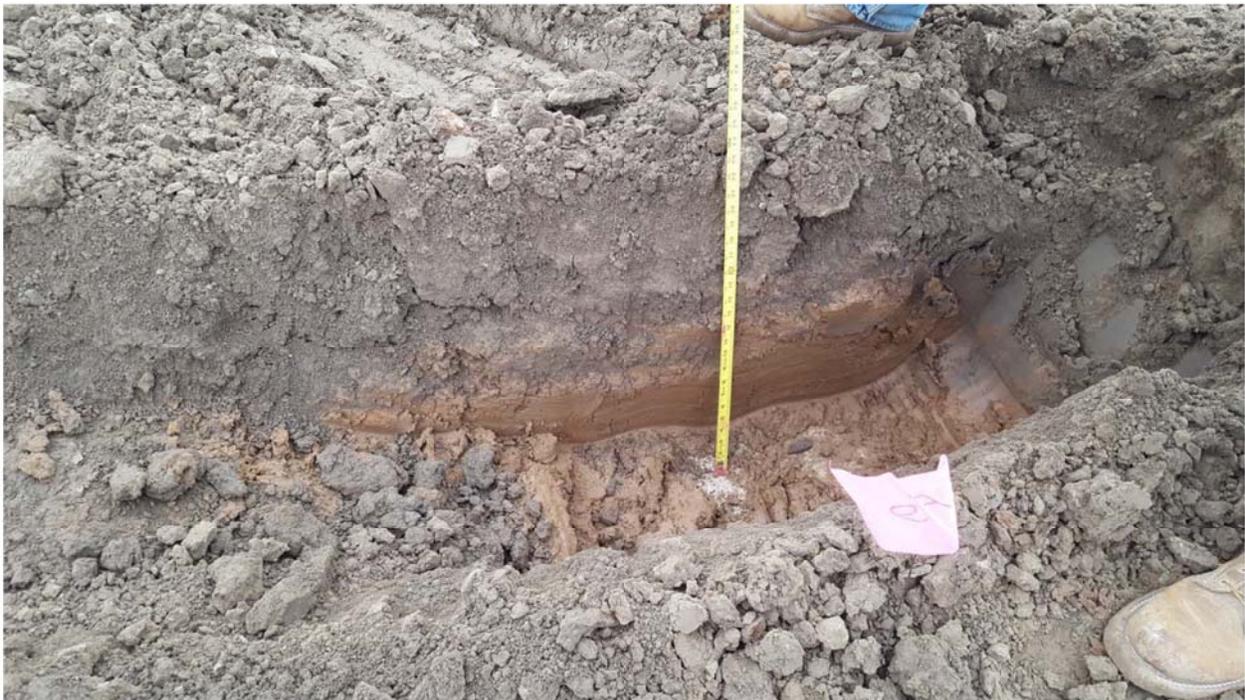
Figure 8: Verifying the clay layer thickness and one foot minimum of topsoil mixed in with the clay layer at one of the test pot hole locations in the southeast fly ash pond.
